# RESERVE STUDY

## The Landing Condominium Association, Inc.

**Altamonte Springs, Florida**

**November 16, 2021**

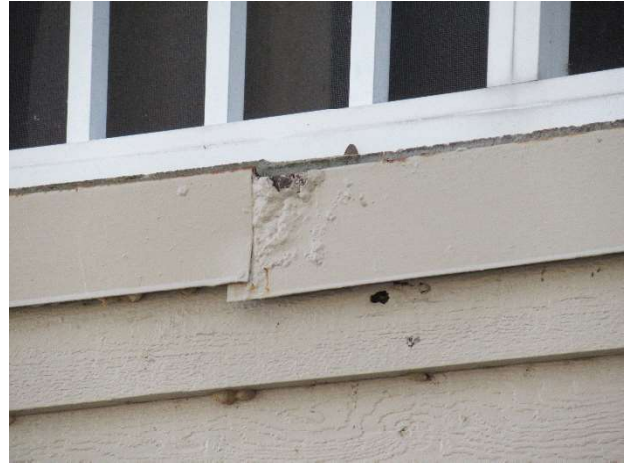
**Misaligned and corroded flashing at balcony edge**

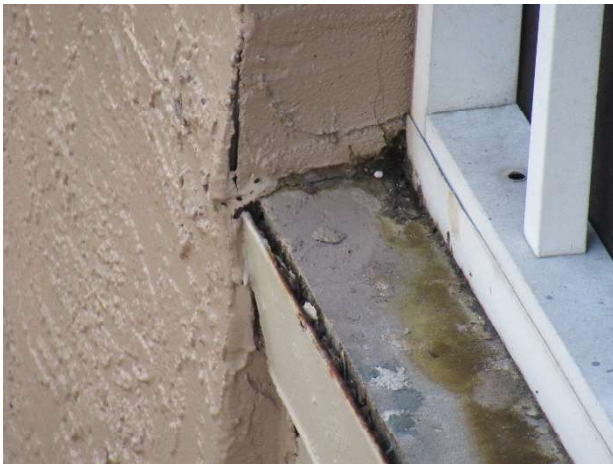
**Detail view of balcony joint to building (note: stains)**

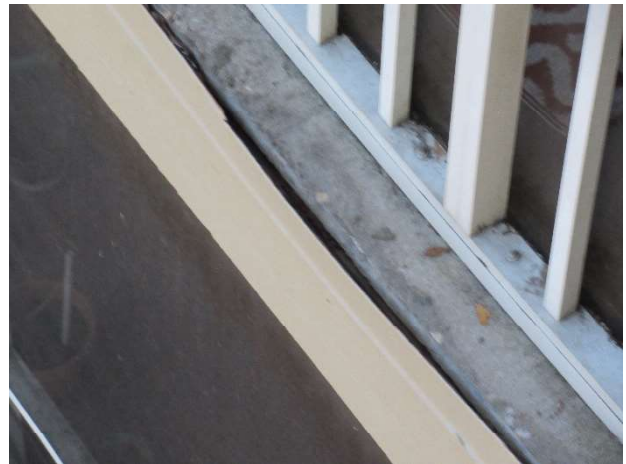
**Misaligned flashing at balcony edge**

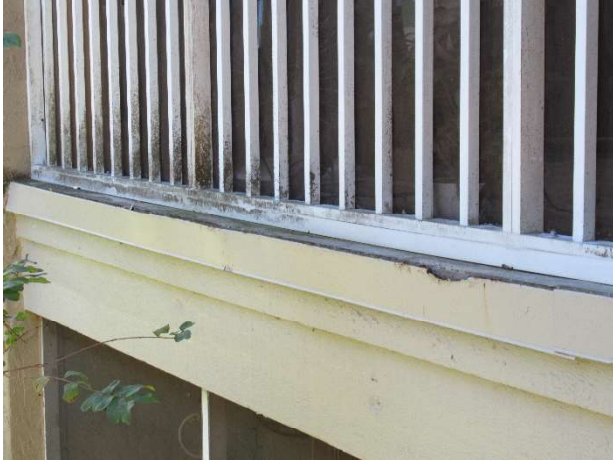
**Damaged flashing and dirt accumulation at railings**

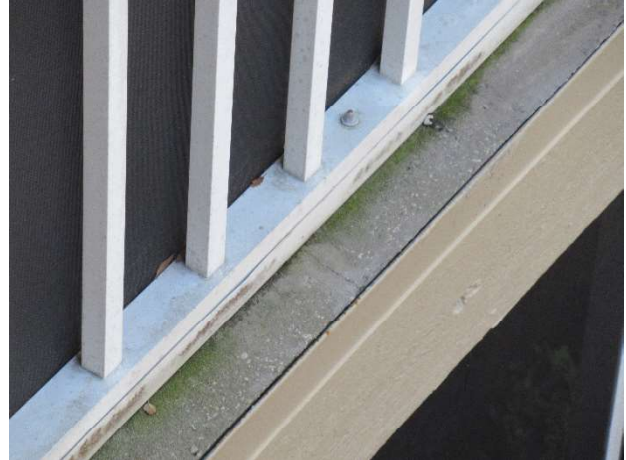
**Organic growth present**

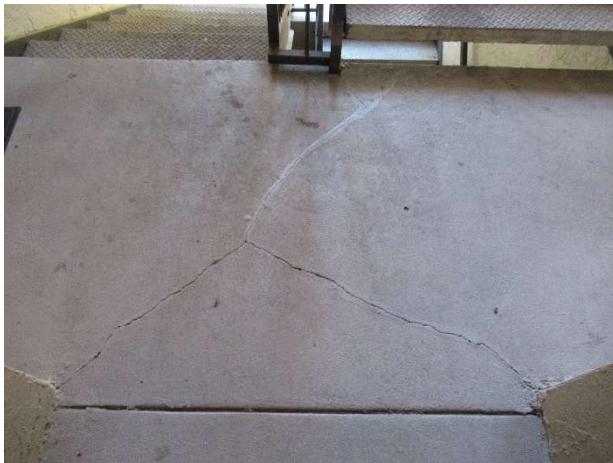
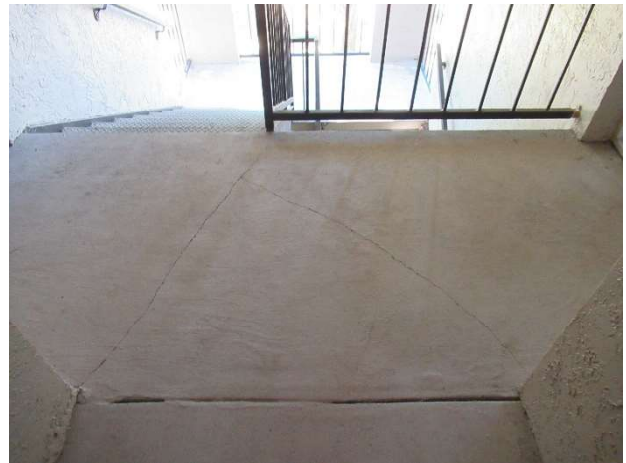
**Condition:** Good to fair overall with isolated misaligned and corroded flashing, organic growth present at the balconies, and concrete cracks at the breezeways

**Cracks at breezeway**

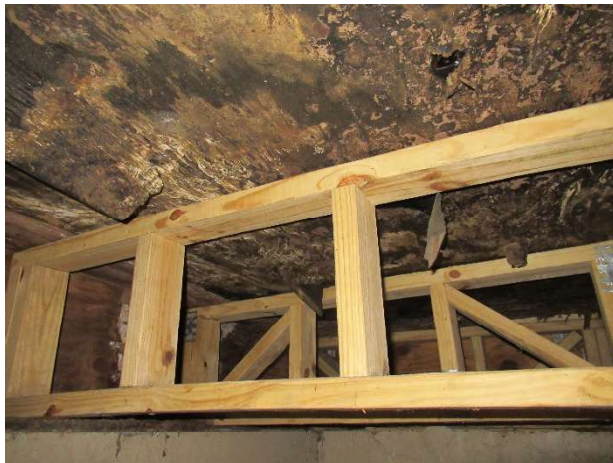
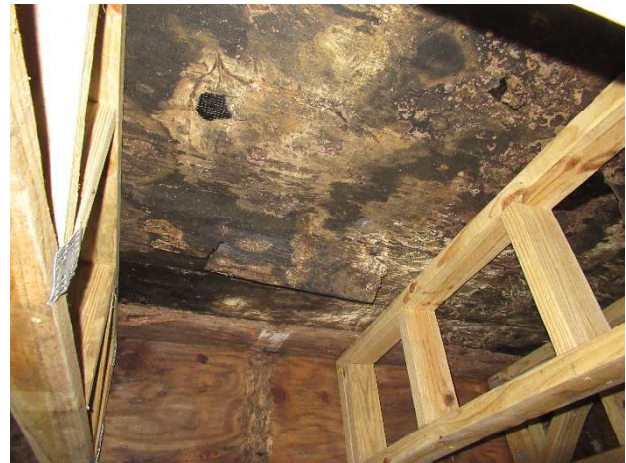
**Condition:** Reported unsatisfactory where visible, actual quantities of wood rot may vary greatly.

Severely rotted plywood at staircase landing  
(building 951)

**Expenditure Detail Notes:** Expenditure timing and costs are depicted in the **Reserve Expenditures** table in Section 3. Due to the noninvasive nature of our inspection we are unable to ascertain the condition of the entirety of the buildings, and the quantities and severity of wood rot throughout. We show an allowance for the Association to

contract in-depth inspections to determine the severity and locations of the wood rot throughout the community. The actual cost of these inspections may vary significantly from our estimates. Once a remediation plan is determined by the Association, future updates of this study can include the costs and detail the scope of work.

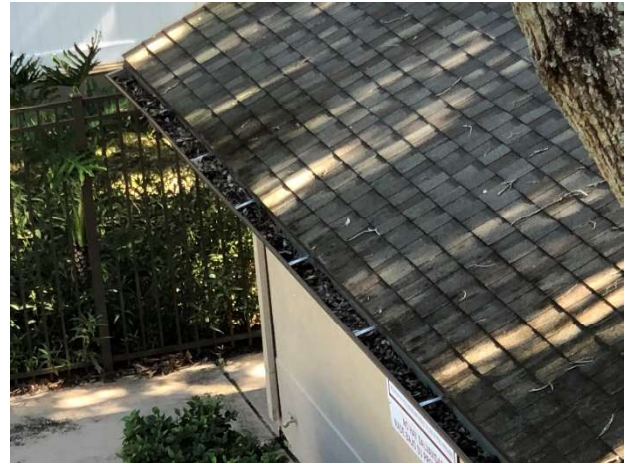
**Debris accumulation at pool house gutters**

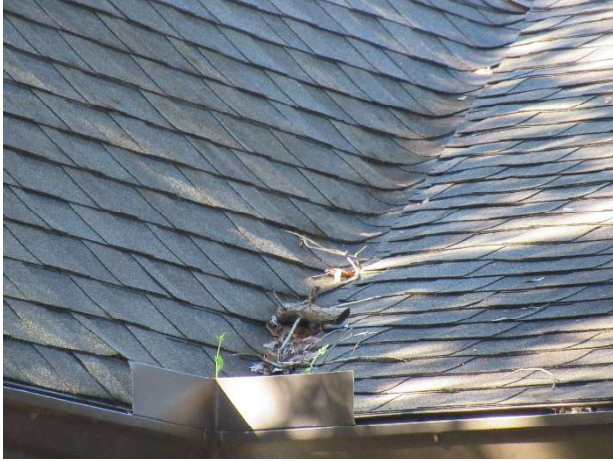
**Debris accumulation**

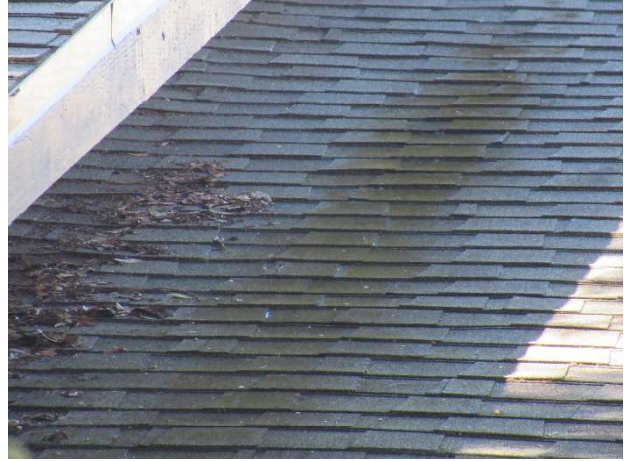
**Debris accumulation and organic growth evident**

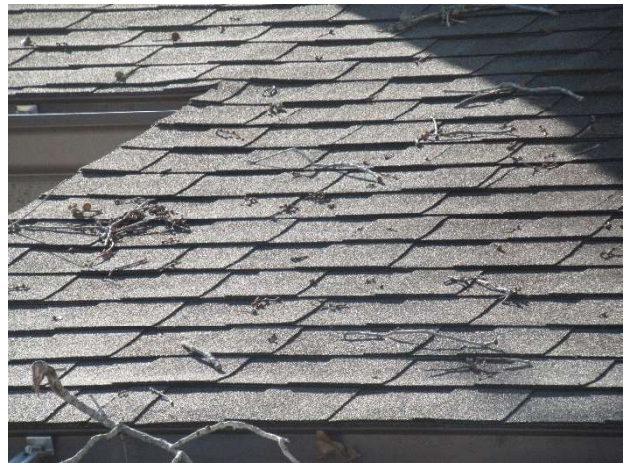
**Debris accumulation**

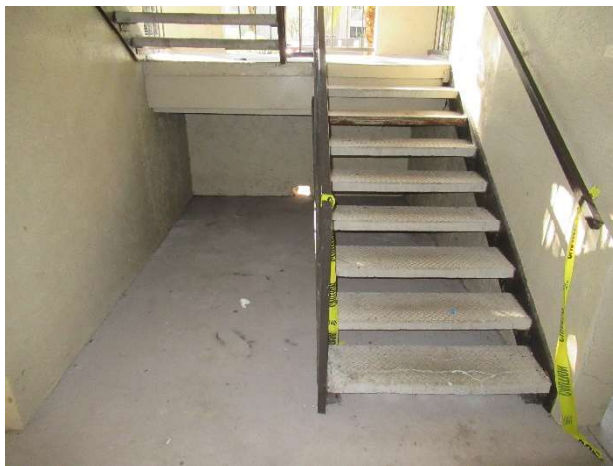
**Staircase with torn safety tape**

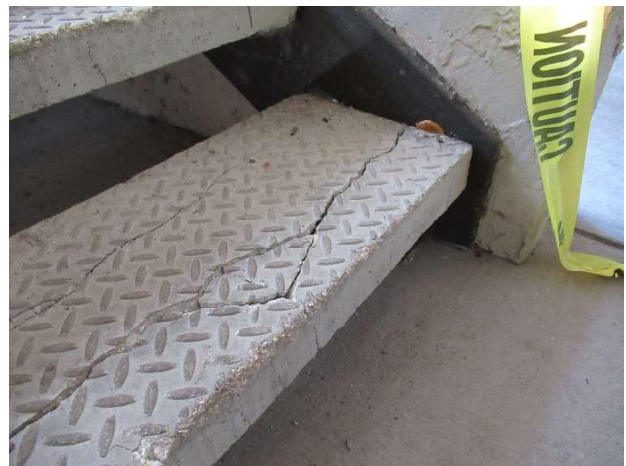
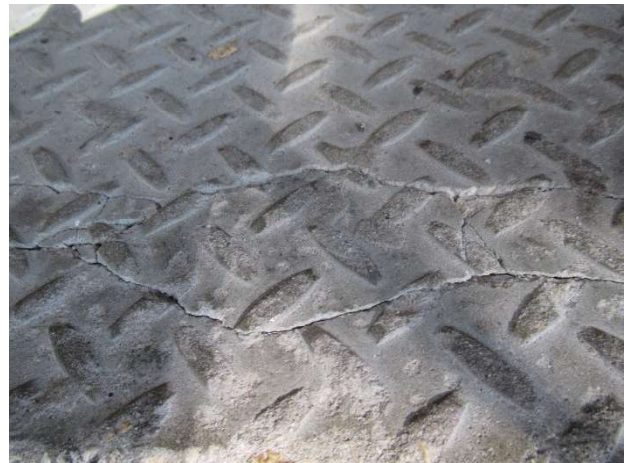
**Condition:** We note urgent necessity for replacement of limited quantities of severely cracked concrete treads throughout the community, and have notified Management immediately following our inspection. We informed Management of torn safety tape cordoning these areas of severe conditions. We note the stringers to be in fair condition with isolated occurrences of corrosion and finish deterioration. We also note water intrusion and wood rot at staircase landings at building 951 where the underside cover was removed. Due to the noninvasive nature of our inspection we were unable to ascertain these conditions throughout the community. We have recommended further inspections, as outlined by line item **1.151, Building Inspections, Wood Rot Identification.**

**Severely cracked concrete treads**

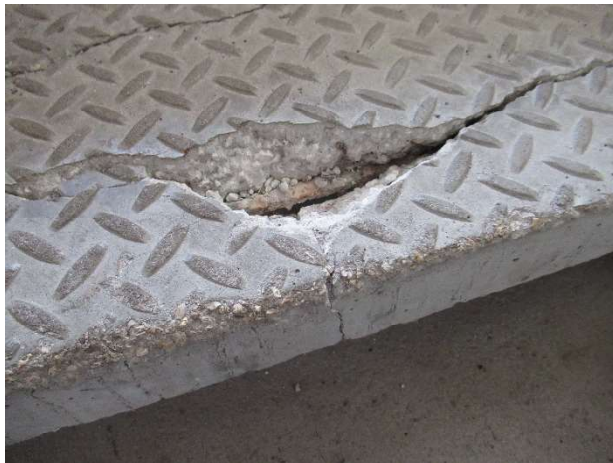
**Exposed rebar at concrete treads**

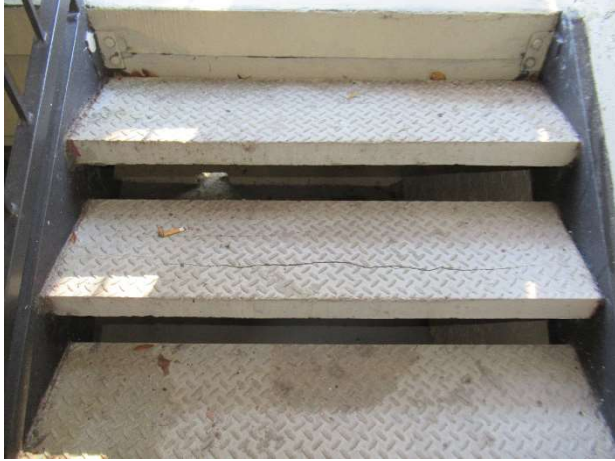
**Tread cracks**

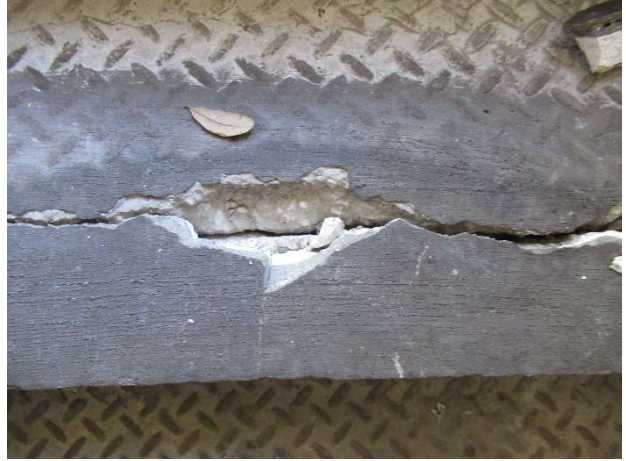
**Severely cracked treads with previous repairs evident**

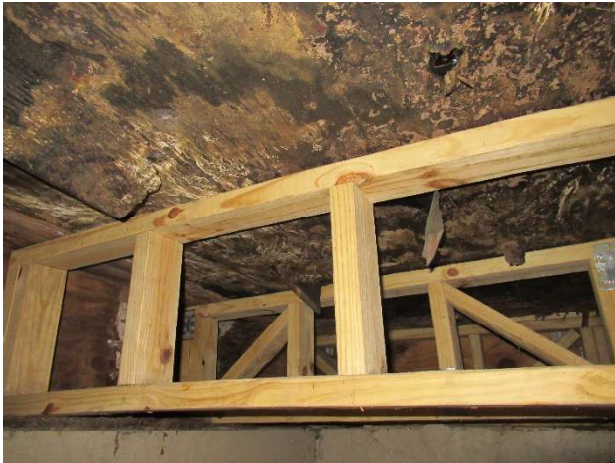
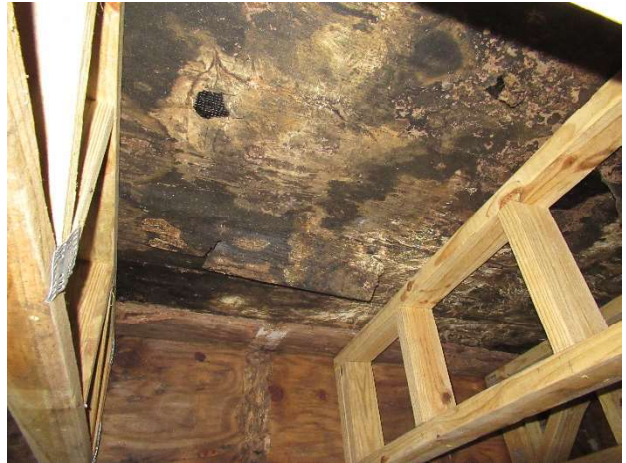
**Severely rotted plywood at landing with evident replaced support frames**

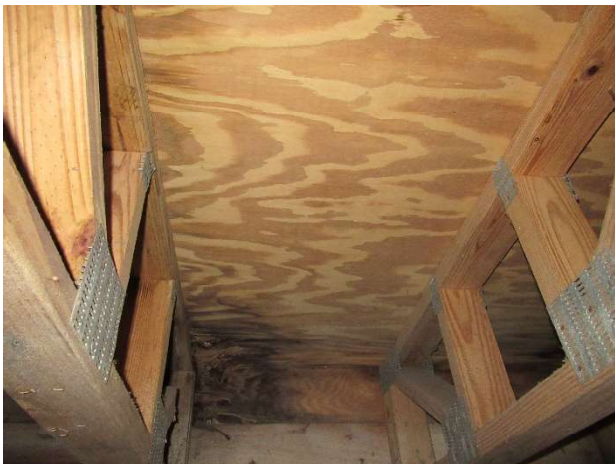
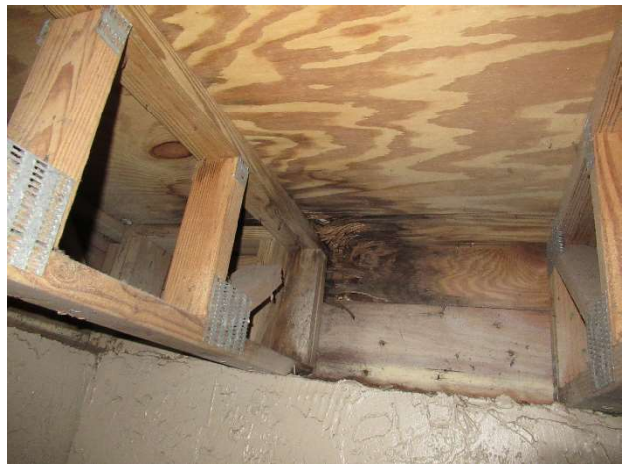
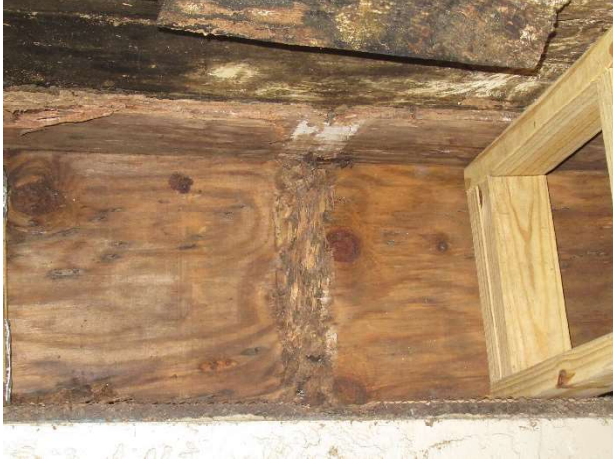
**Wood rot at landing**

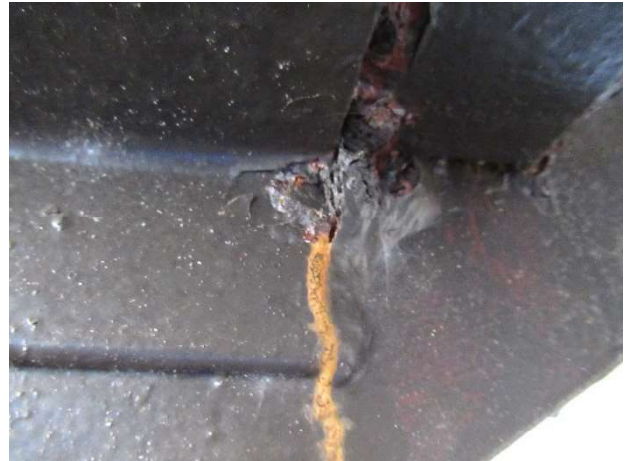
**Isolated corrosion at tread mount angle**

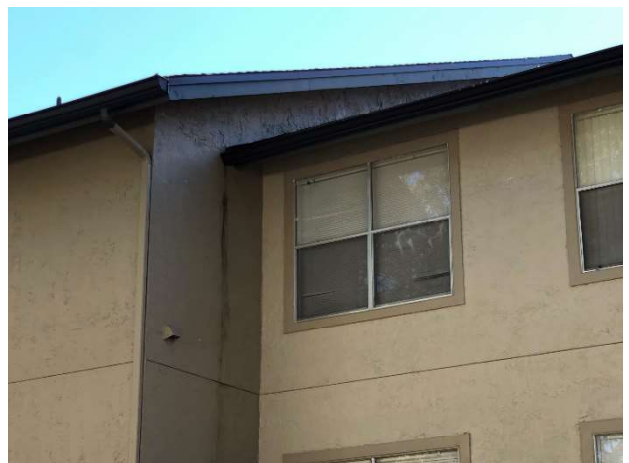
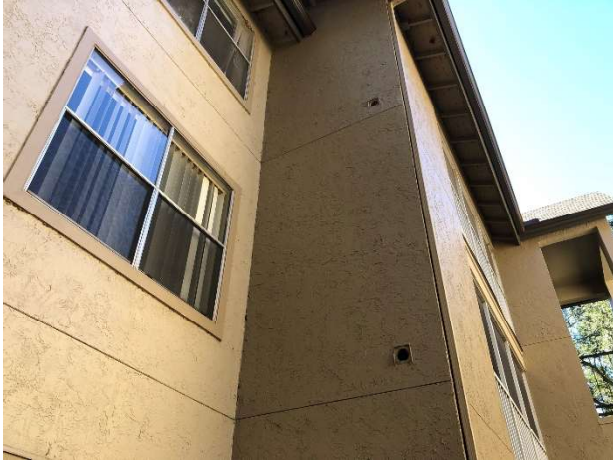
**Vegetative growth present**

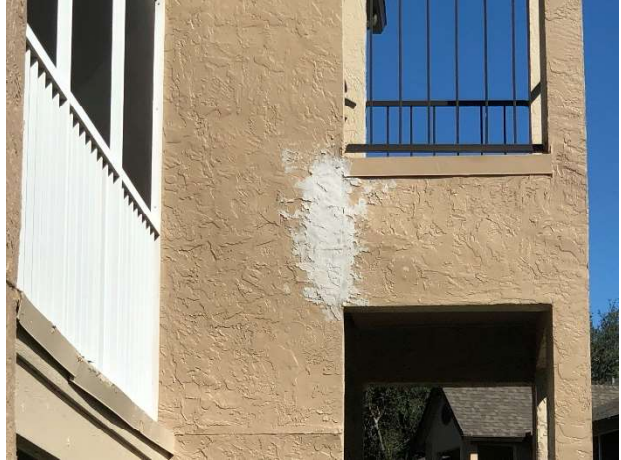
**Repairs evident**
