Priority/Criticality: Defer only upon opinion of independent professional or engineer

Property Site Elements

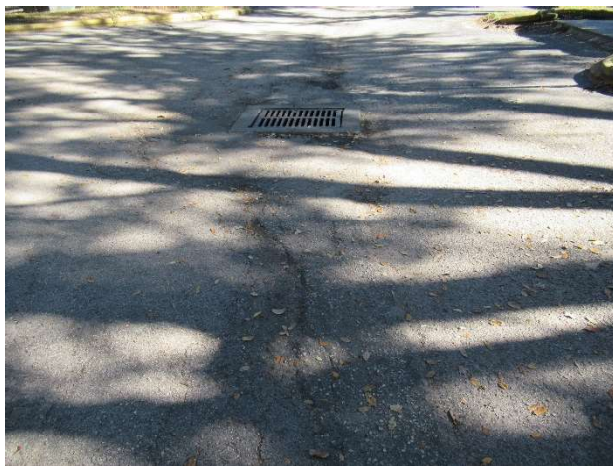
Centerline cracks and raveling

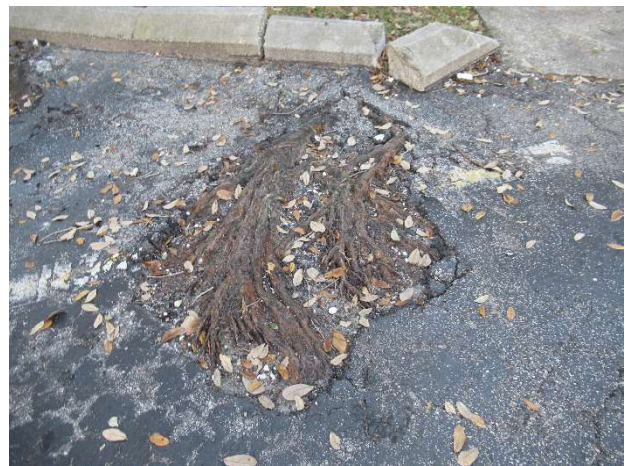
Completely deteriorated asphalt pavement

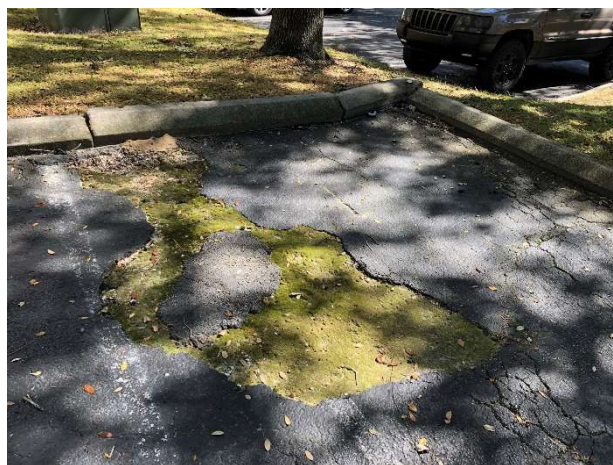
Pavement delamination and organic growth

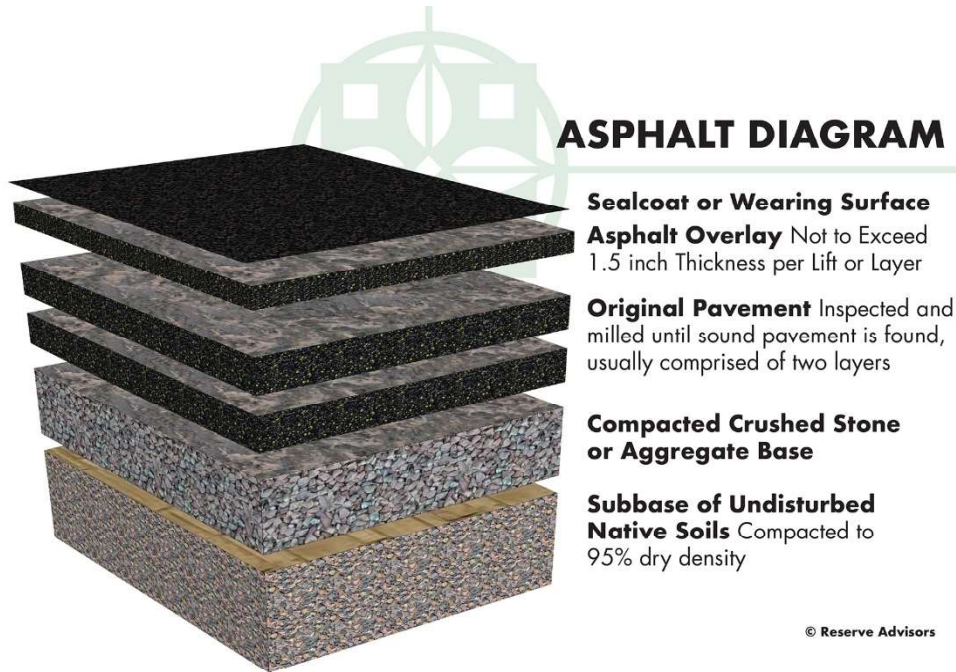
Component Detail Notes: The initial installation of asphalt uses at least two lifts, or two separate applications of asphalt, over the base course. The first lift is the binder course. The second lift is the wearing course. The wearing course comprises a finer aggregate for a smoother more watertight finish. The following diagram depicts the typical components although it may not reflect the actual configuration at The Landing:

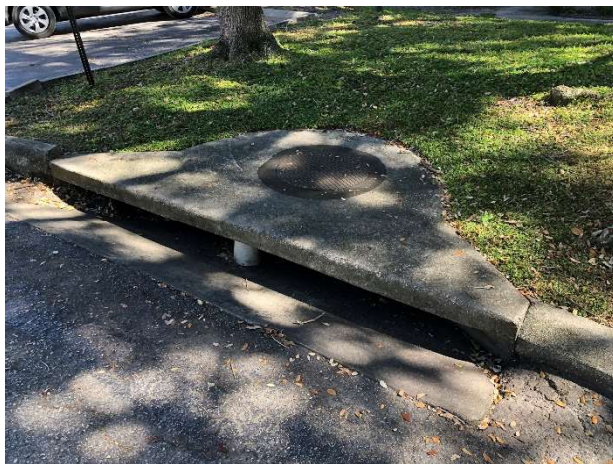
Condition: Fair overall with settlement visually apparent

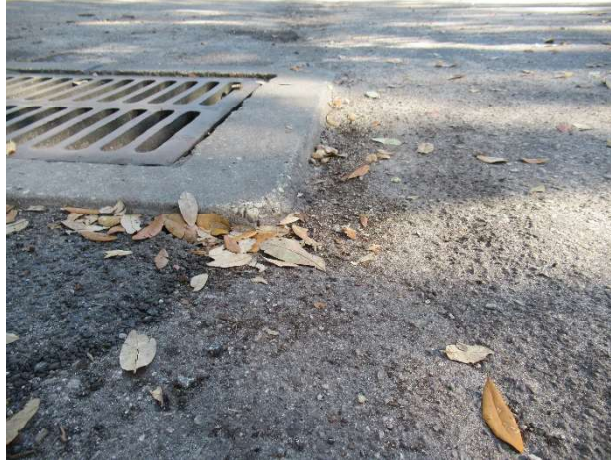
Catch basin crown detail view

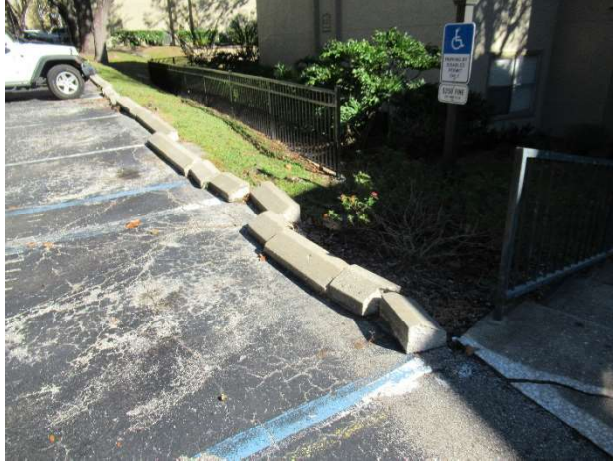
Broken and displaced curb

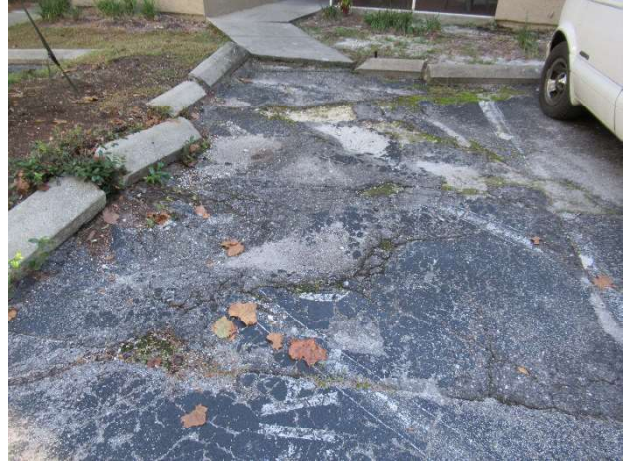
Broken and displaced curbs

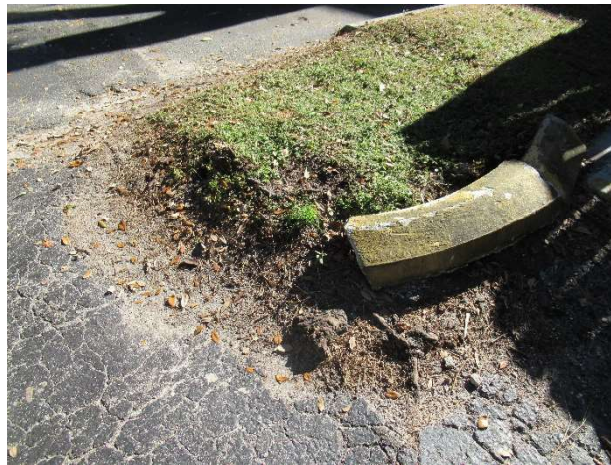
Broken and completed missing sections of curbs

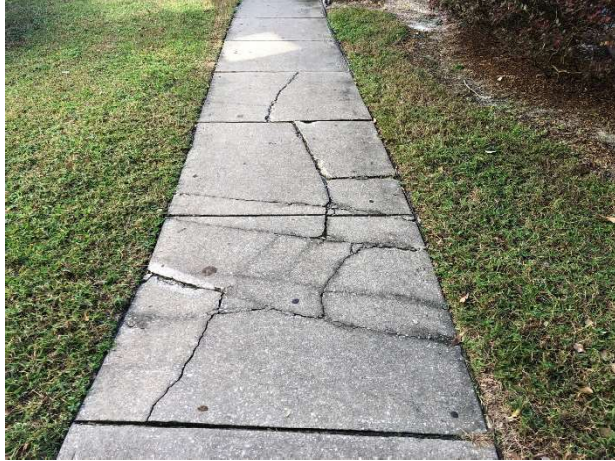
Condition: Fair overall with replacements, repairs, trip hazards, and extensive deterioration evident

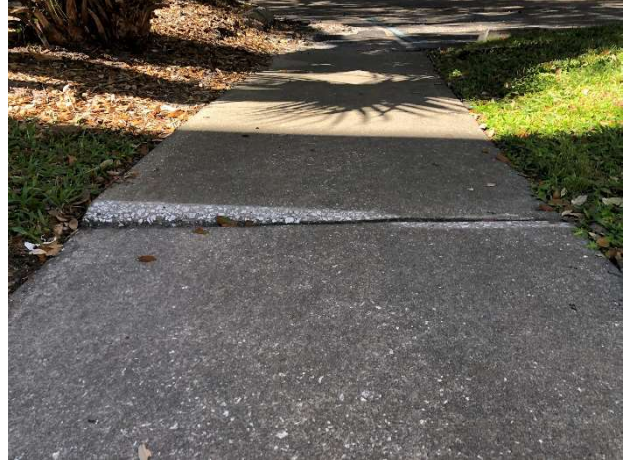
Trip hazard and previous repairs evident

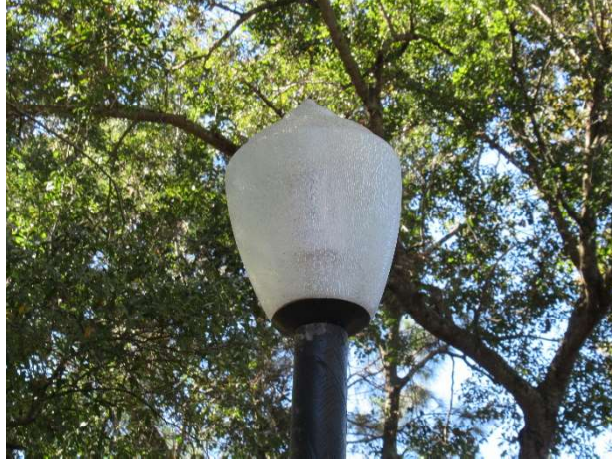
Condition: Satisfactory overall

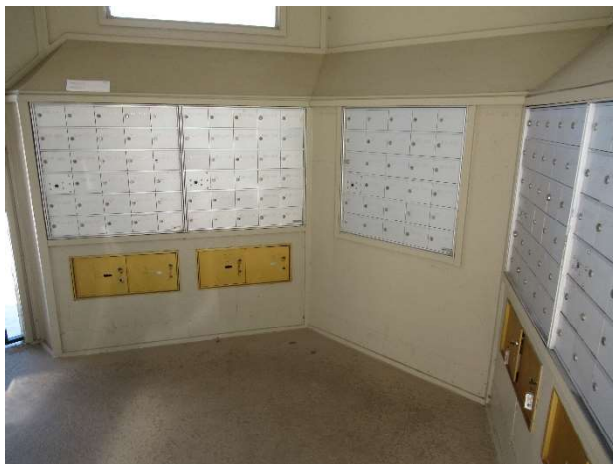
Mailboxes near main pool

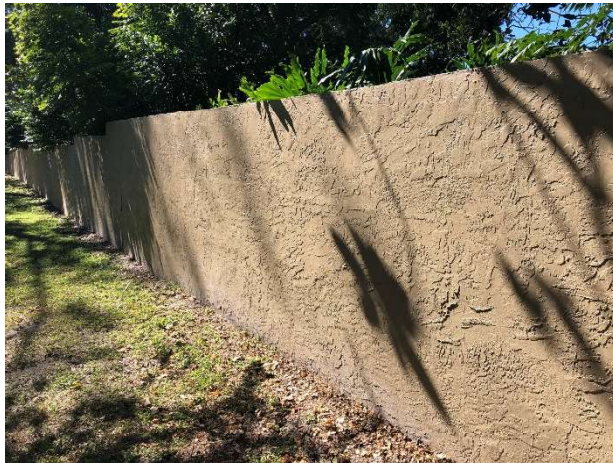
Perimeter wall overview

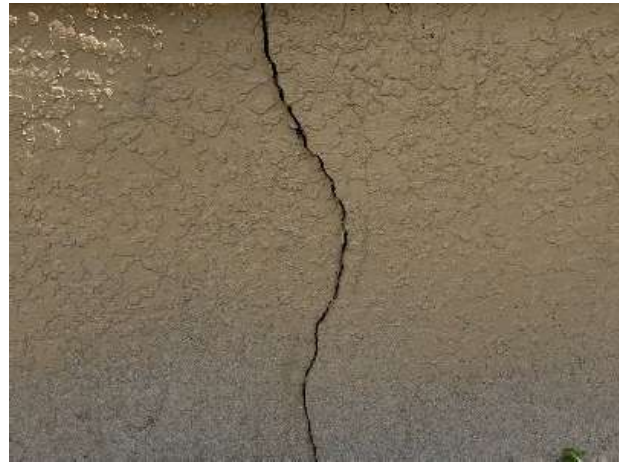
Perimeter wall crack

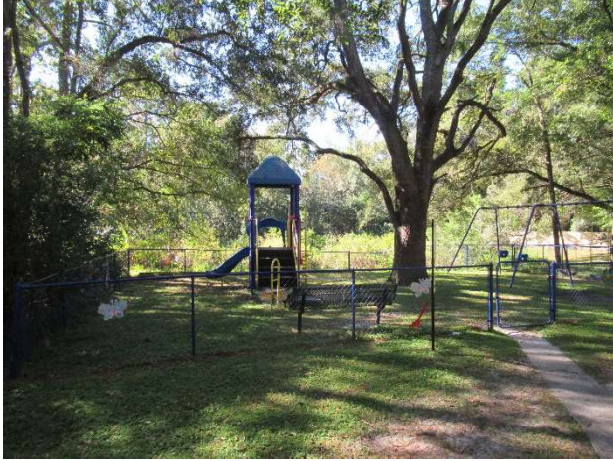
Playground equipment

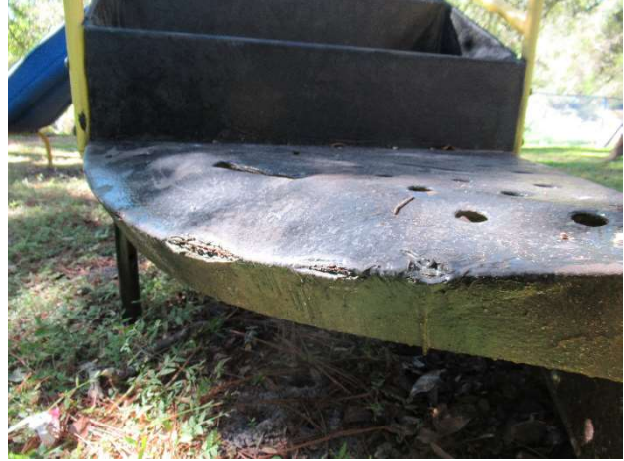
Bent step with rust present

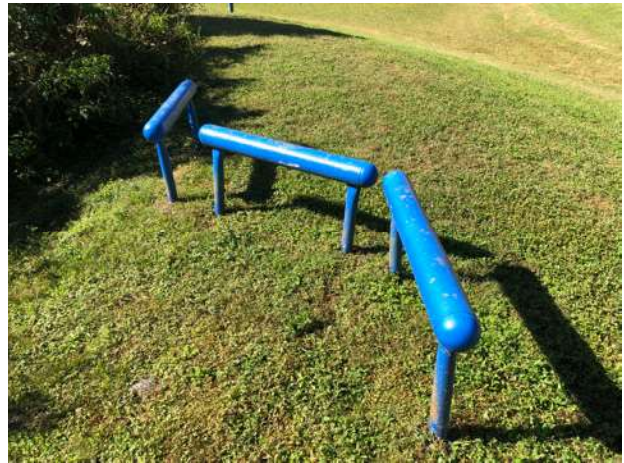
Paint finish deterioration at fitness equipment

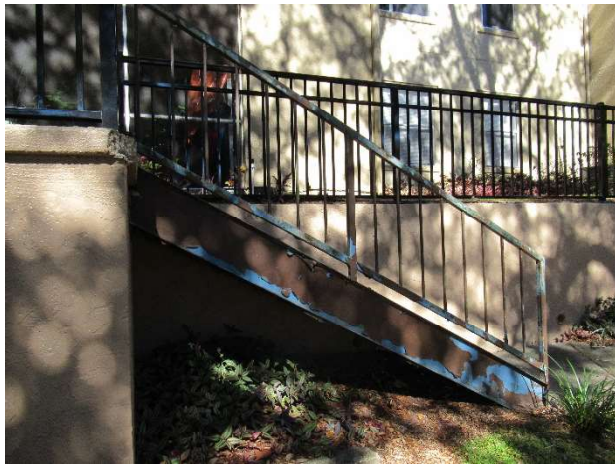
Deteriorated paint finishes at site staircases

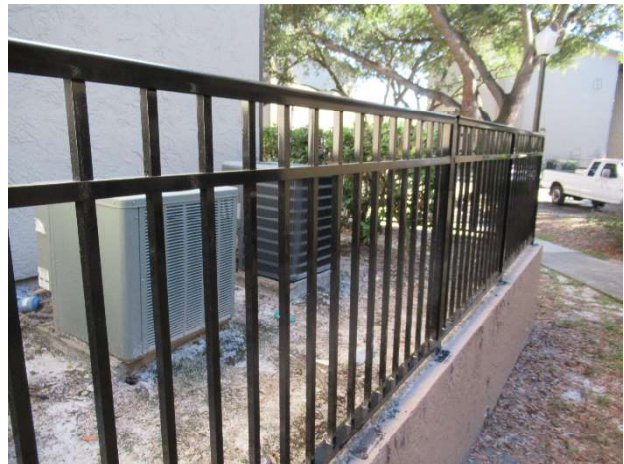
Recently replaced railings

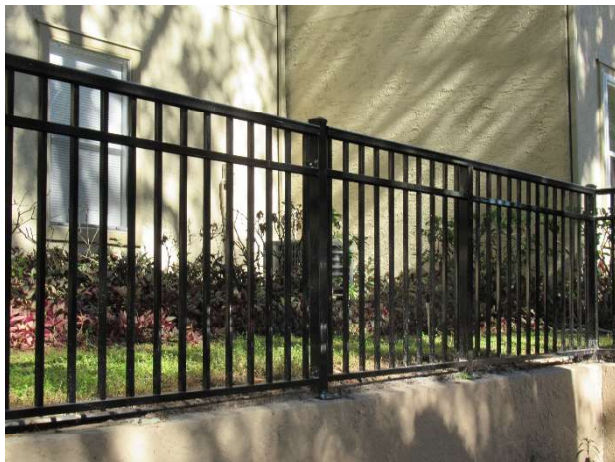
Recently replaced railings

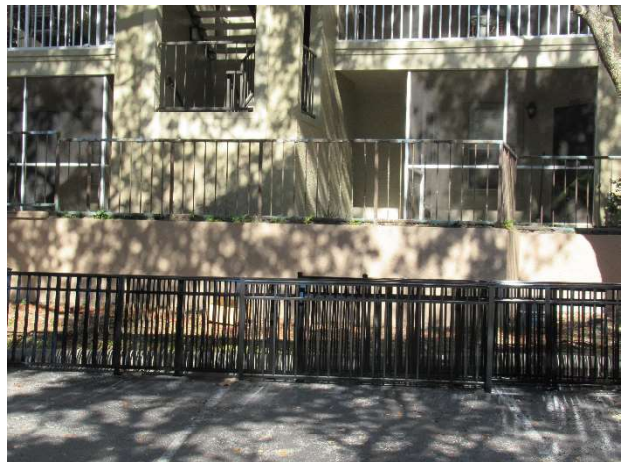
Railings awaiting installation

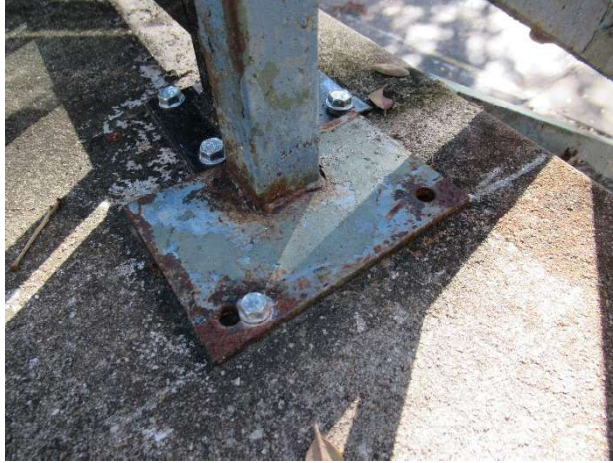
Rusted mount plate at staircase railings

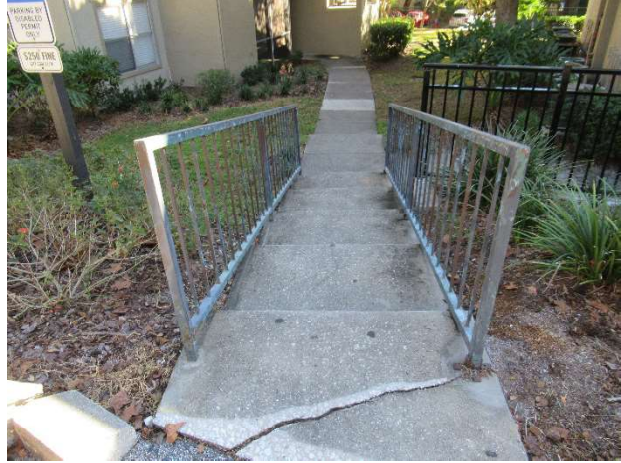
Deteriorated steel railings

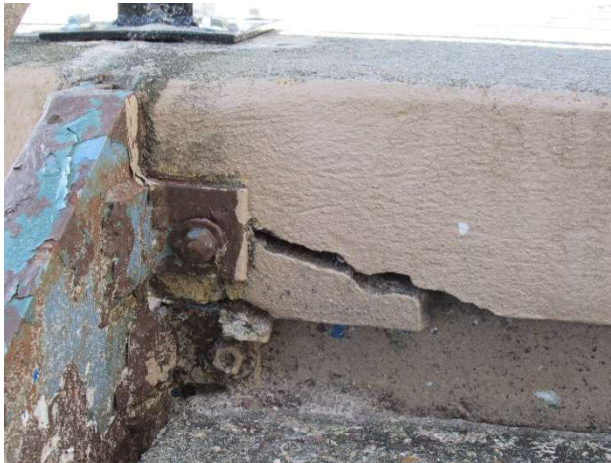
Deteriorated mount points and concrete cracks at the join of the site staircases and sidewalks

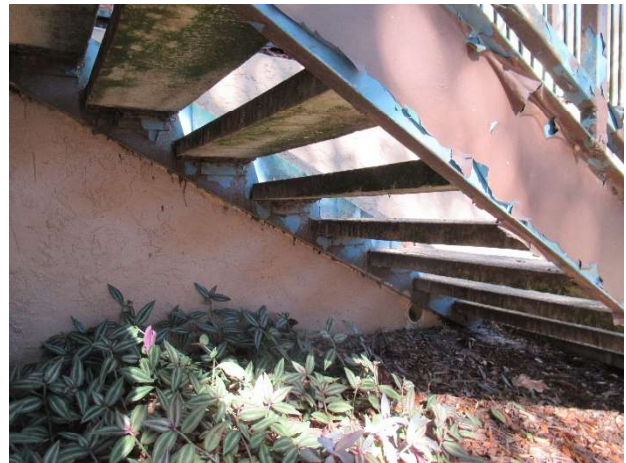
Finish deterioration and weathered stair treads and tread mounting angle

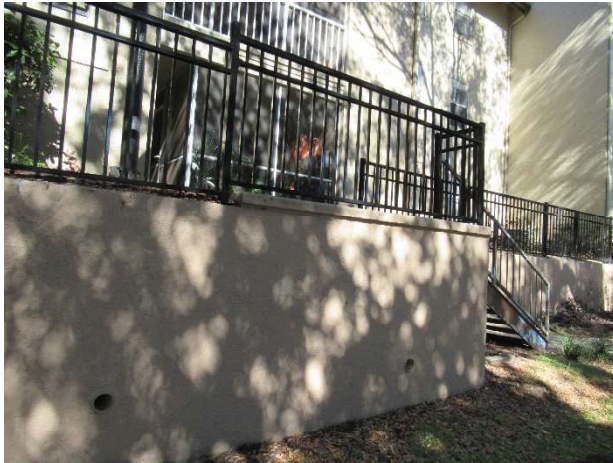
Retaining wall overview

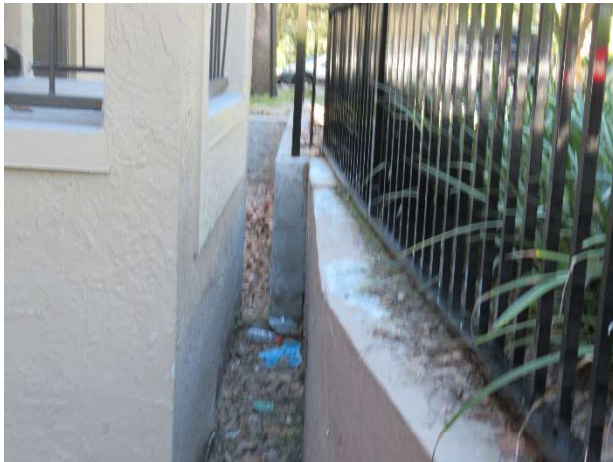
Retaining wall at this location has evidently been repaired since 2017

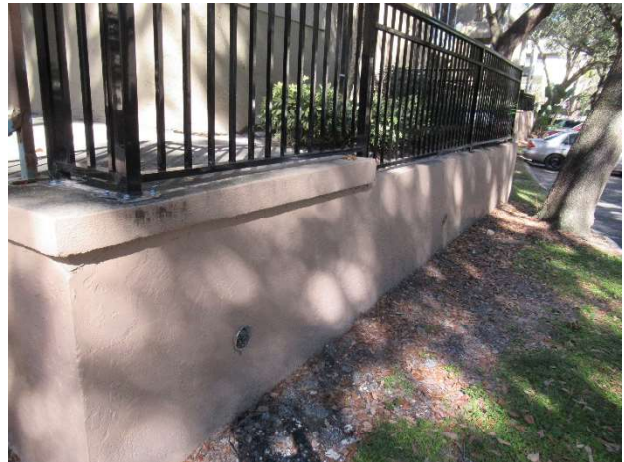
Retaining wall overview

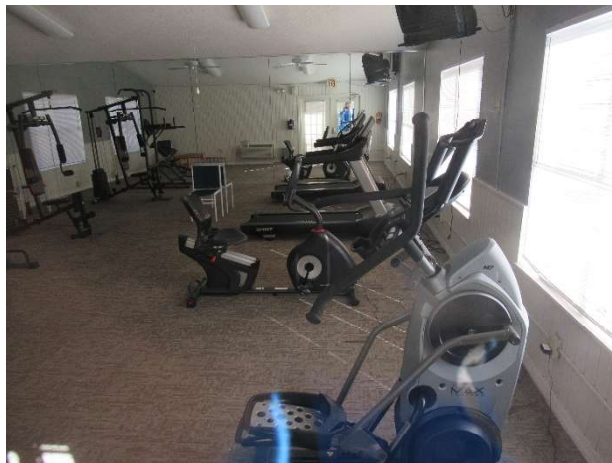
Condition: Reported satisfactory overall, with a planned additional treadmill in 2022

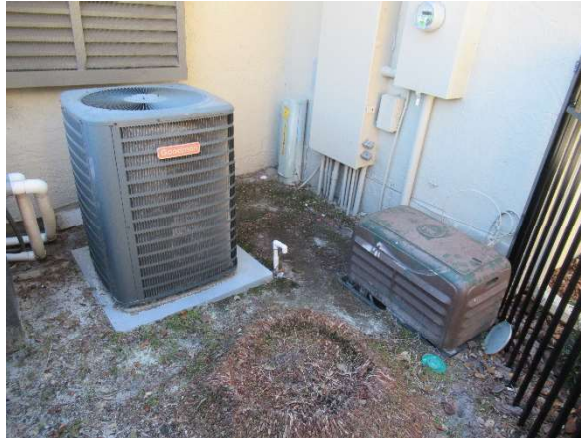
Condition: Reported satisfactory

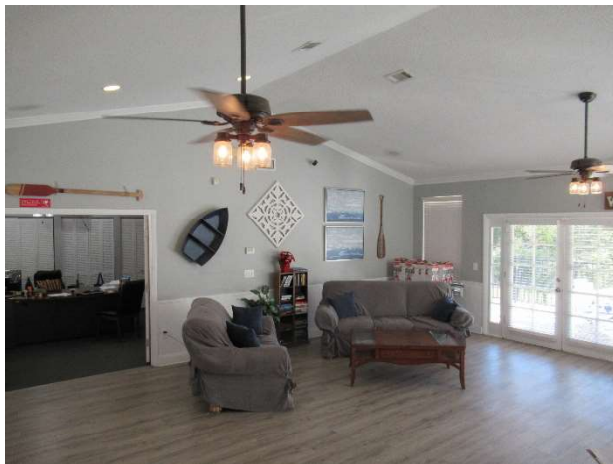
Condition: Satisfactory overall condition

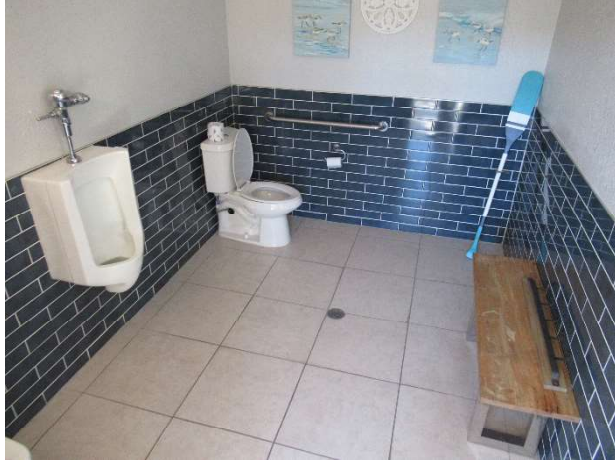
Condition: Satisfactory overall condition

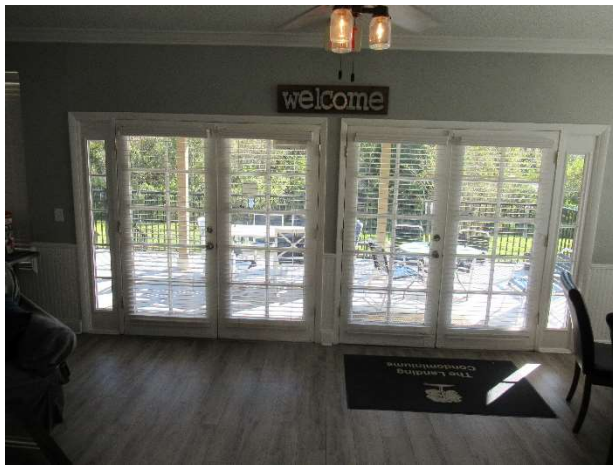
Condition: Good to fair condition with plans for partial replacements in 2022.

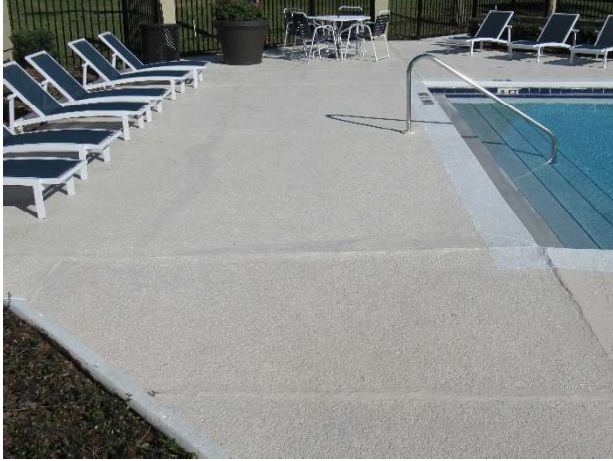
Condition: Good to fair overall condition

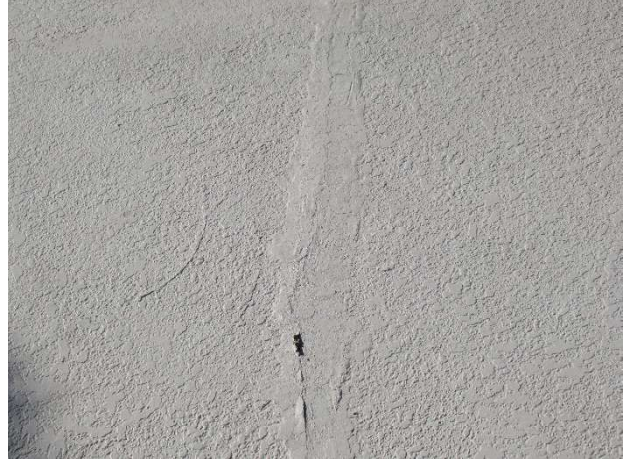
Repairs at main pool deck

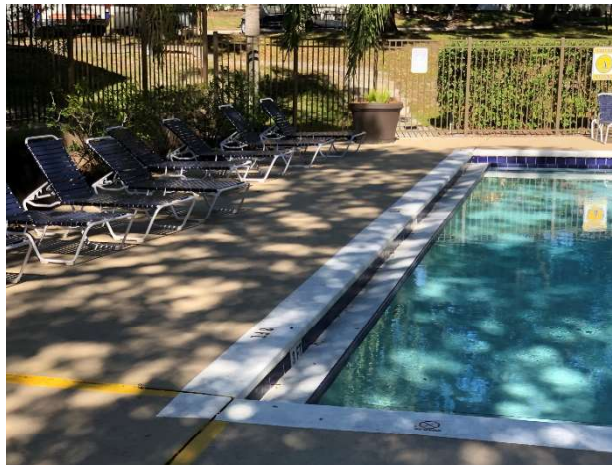
Deck overview at lap pool

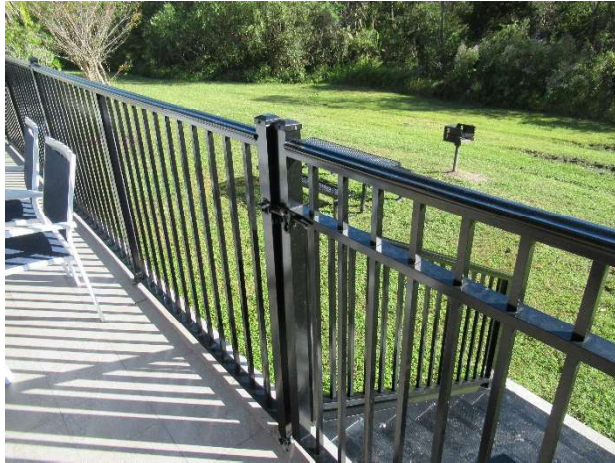
Condition: Good to fair overall with isolated bent pickets at the lap pool

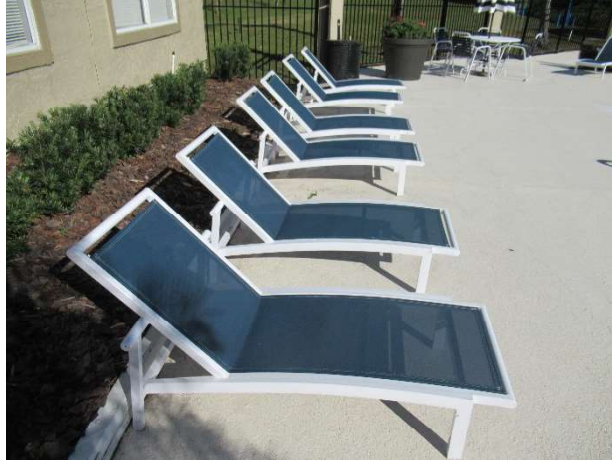
Pool furniture at main pool

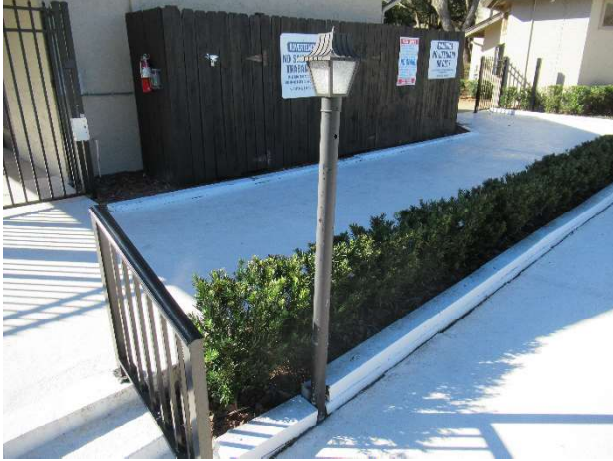
Light pole and fixture

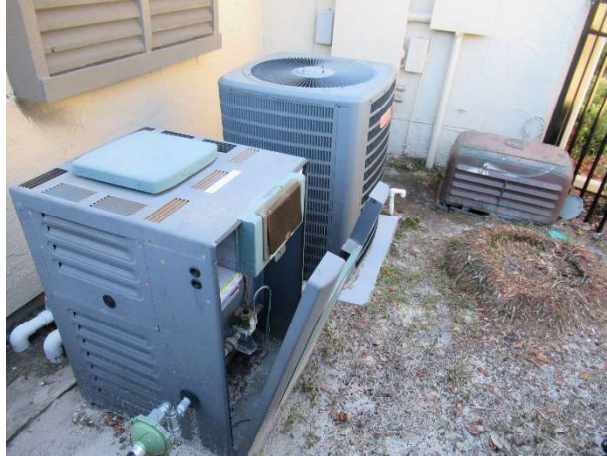
Spa heater missing cover

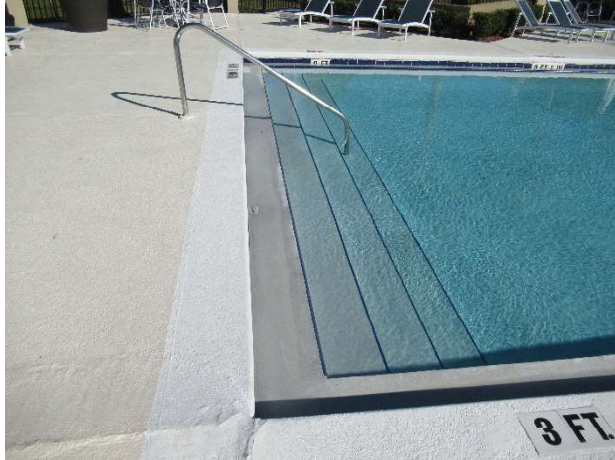
Stair entry, main pool

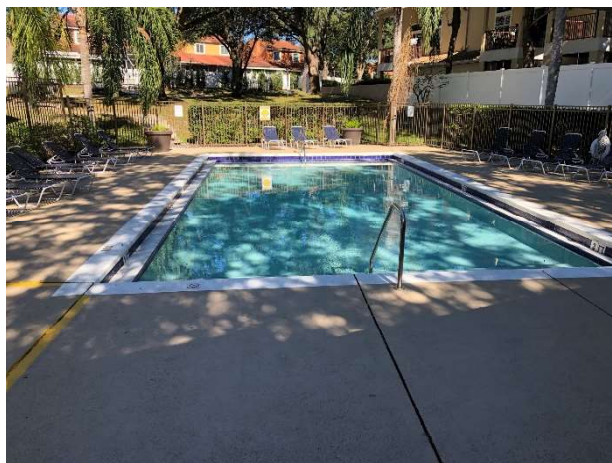
Conditions: The pools visually appear in good to fair condition. The concrete floors and walls have a plaster finish. This finish makes it difficult to thoroughly inspect the concrete structures during a noninvasive visual inspection.

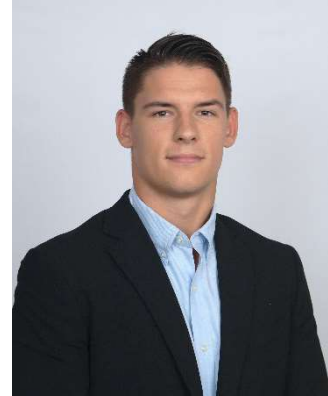
The following is a partial list of clients served by Brandon Bloomer demonstrating his breadth of experiential knowledge of community associations in construction and related buildings systems.
