August 25, 2023

Janette Barcena
The Landing Condominium Association, Inc.
953 Salt Pond Place
Altamonte Springs, Florida 32714

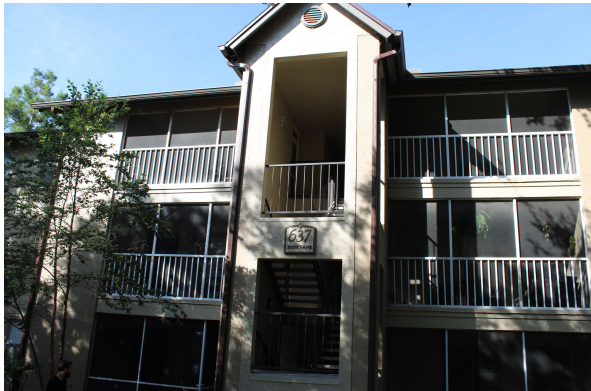
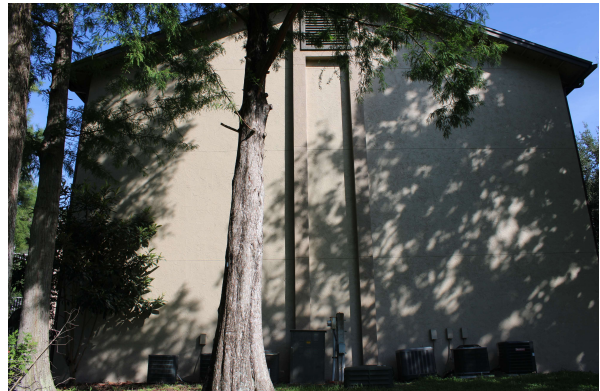
Stucco Repairs - 2030

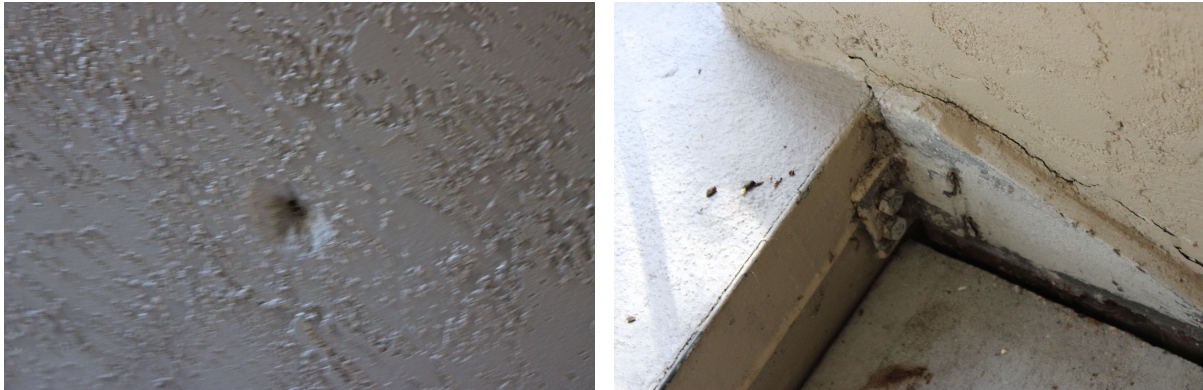
Painting - Total Current Cost	\$17,000
Assigned Reserves	\$17,000
Fully Funded Reserves	\$8,514

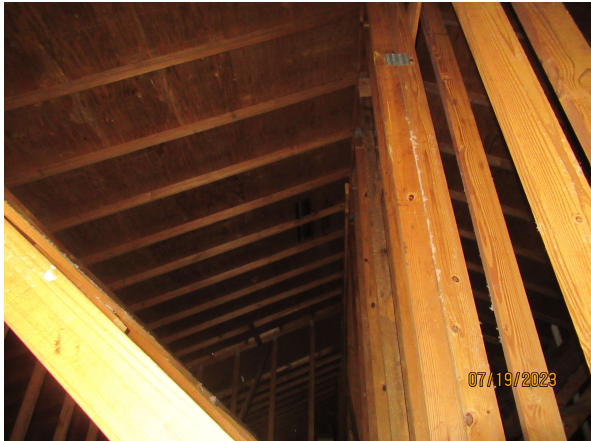
Structural Components - Total Current Cost	\$6,000
Assigned Reserves	\$9,000
Fully Funded Reserves	\$3,300

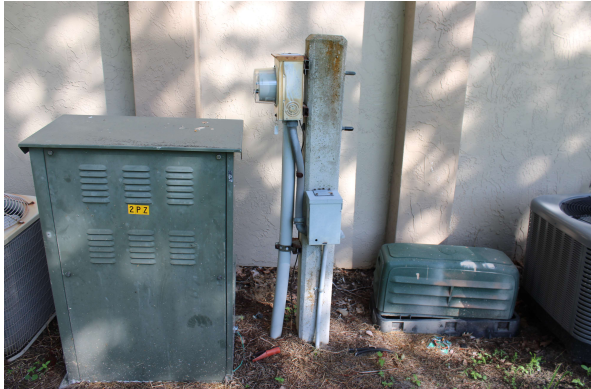
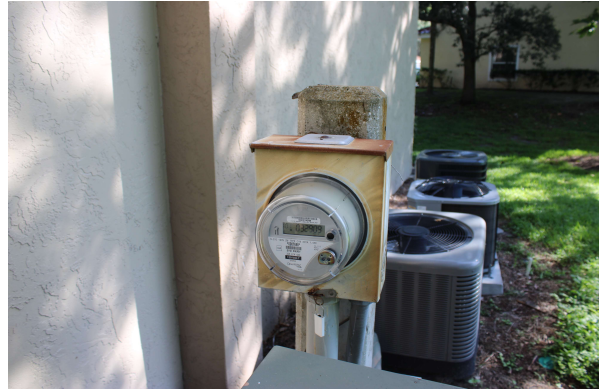
Electrical Systems - Total Current Cost	\$2,500
Assigned Reserves	\$5,000
Fully Funded Reserves	\$2,500

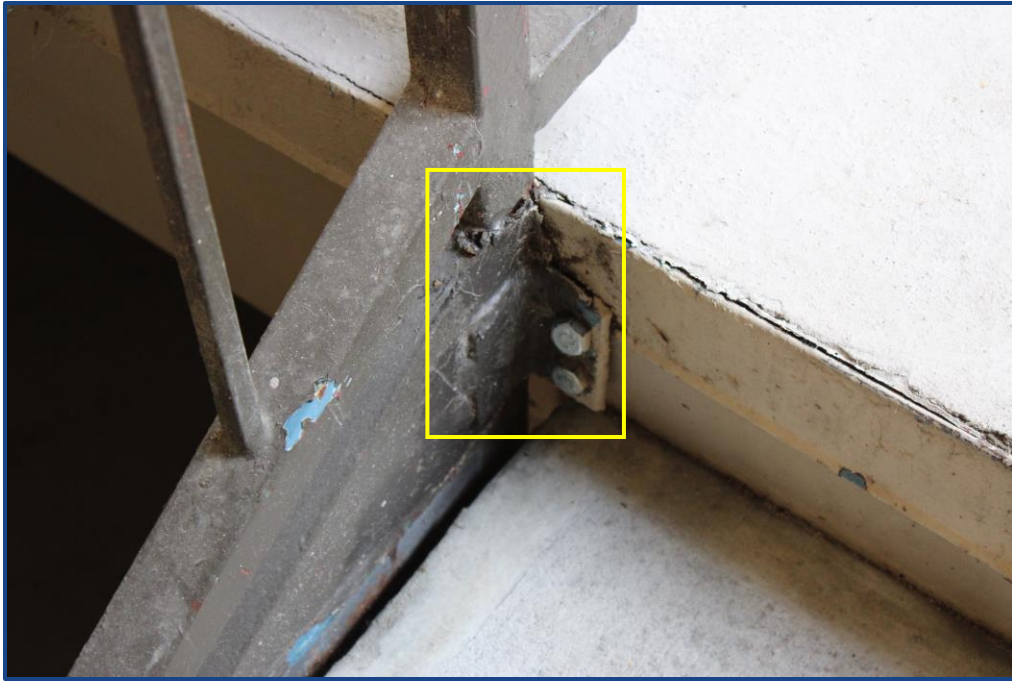
Photograph No. 7: Corrosion to the steel framing, located in the stairway.

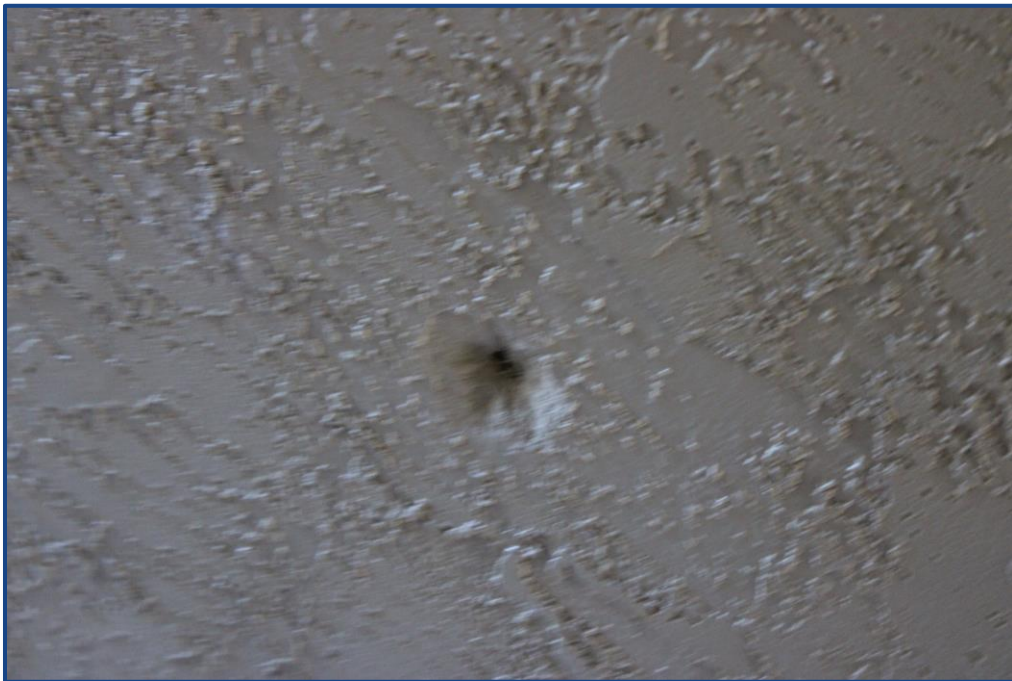
Photograph No. 8: View of damaged stucco in the exterior wall at the 2nd floor breezeway.

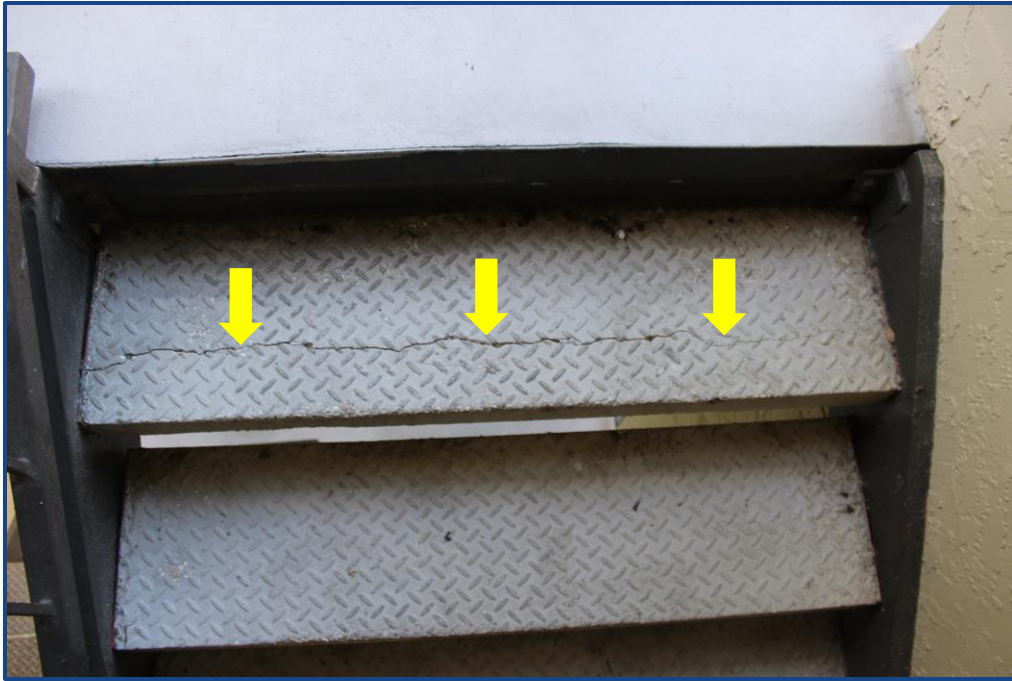
Photograph No. 9: Crack in a concrete step.

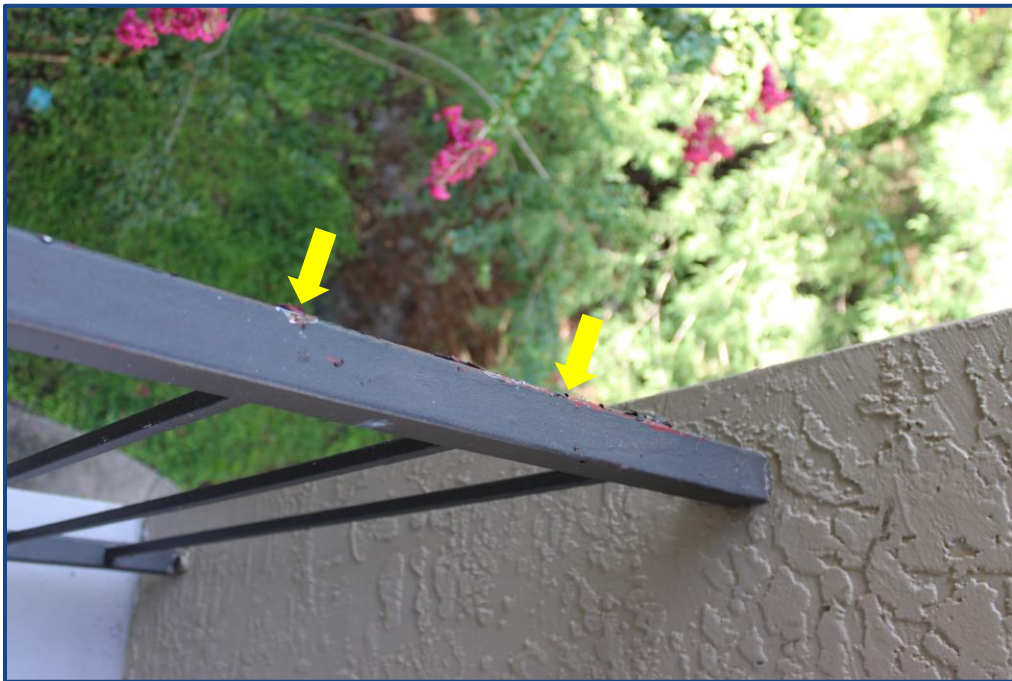
Photograph No. 10: Paint peeling located on the southwest stairway railing.

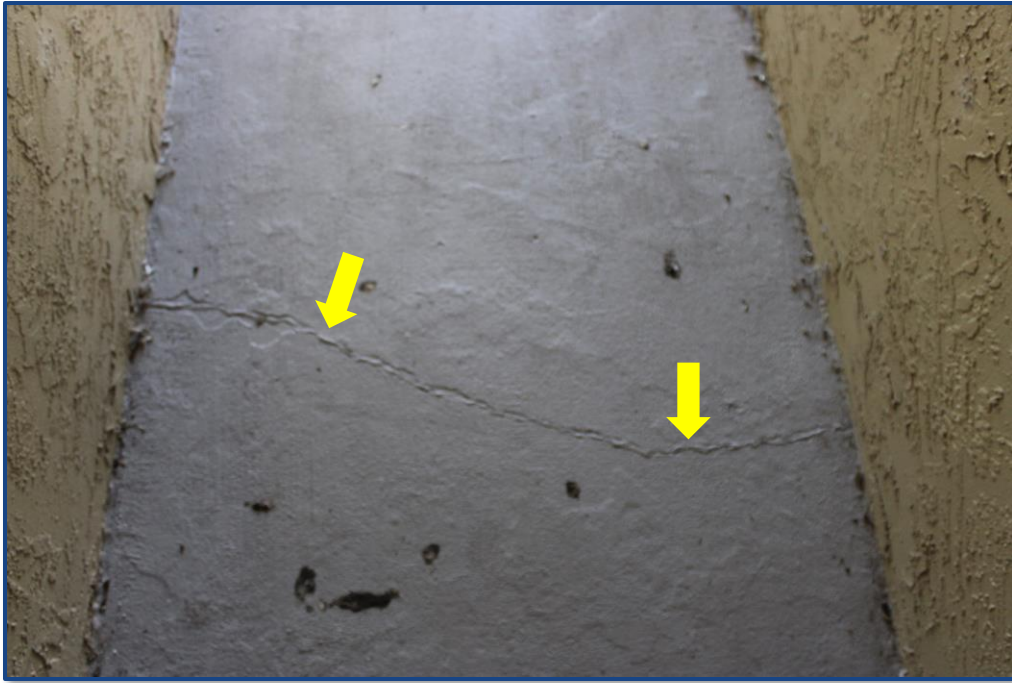
Photograph No. 11: Crack in the concrete slab located in the breezeway.

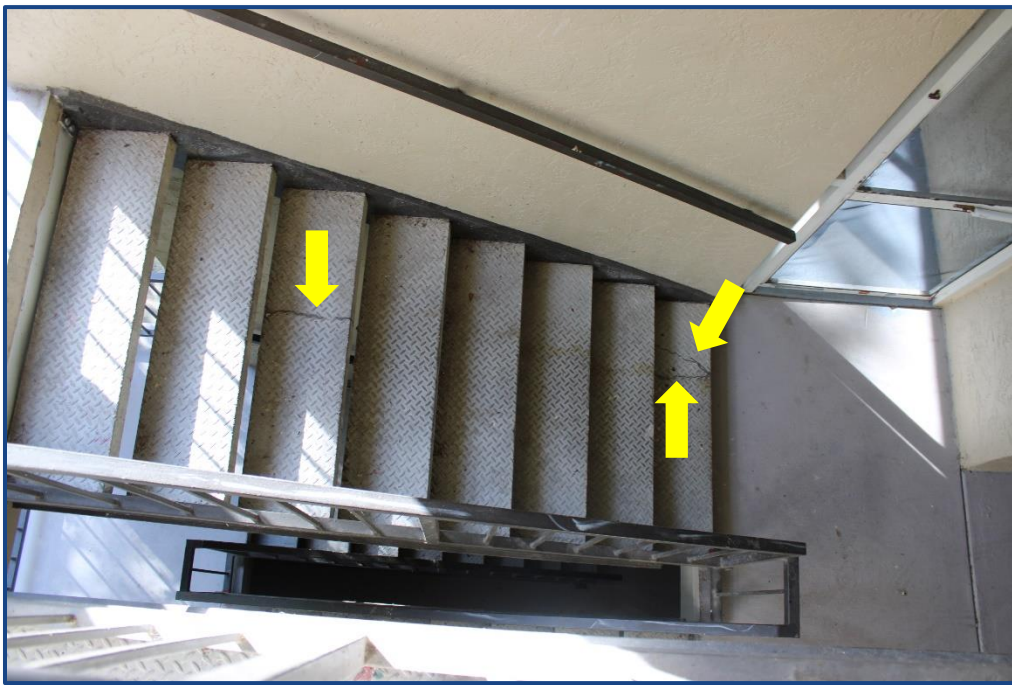
Photograph No. 12: Previously sealed cracks located in the concrete steps in the stairway.

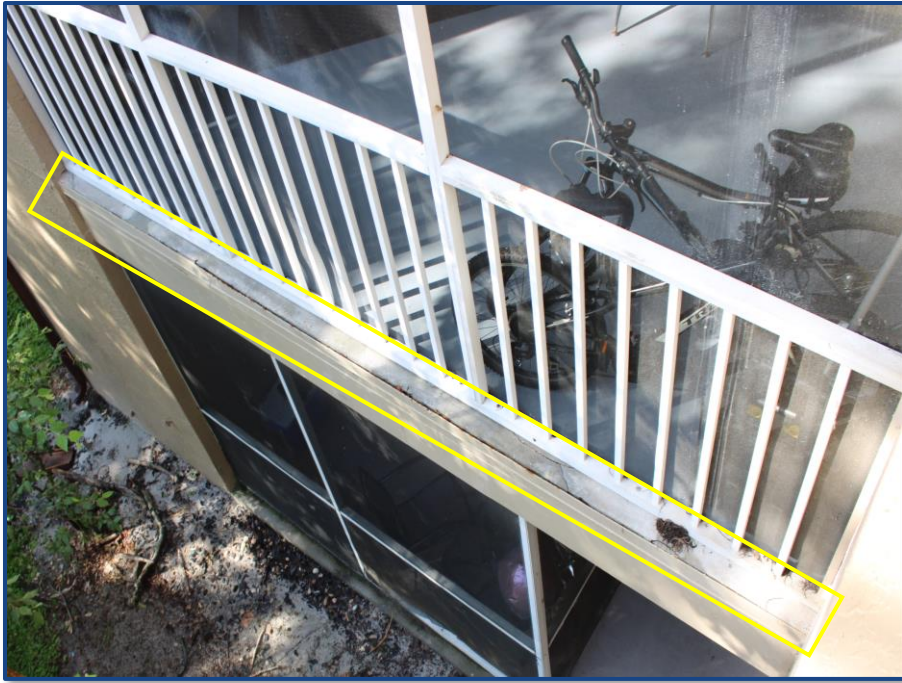
Photograph No. 13: View of cracks in the exterior balcony slab.

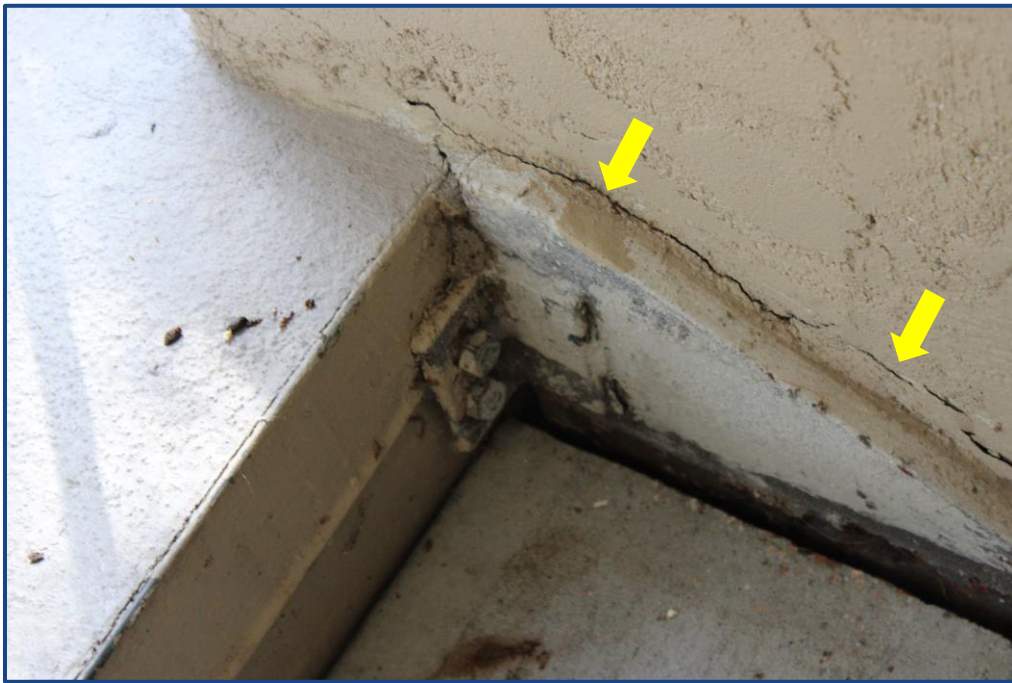
Photograph No. 14: View of cracks in the stucco finish located along the stairway riser.

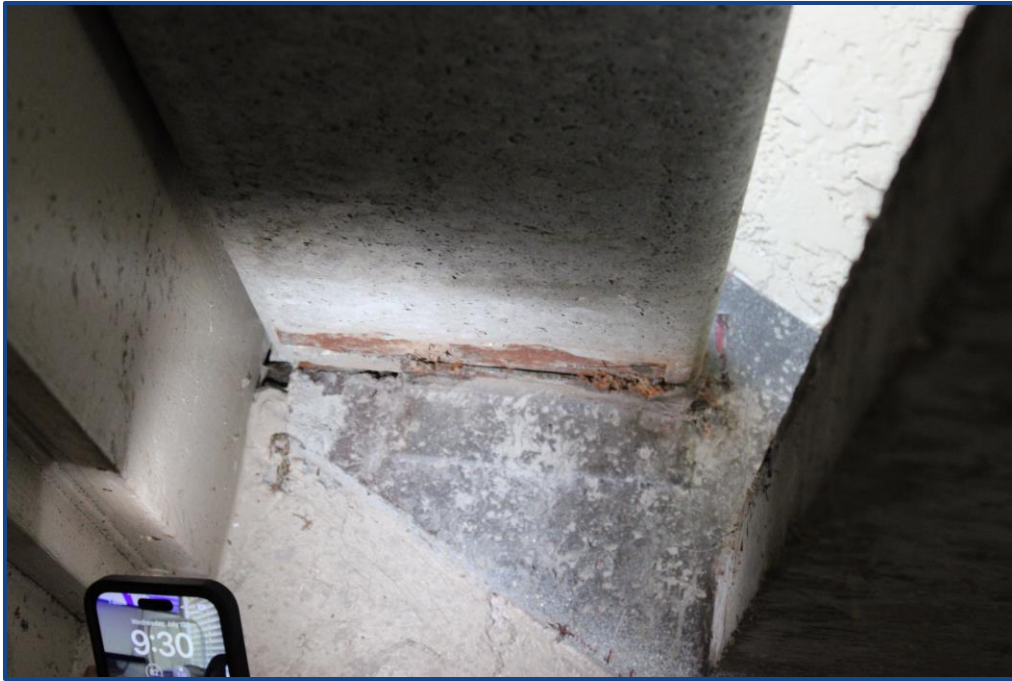
Photograph No. 15: Corrosion to the concrete step angle connection located in the stairway.

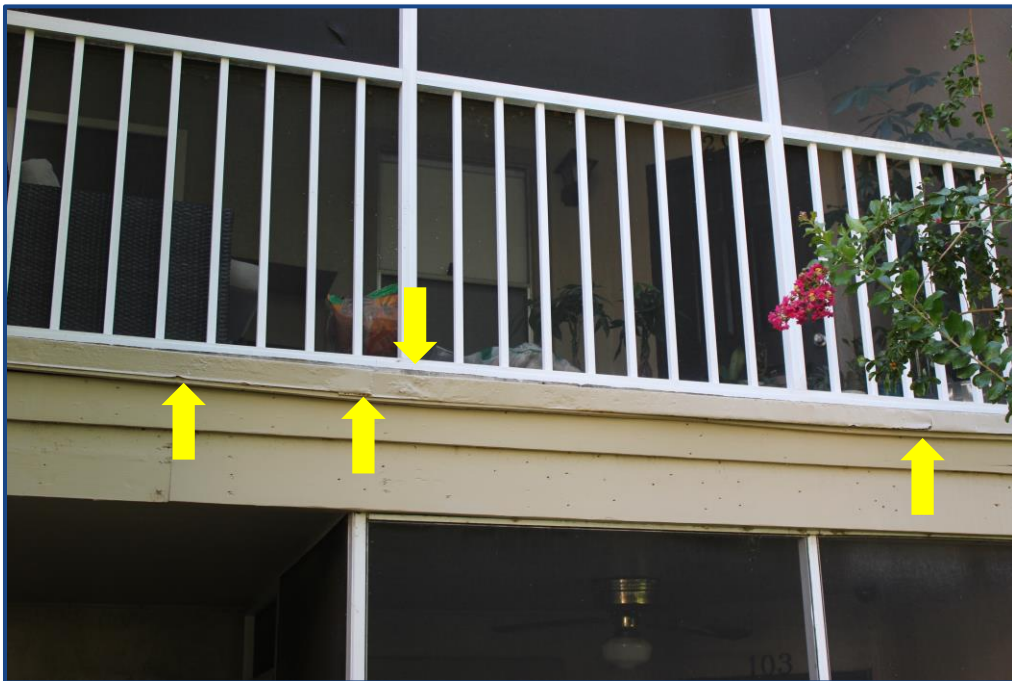
Photograph No. 16: Damage to the metal flashing located at the edge of the balcony slab on Unit 203.
