August 25, 2023

Janette Barcena
The Landing Condominium Association, Inc.
953 Salt Pond Place
Altamonte Springs, Florida 32714

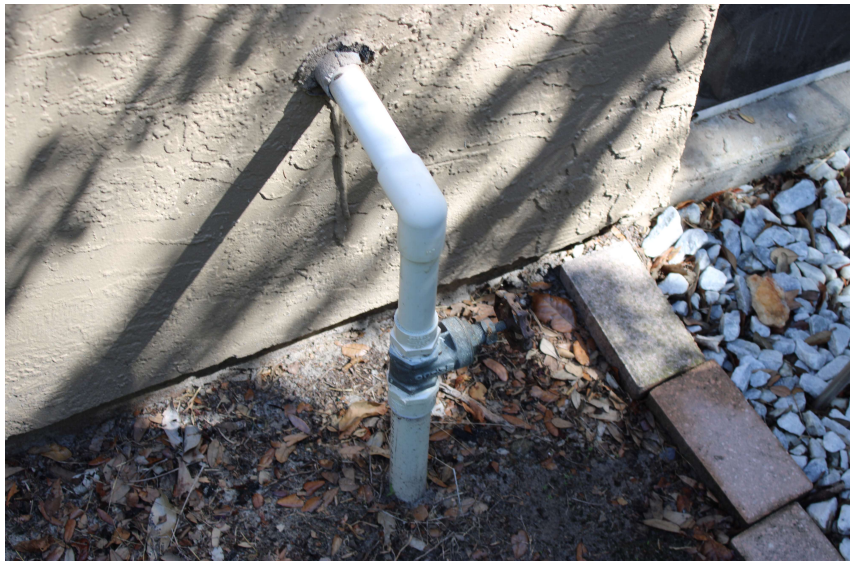
| Plumbing - Total Current Cost | \$2,500 |

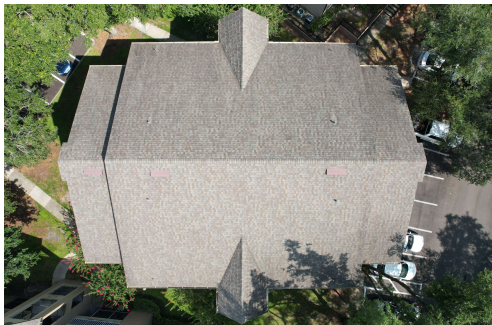
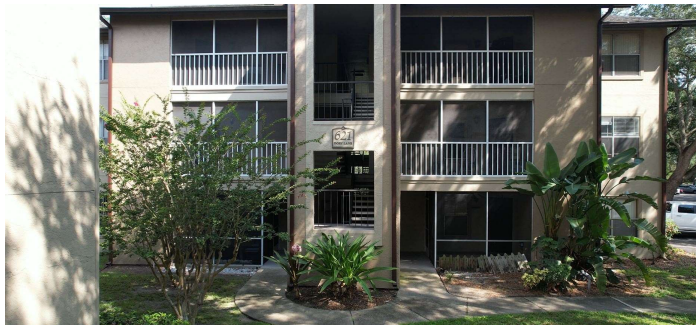
| Roofing - Total Current Cost | \$20,000 |

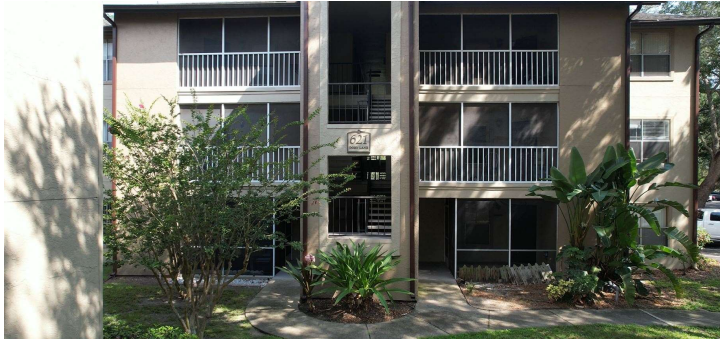
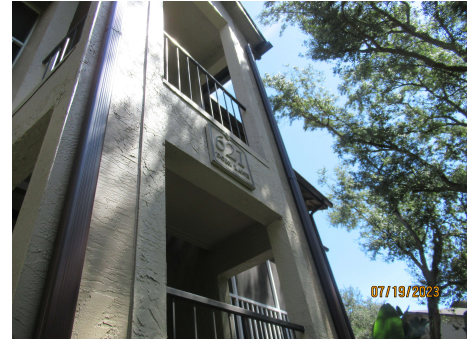
Stucco Repairs - 2030

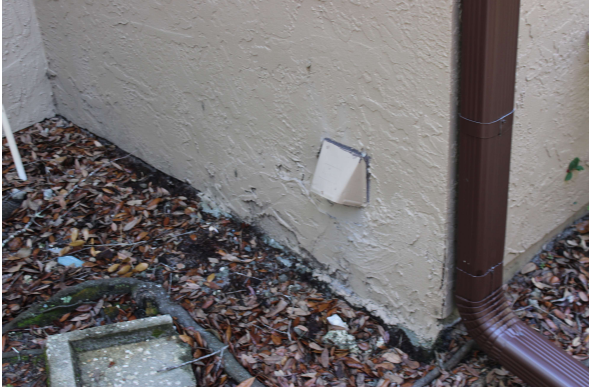
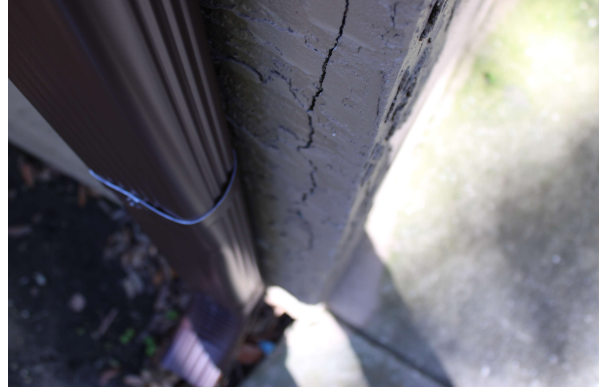
| Painting - Total Current Cost | \$17,000 |

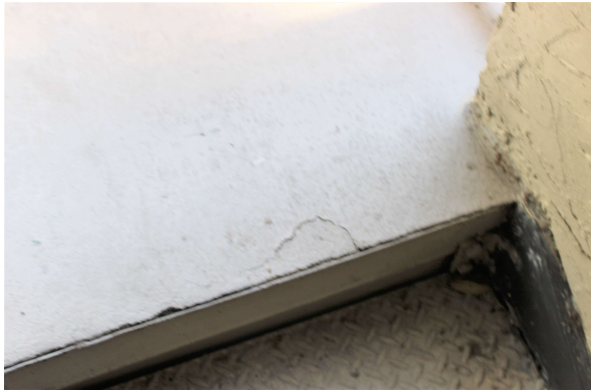
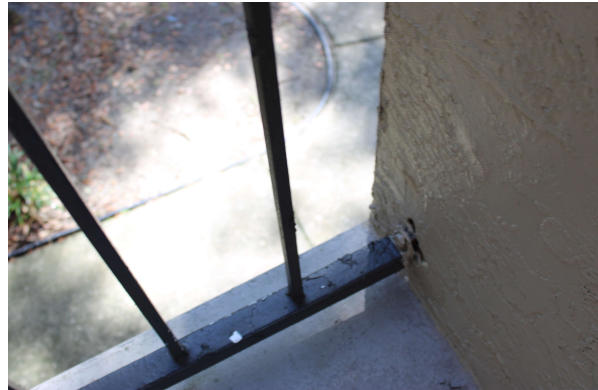
Concrete and Stairway Repairs for year 2024 shall include repairs to cracked concrete and corrosion to the steel framing referenced within this report.

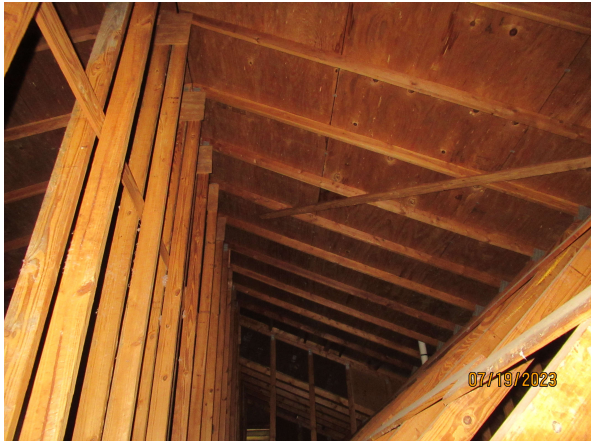
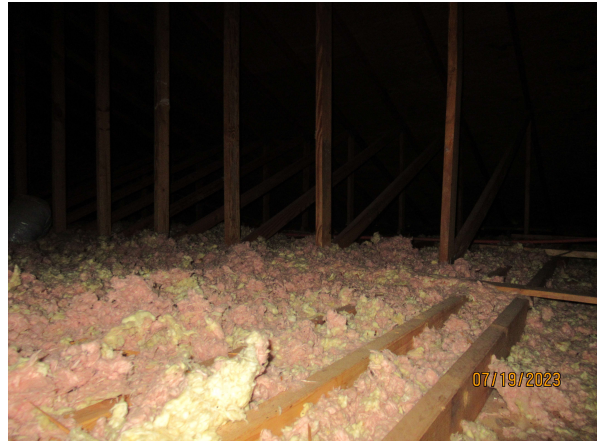
| Structural Components - Total Current Cost | \$6,000 |

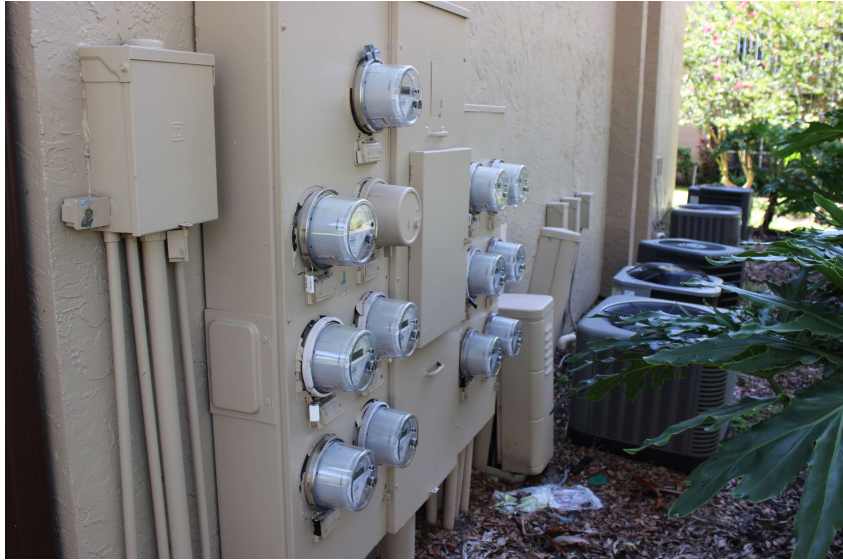
| Electrical Systems - Total Current Cost | \$2,500 |

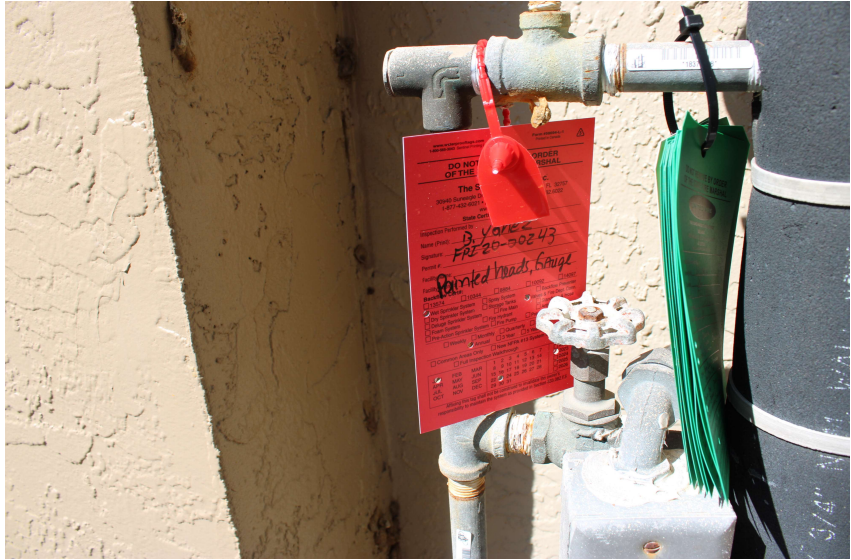
| Fire Protective Systems - Total Current Cost | \$2,500 |

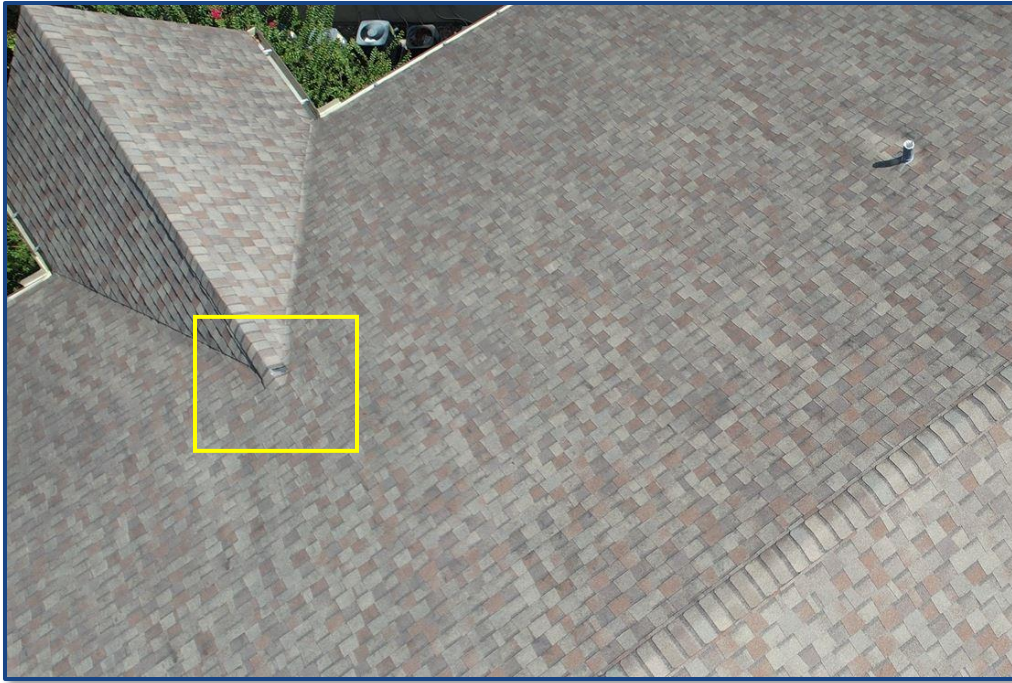
Photograph No. 3: View of damaged shingle at the north stairway gable ridge.

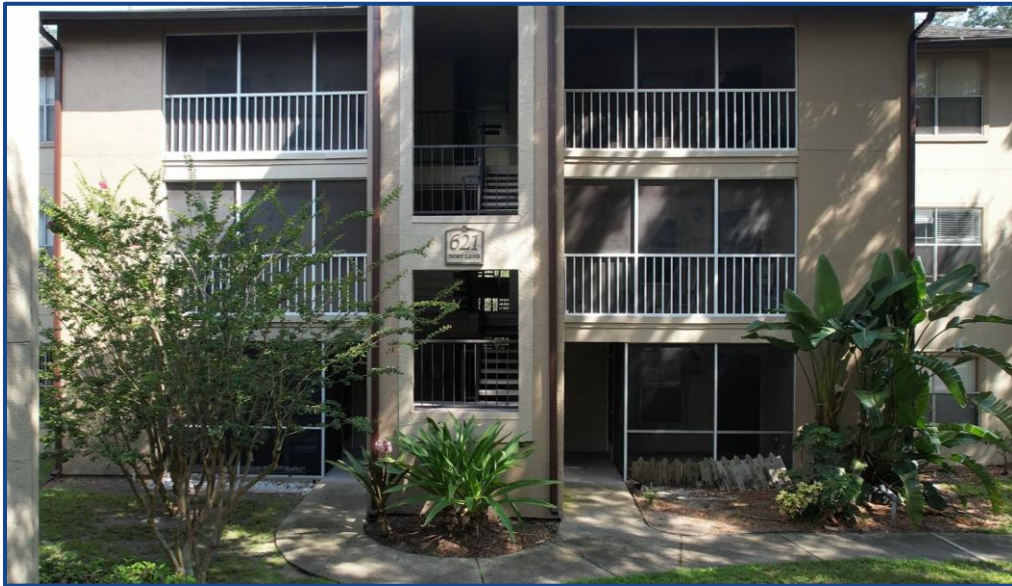
Photograph No. 4: View of the balconies and stairway on the south side of the building.

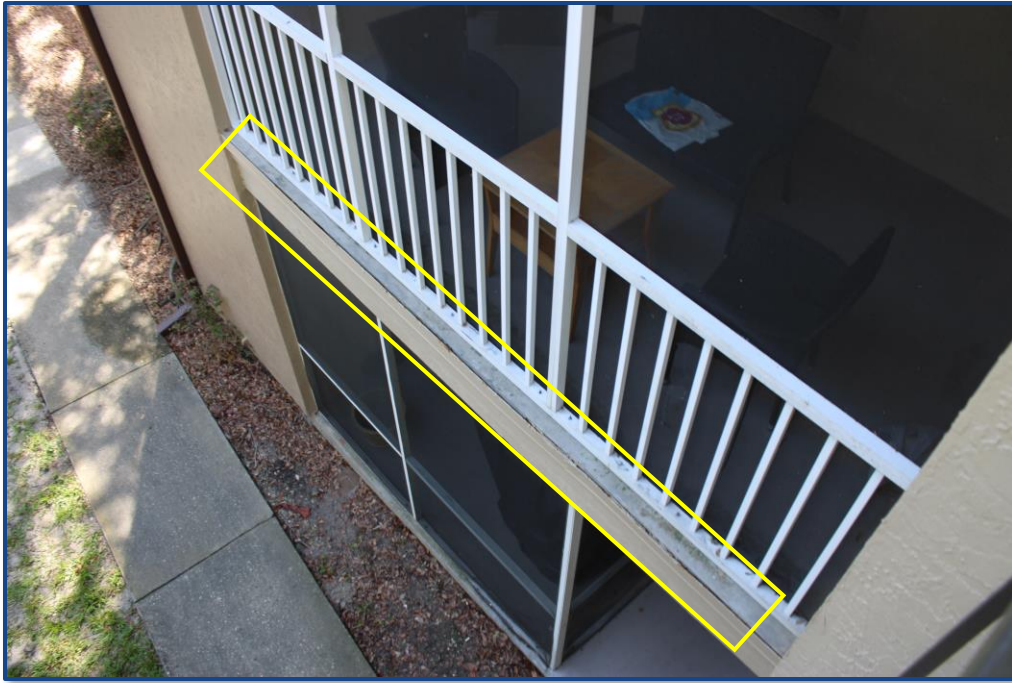
Photograph No. 5: Corrosion and separation of the metal flashing at the edge of the balcony slab on Unit 202.

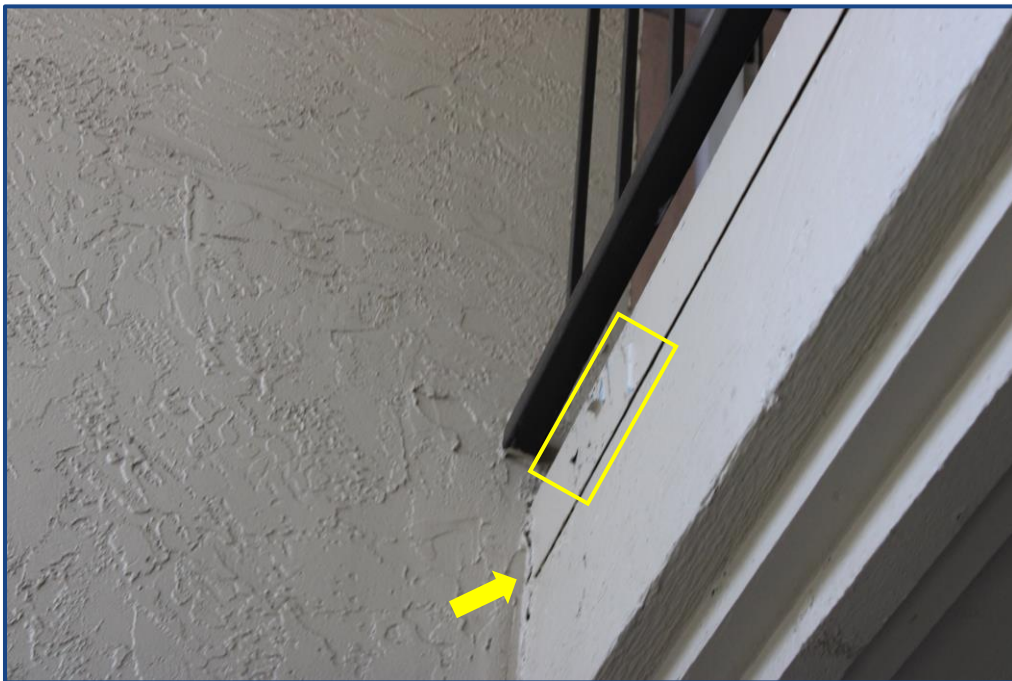
Photograph No. 6: Crack in the stucco wall finish and damage to the metal flashing at the edge of the stairway landing slab edge at the south stairway.

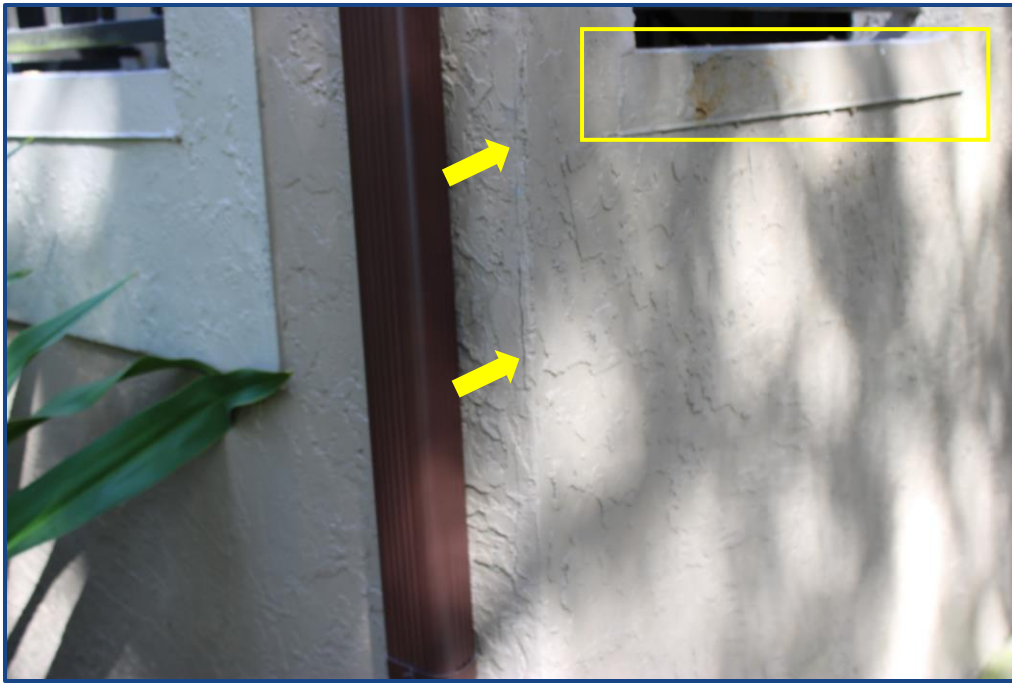
Photograph No. 7: Crack in the stucco wall finish and damage to the metal flashing at the edge of the stairway landing slab edge at the south stairway.

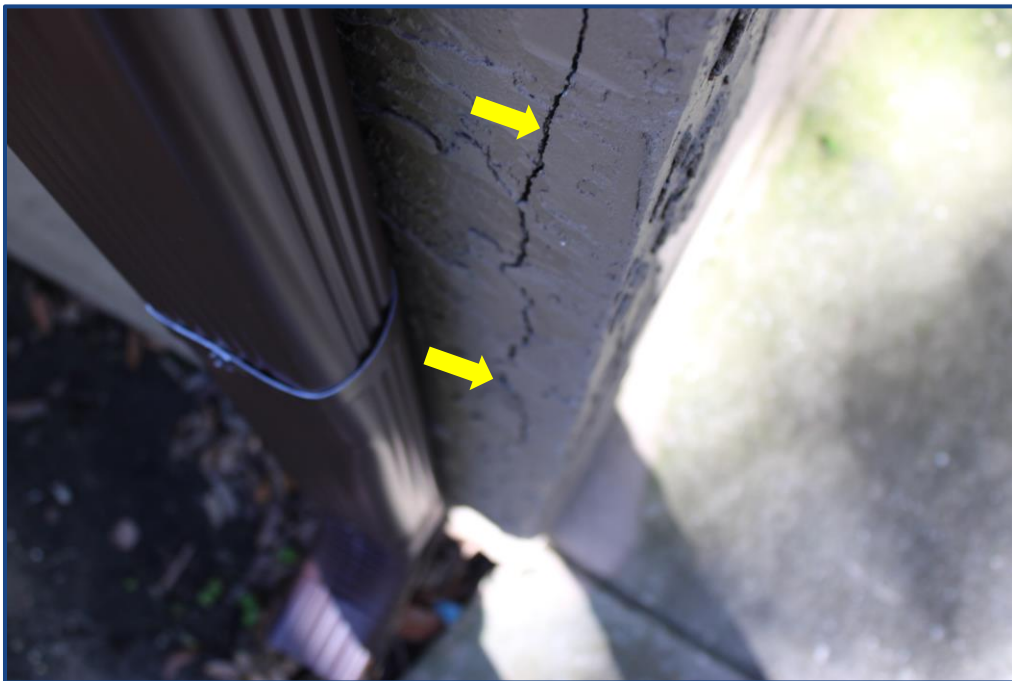
Photograph No. 8: Crack in the stucco wall finish located on the south stairway.

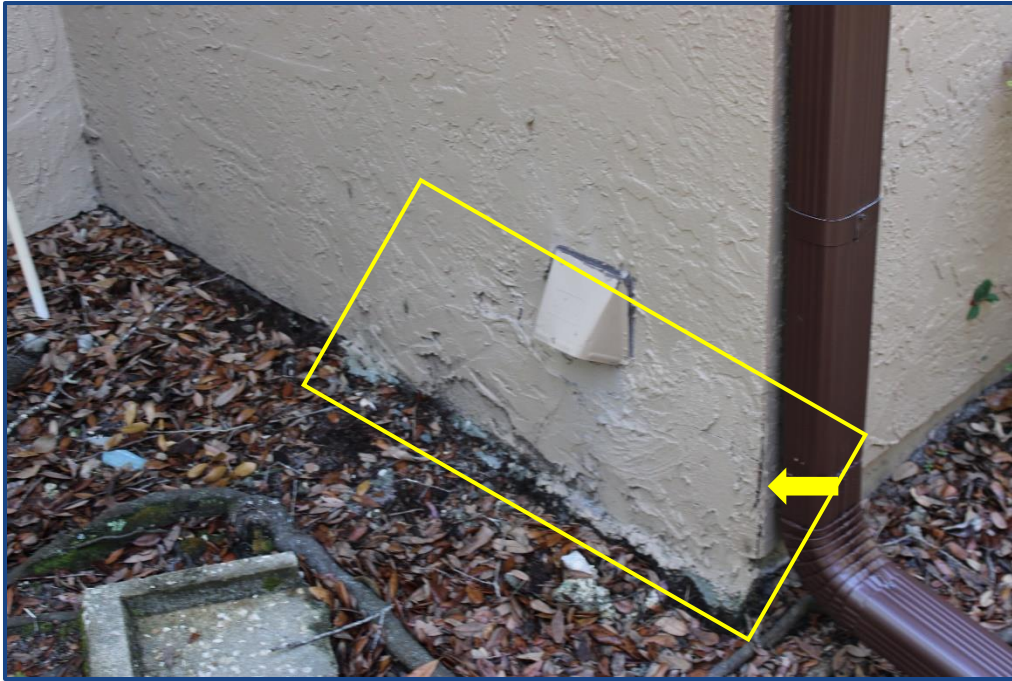
Photograph No. 9: Crack in the stucco wall finish and previous stucco patch located on the north side of the building.

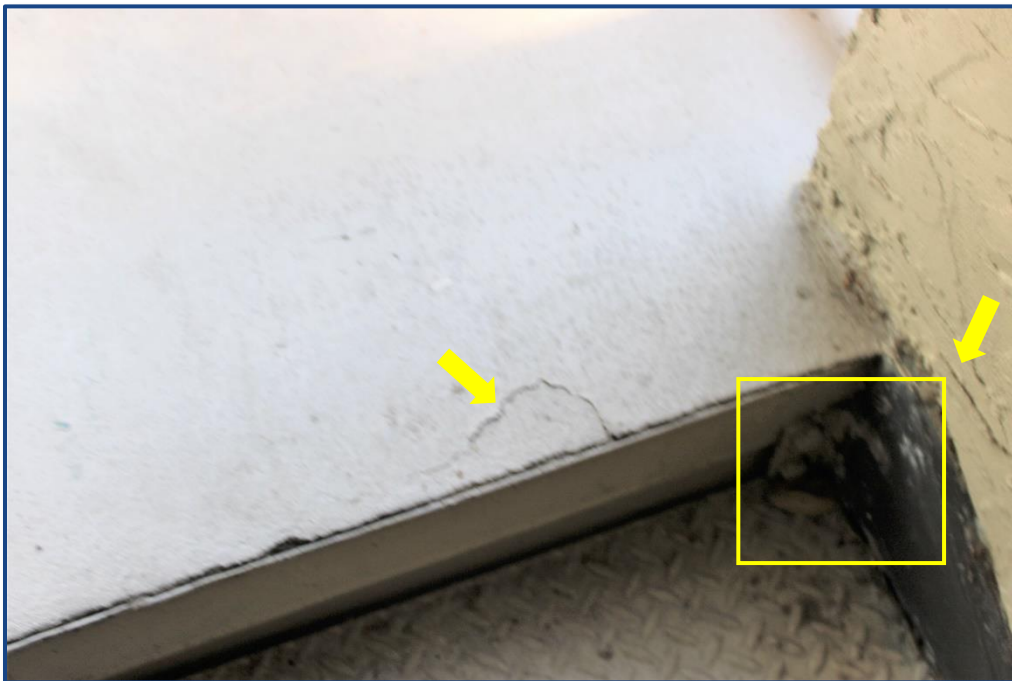
Photograph No. 10: Crack in the stucco wall finish, crack in the stairway landing slab, and corrosion to the steel framing located in the south stairway.

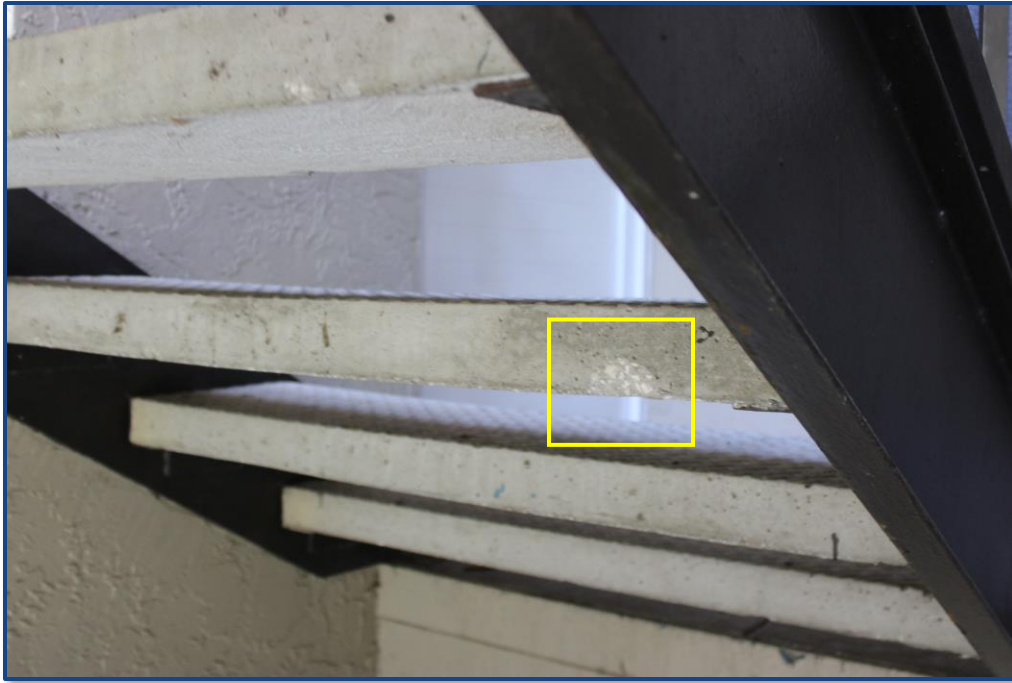
Photograph No. 11: Spalling in a concrete step located in the south stairway.

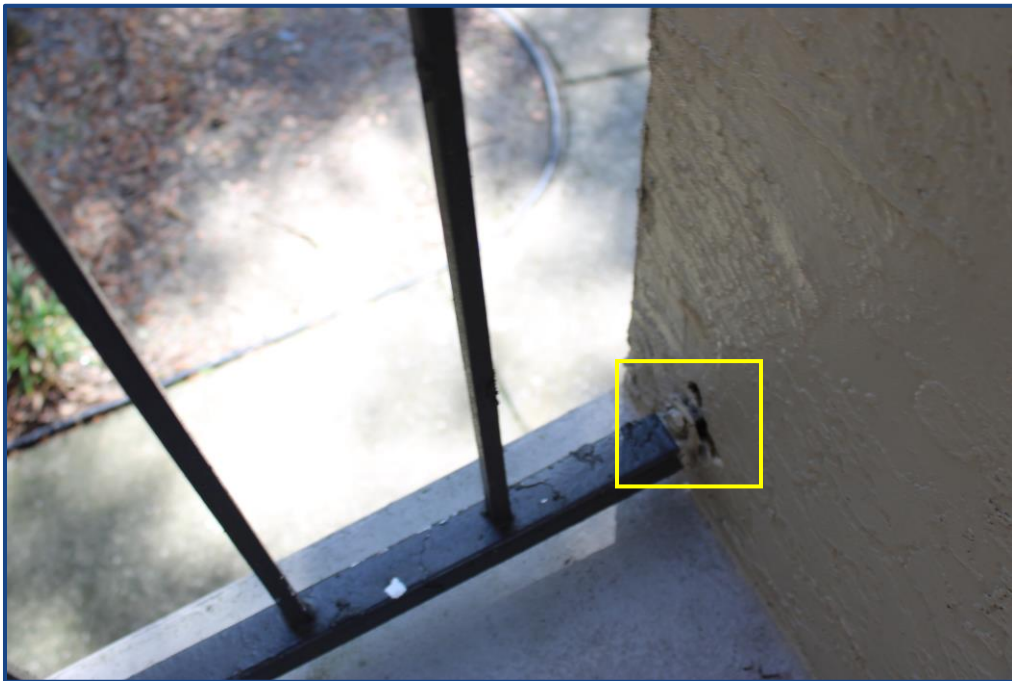
Photograph No. 12: Damage to the metal guardrail connection located in the south stairway.
