Stucco Repairs continued...

Painting - Total Current Cost Assigned Reserves Fully Funded Reserves \$40,000 \$40,000 \$21,143

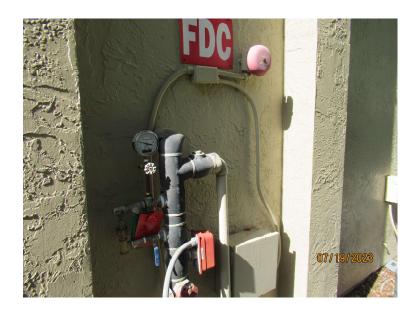
Fire Protective Systems - Total Current Cost
Assigned Reserves

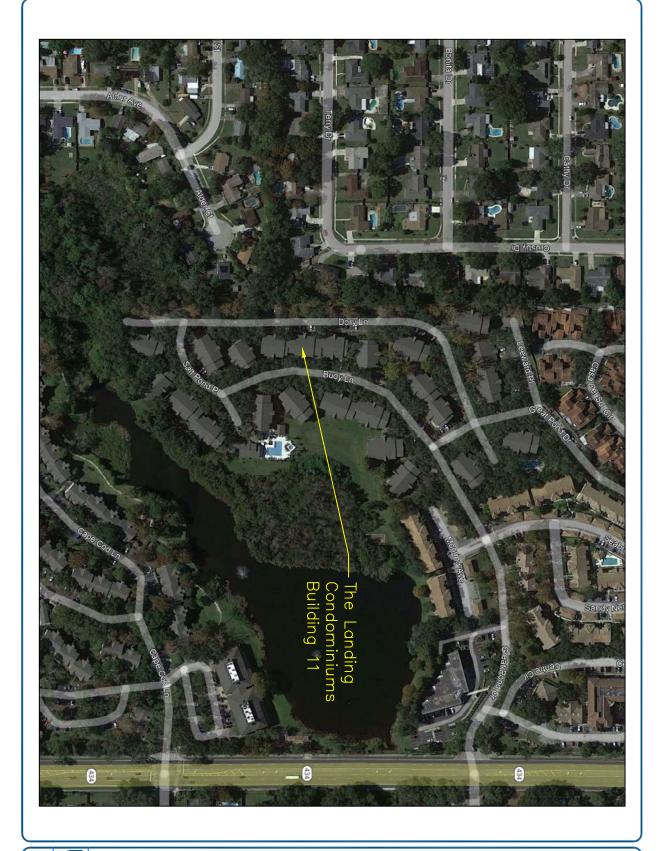
APPENDIX B
SITE LOCATION MAP

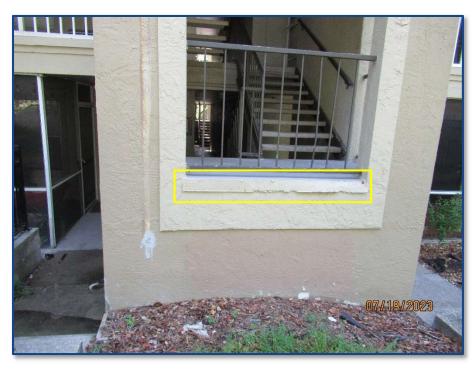
Photograph No. 11: Peeling paint, corrosion, and separation of the metal flashing at the edge of the southwest stairway landing slab.

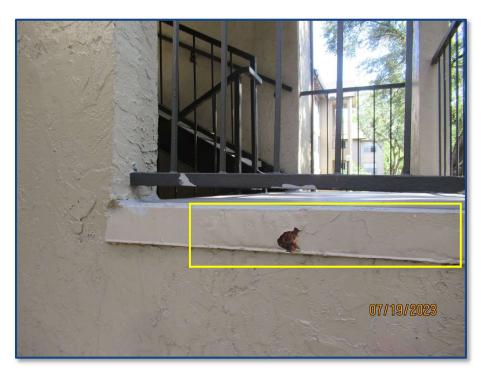
Photograph No. 12: Peeling paint and surface corrosion to the metal flashing at the edge of the northeast stairway landing slab.

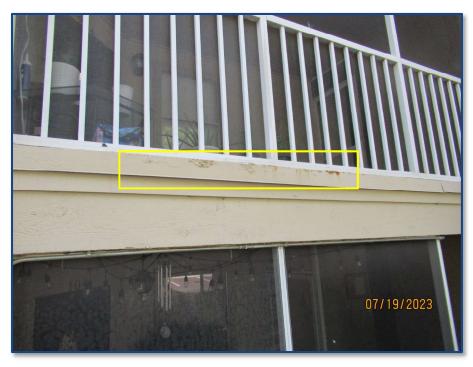
Photograph No. 13: Corrosion and separation of the metal flashing at the edge of the balcony slab on Unit 204.

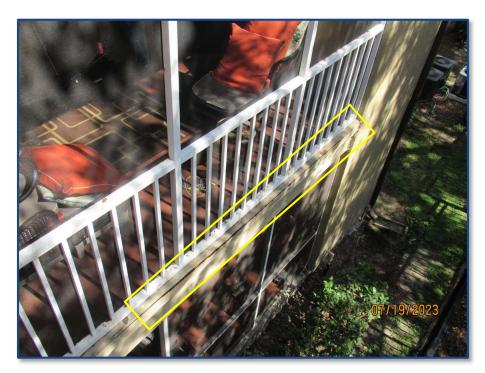
Photograph No. 14: Corrosion and separation of the metal flashing at the edge of the balcony slab on Unit 209.

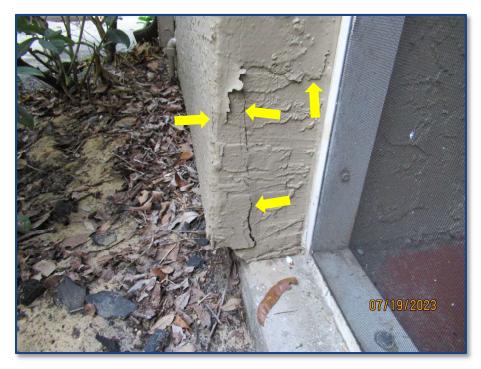
Photograph No. 15: Cracks in the exterior wall stucco finish and paint peeling at the exterior of Unit 106.

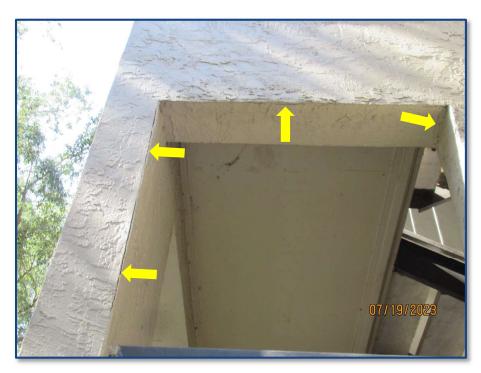
Photograph No. 16: Cracks in the stucco wall finishes located on the northeast stairway.

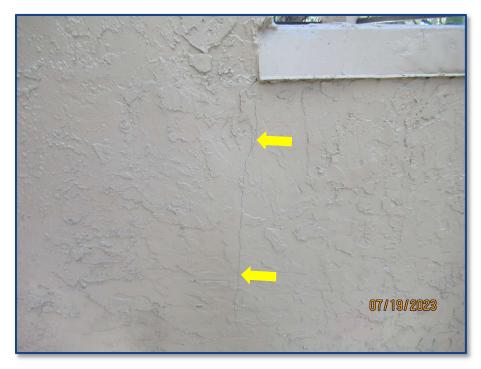
Photograph No. 17: Crack in the stucco wall finish located on the northeast stairway.

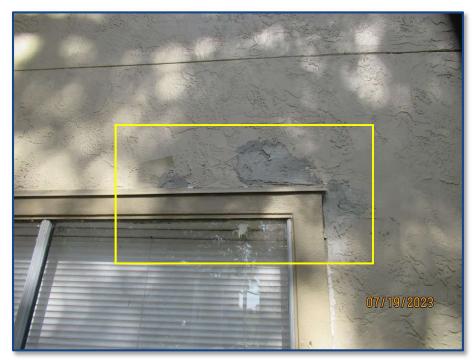
Photograph No. 18: Peeling of the paint finish and cracks in the exterior wall stucco patch located on the east side of the building.

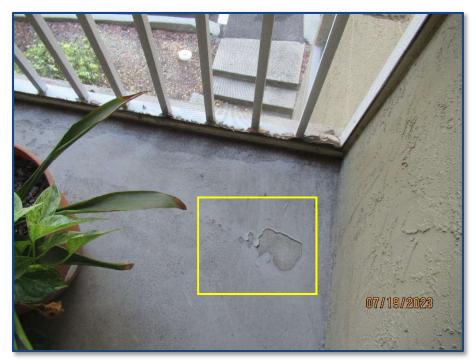
Photograph No. 19: Peeling of the balcony slab paint finish located on Unit 203.

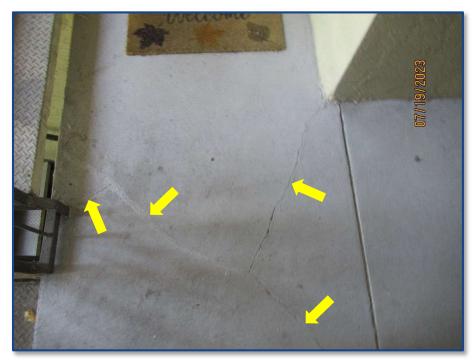
Photograph No. 20: Previously sealed crack in the concrete slab located at the north part of the building on the 2nd floor.

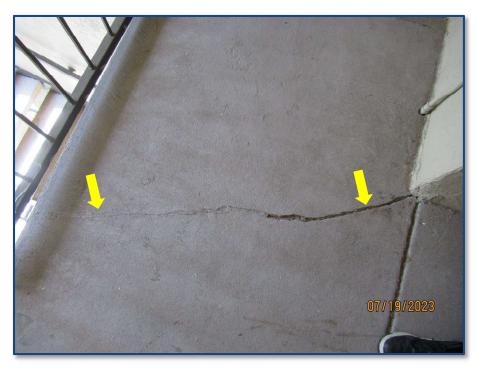
Photograph No. 21: Previously sealed crack in the concrete slab located at the north part of the building on the 3rd floor.

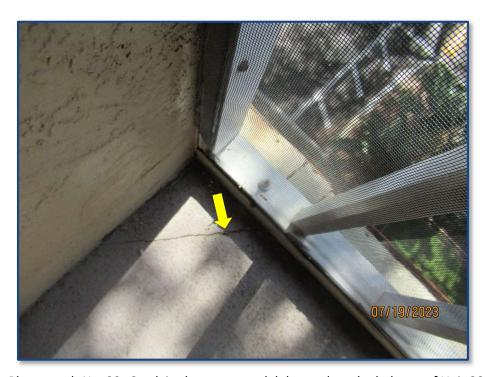
Photograph No. 22: Crack in the concrete slab located on the balcony of Unit 309.

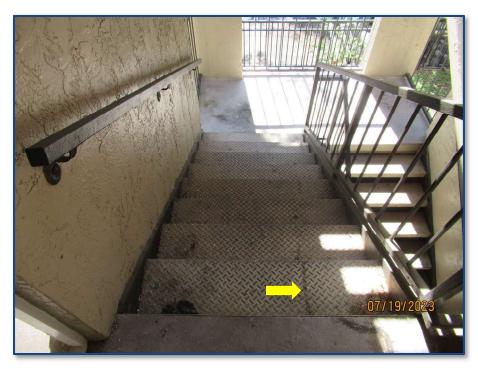
Photograph No. 23: Previously sealed crack in a concrete step located in the northeast stairway.

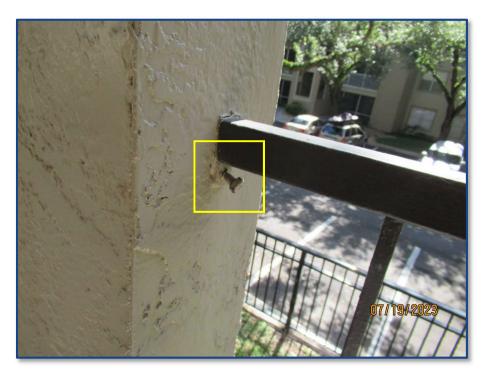
Photograph No. 24: A loose bolt located in the handrail connection in the northeast stairway.

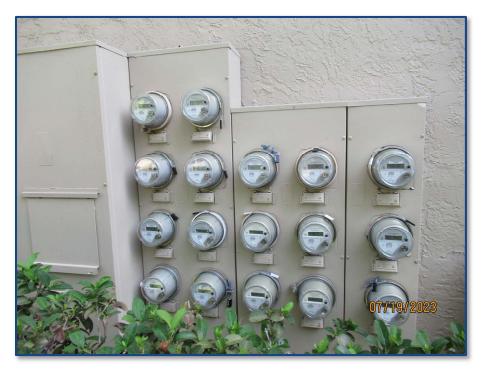
Photograph No. 25: Electrical meters.
