August 25, 2023

Re: The Landing Condominiums – Building 12
Structural Integrity Reserve Study (SIRS)
625 Dory Lane
Altamonte Springs, FL 32714
UES Project No: 0811.2300006.0000

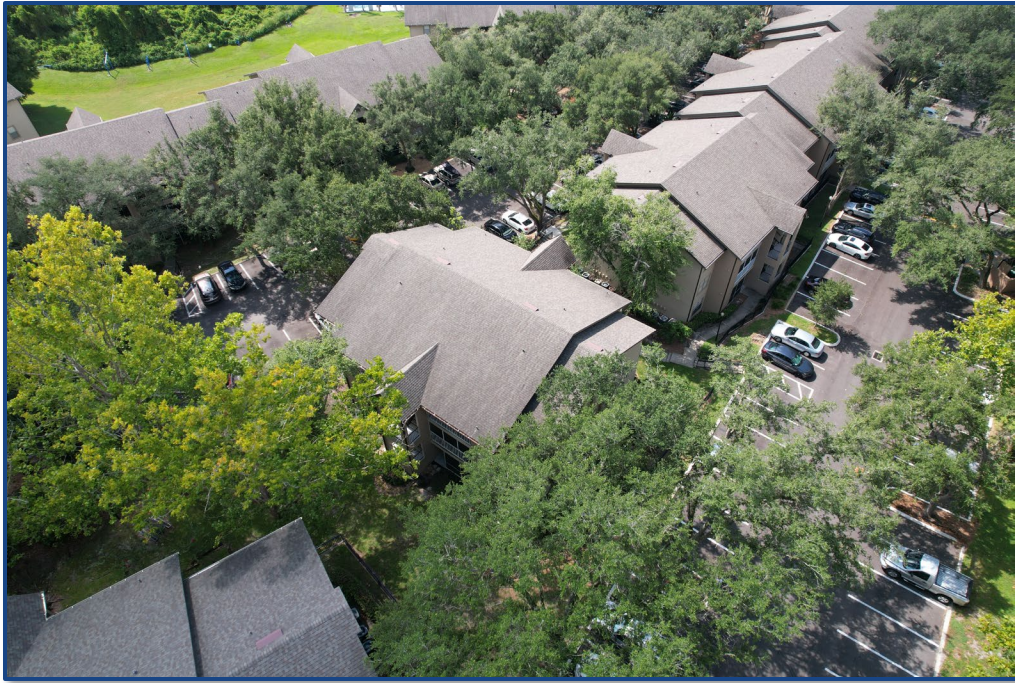
Photograph No. 1: North elevation.

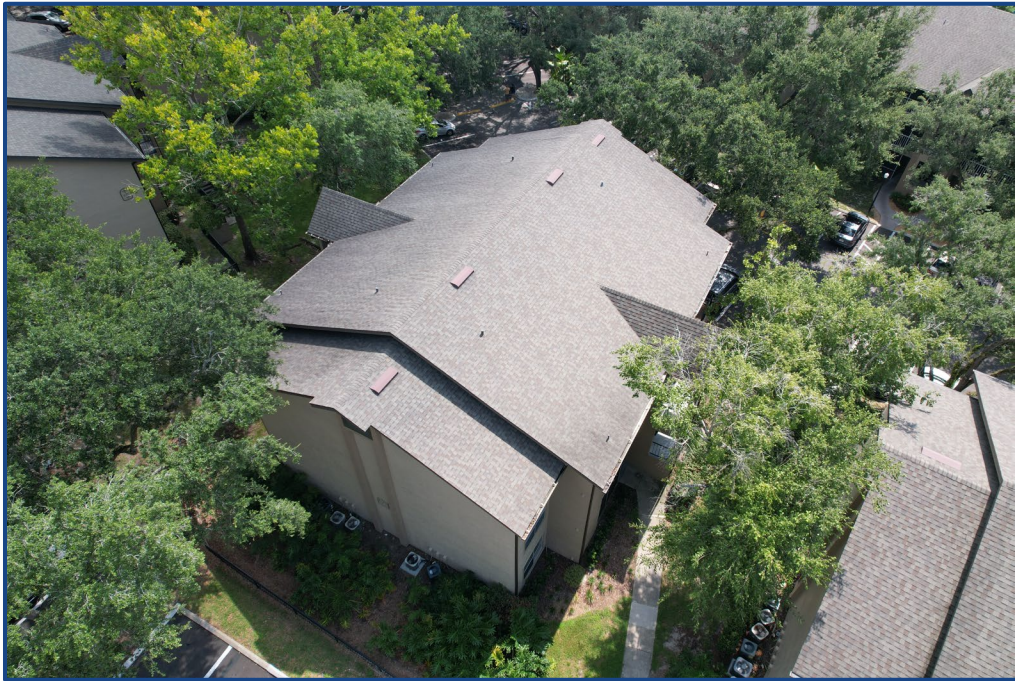
Photograph No. 2: West elevation.

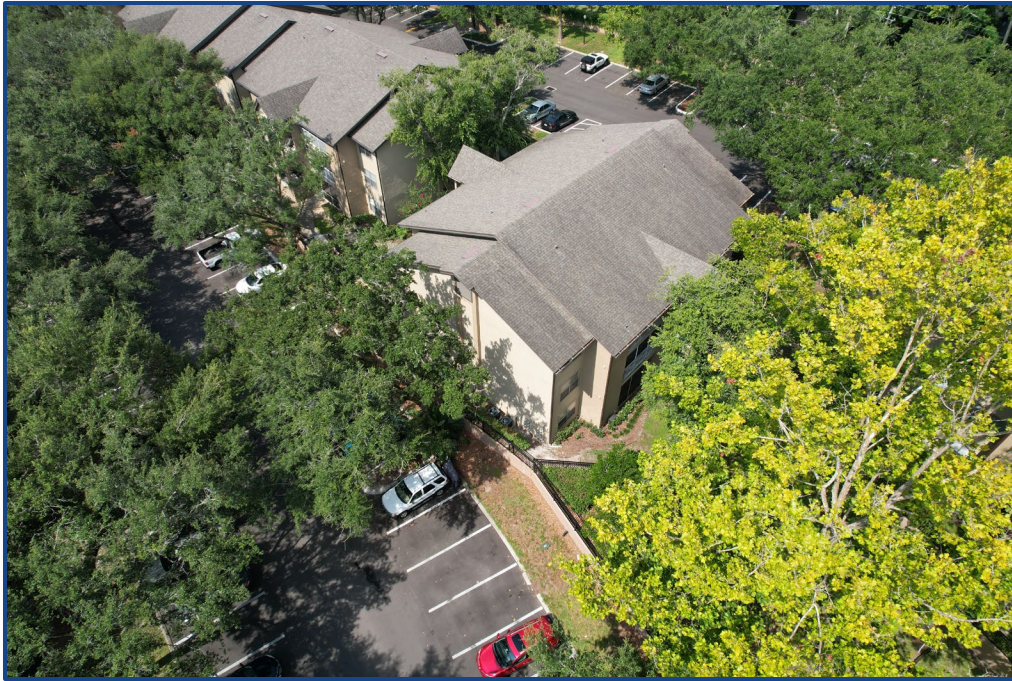
Photograph No. 3: East elevation.

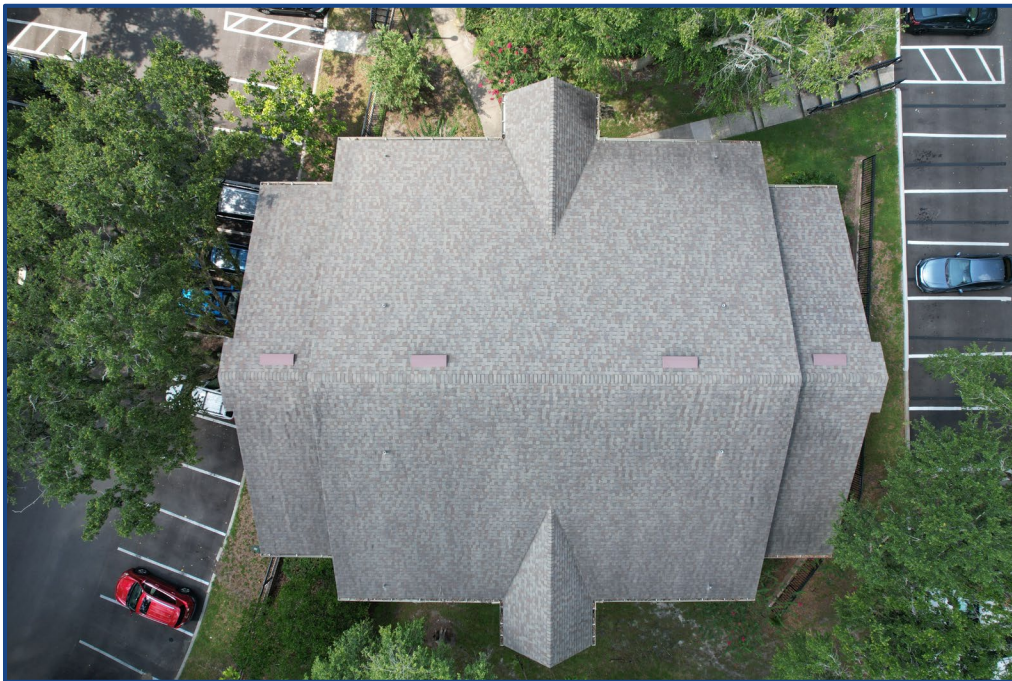
The roof system of the building is composed of architectural asphalt shingles. At the time of inspection, no damage was observed in the roof system. The roof system was observed to be in good condition.

Photograph No. 4: View of the roof.

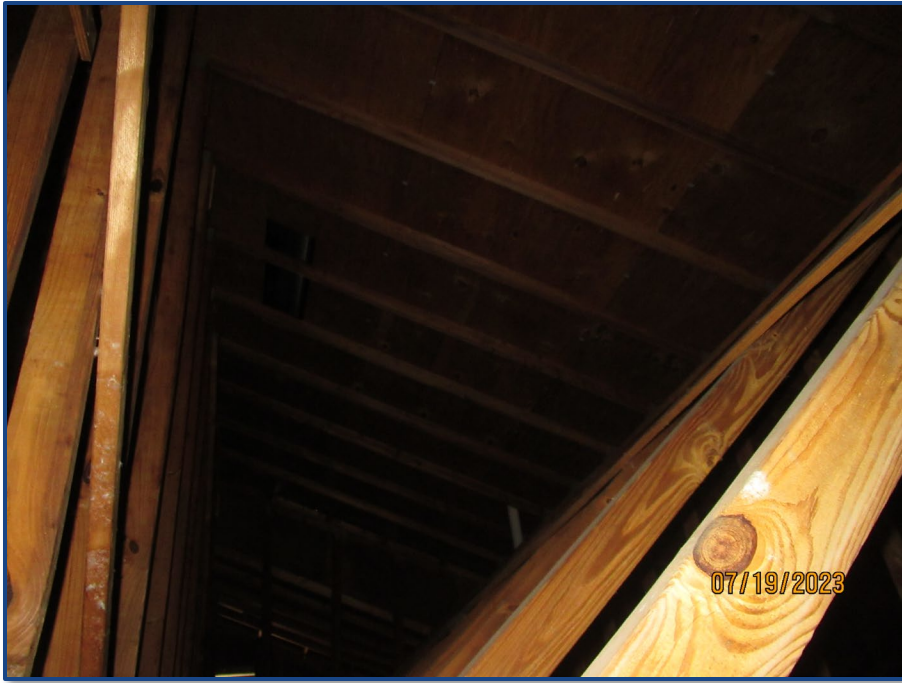
Photograph No. 5: General view of the prefabricated wooden roof trusses.

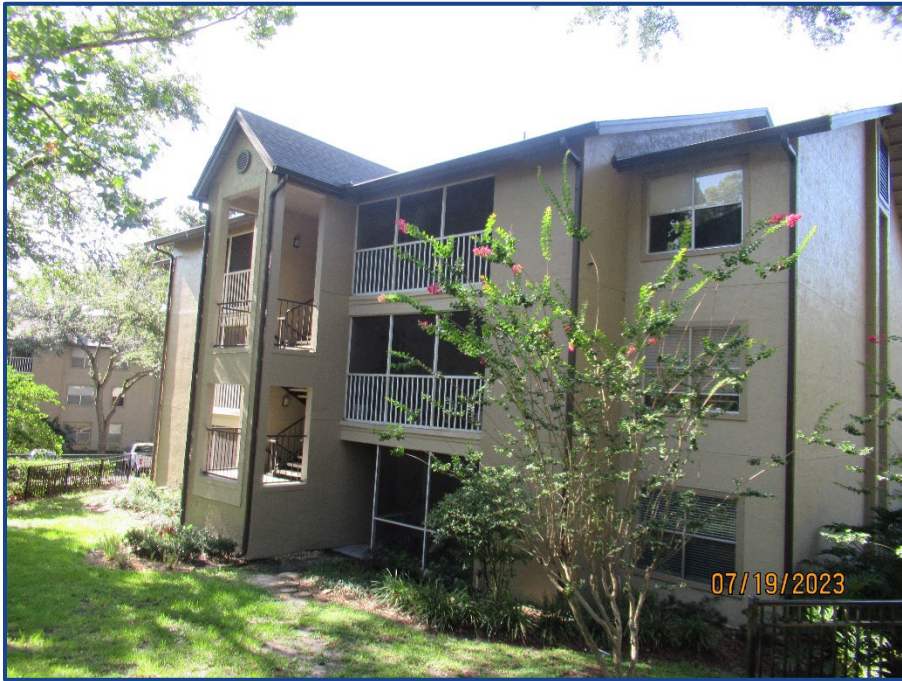
Photograph No. 6: View of the balconies and stairway on the north side of the building.

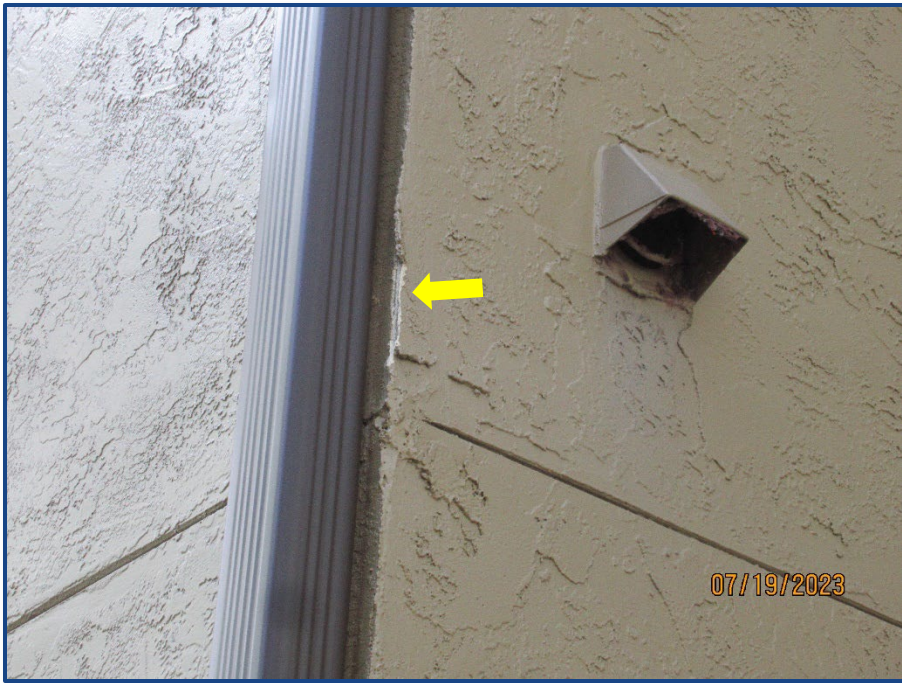
The exterior finishes of the building consists of painted stucco finishes. At the time of inspection, cracks and damage to the exterior stucco finishes were observed in multiple locations. (Photographs No. 7 through 10 and 18). Ponding was observed on the balcony of Unit 204 (Photograph No. 11). Peeling paint was observed on the balcony slab located on Unit 303 (Photograph No. 12). Overall, the general condition of the exterior finishes is in good condition. See **Appendix C** for reference site photographs.

- Cracks and damage to the exterior stucco finishes were observed in multiple locations. See **Appendix C** Photographs No. 7 through 10 and 18.
- Ponding was observed on the balcony of Unit 204. See **Appendix C** Photograph No. 11.
- Peeling paint was observed on the balcony slab located on Unit 303. See **Appendix C** Photograph No. 12.
- Cracks in the elevated concrete slabs were observed in multiple locations. See **Appendix C** Photographs No. 13 through 15.
- Corrosion to the steel framing was observed in the south stairway. See **Appendix C** Photograph No. 16.
- Paint peeling and surface corrosion was observed on the metal guardrails in multiple locations. See **Appendix C** Photographs No. 17 and 18.

Photograph No. 7: Damage to the exterior wall stucco finish located on the northside of the building.

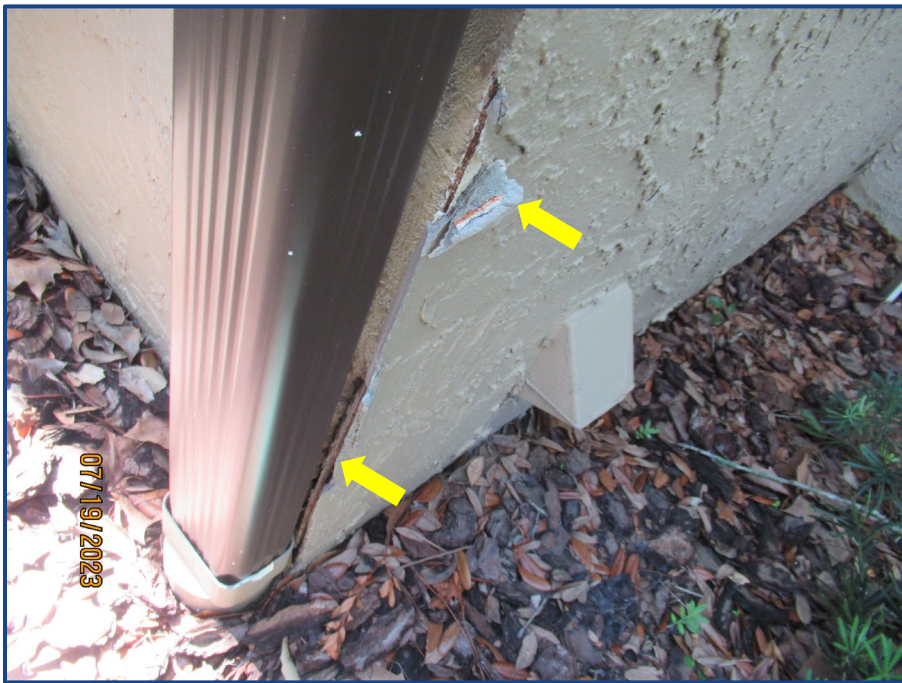
Photograph No. 8: Damage to the exterior wall stucco finish located on the northside of the building.

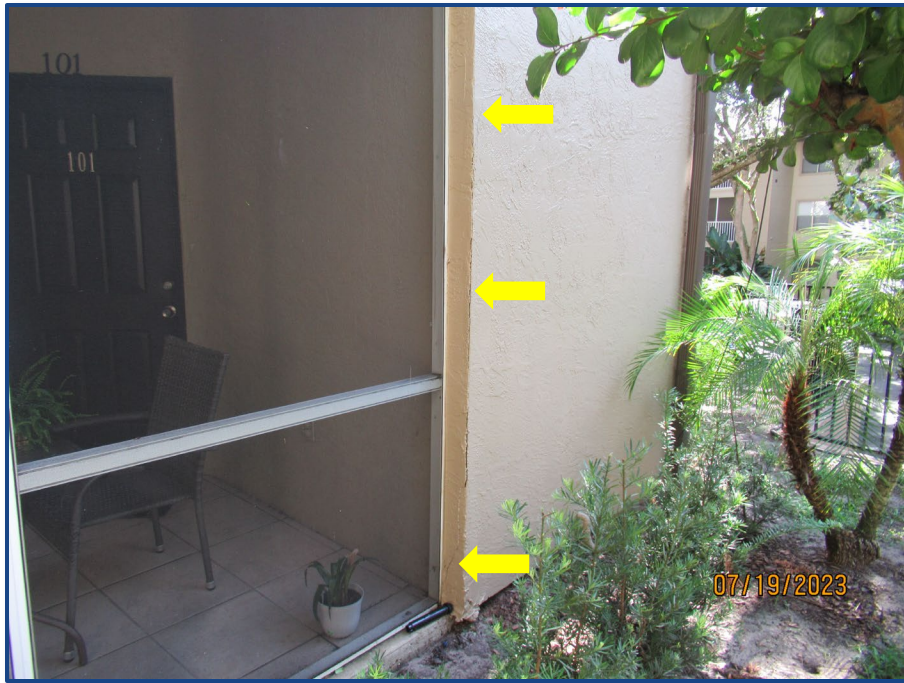
Photograph No. 9: Crack in the exterior wall stucco finish located on the exterior of Unit 101.

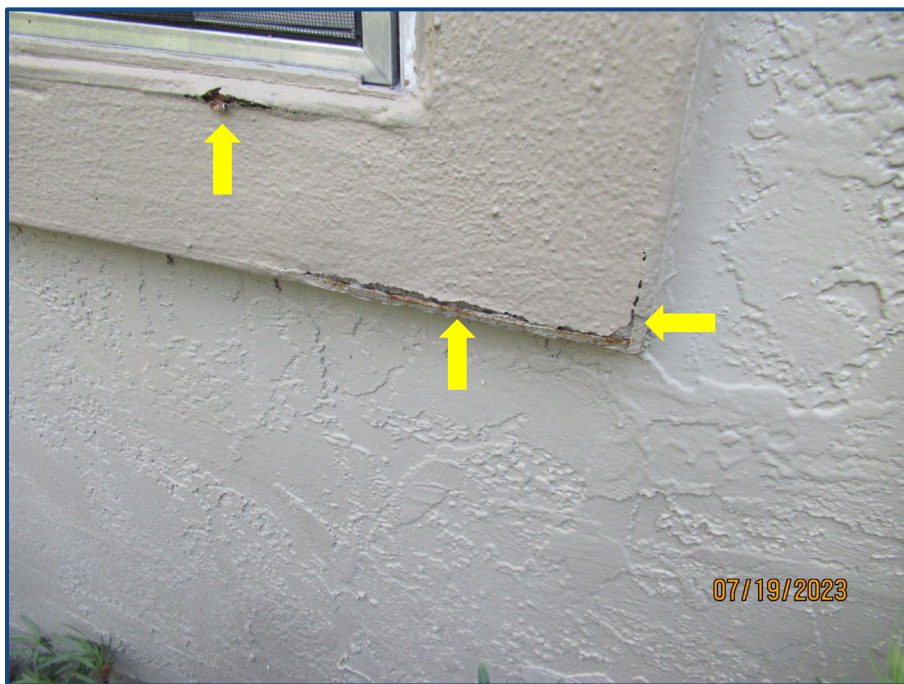
Photograph No. 10: Damage to the stucco finish around the window on Unit 101.

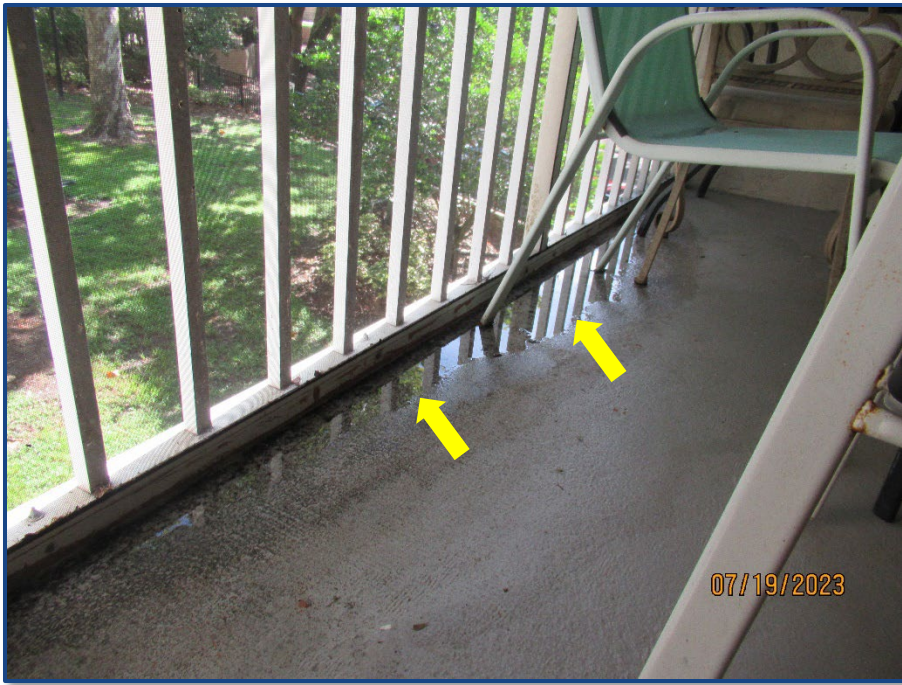
Photograph No. 11: Ponding observed on the balcony of Unit 204.

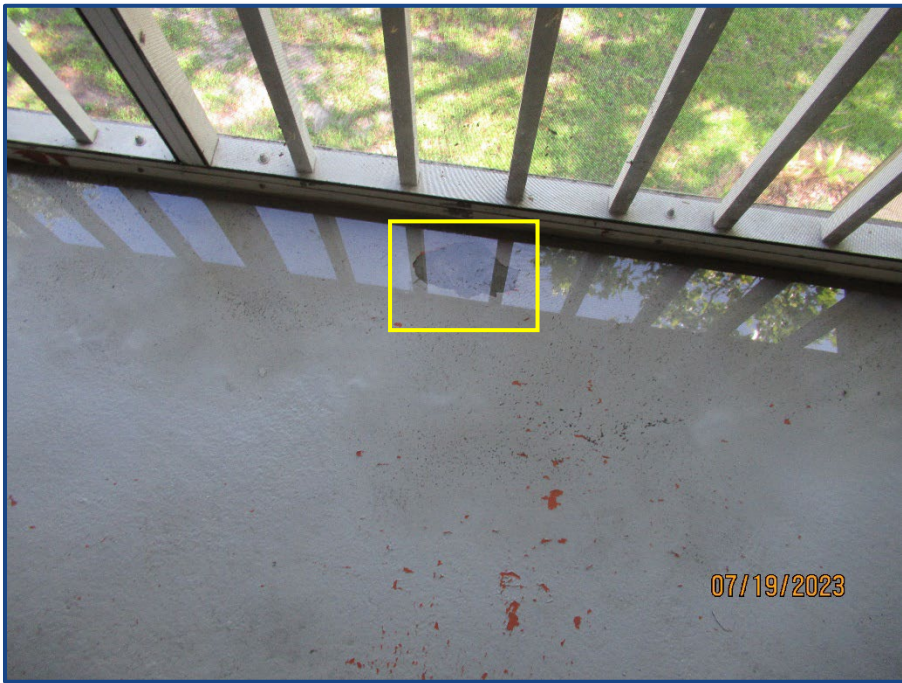
Photograph No. 12: Peeling of the balcony slab paint finish located on the balcony of Unit 303.

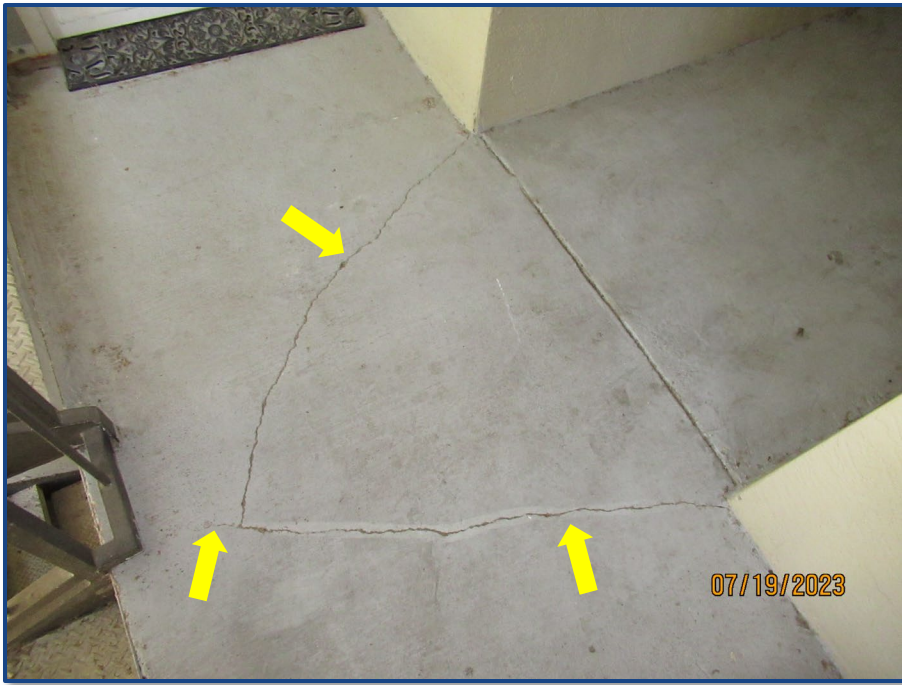
Photograph No. 13: Previously sealed cracks in the concrete slab on the 2nd floor.

Concrete and Stairway Repairs for year 2024 shall include repairs to cracked concrete and corrosion to the steel framing and handrails referenced within this report.

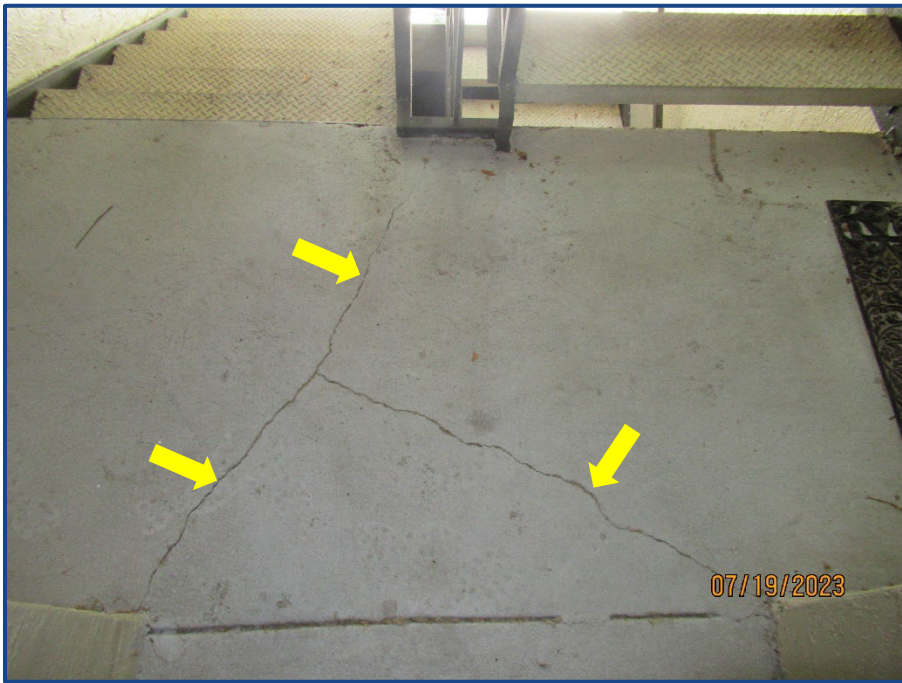
Photograph No. 14: Cracks in the concrete slab on the 2nd floor.

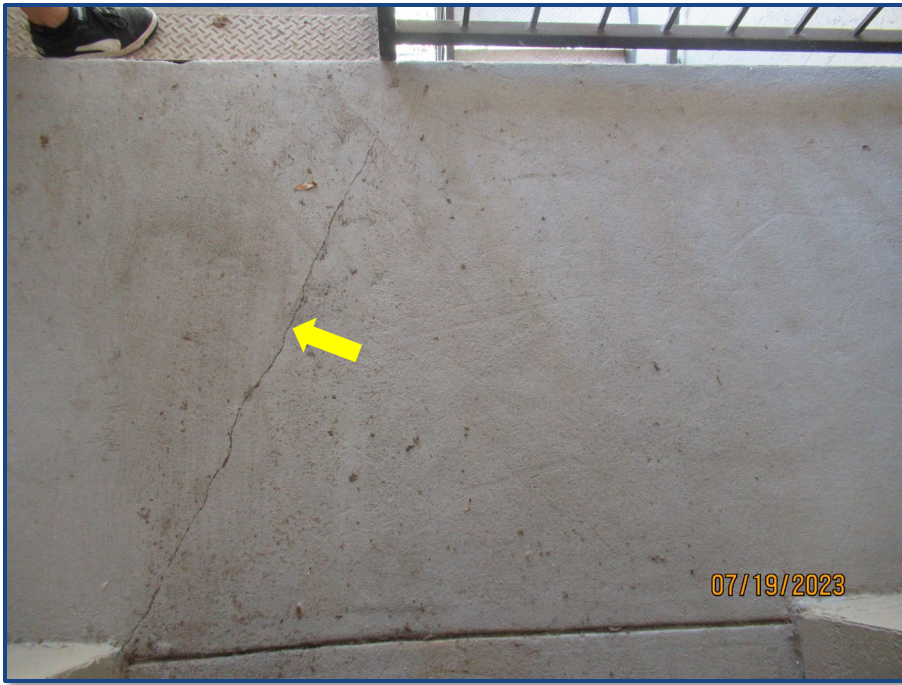
Photograph No. 15: Crack in the concrete slab located on the 3rd floor.

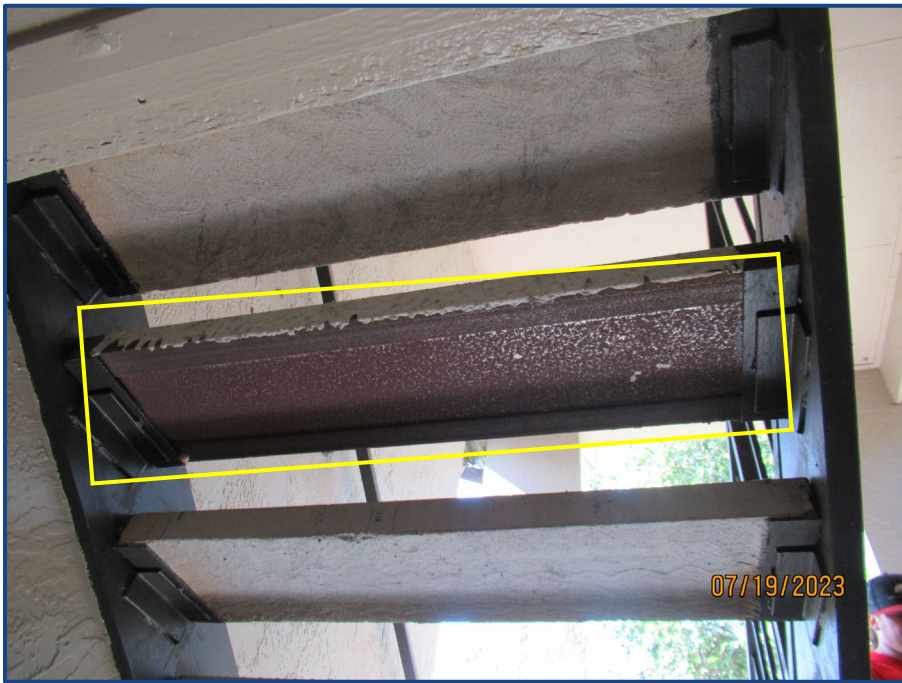
Photograph No. 16: Corrosion to the steel framing located in the south stairway.

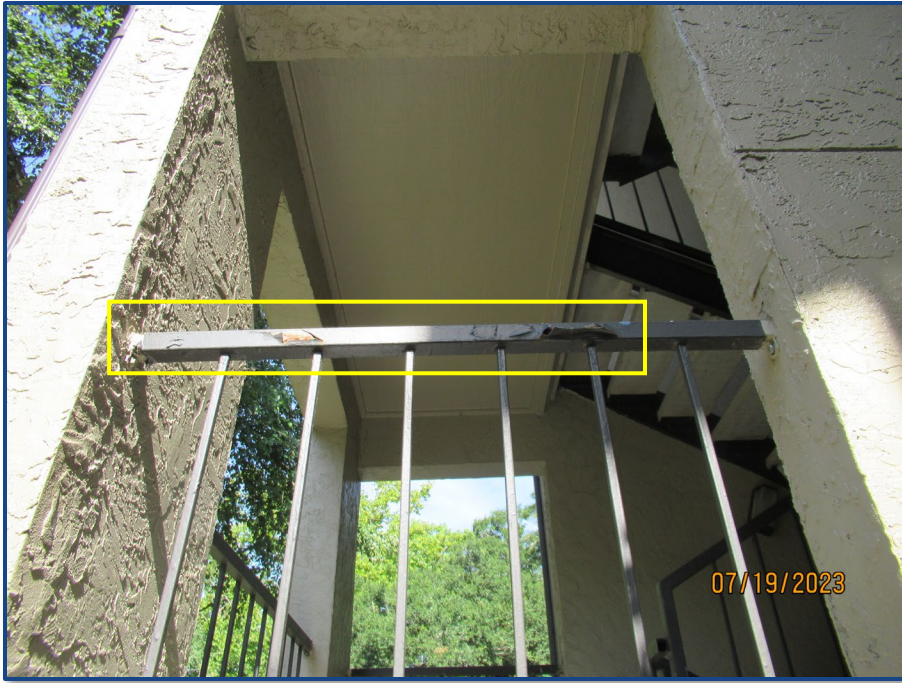
Photograph No. 17: Paint peeling and surface corrosion to the metal guardrail located in the south stairway.

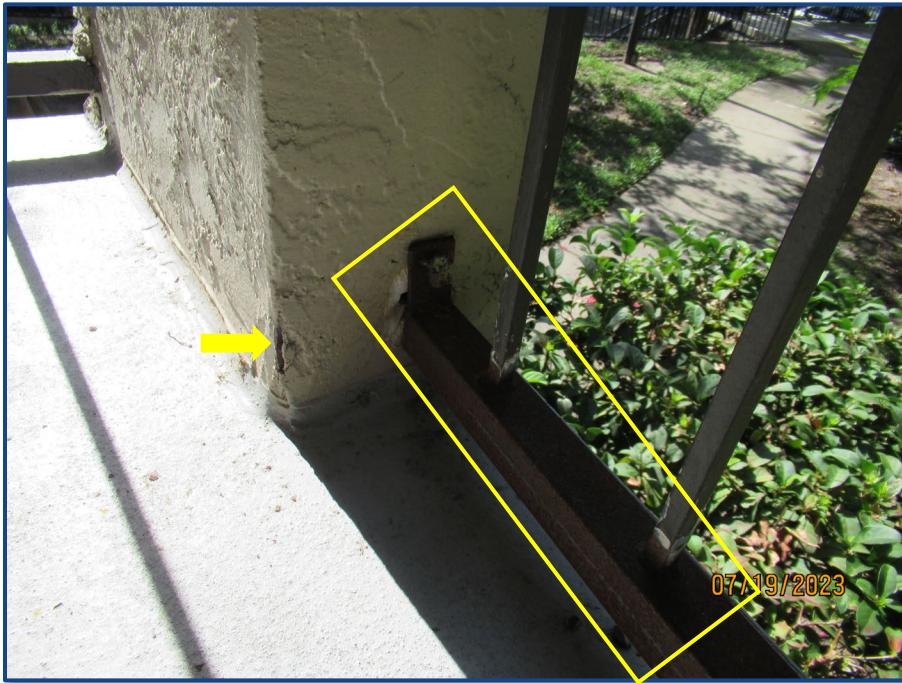
Photograph No. 18: Stucco damage, paint peeling, and surface corrosion to the metal guardrail located in the south stairway.

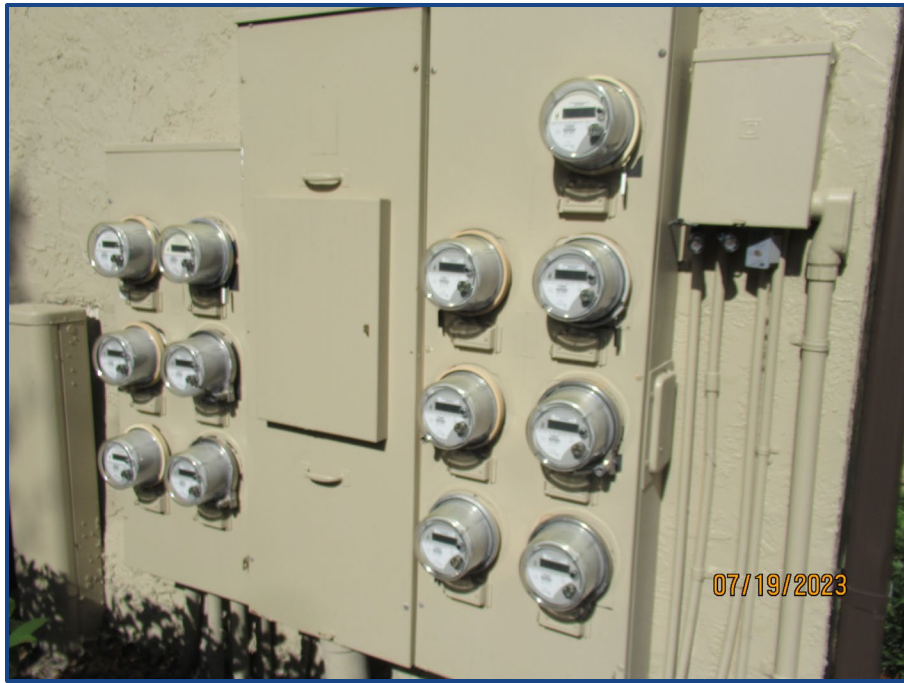
The visible electrical systems inspected at the time of inspection included electrical meters, main disconnects, air conditioning disconnects on each unit, and electrical conduits. At the time of inspection, no damage or deficiencies were observed to the electrical systems.

Photograph No. 19: Electrical meters.

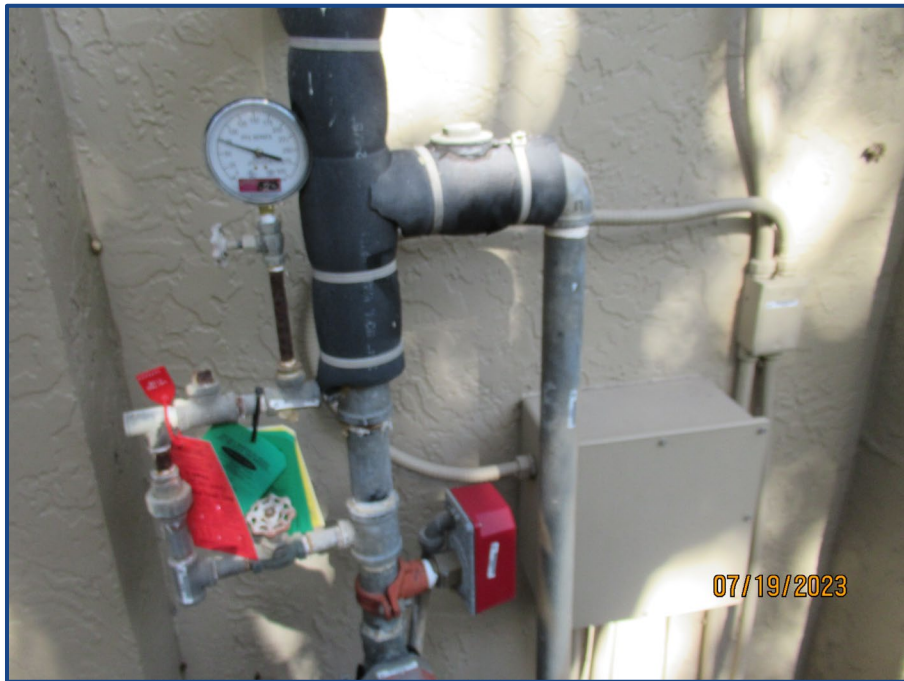
The fire protection system of the building consists of a wet pipe fire sprinkler system with sprinkler heads located in the units. In addition, a riser system and fire alarm are located at the exterior of the building. No issues or concerns were observed or reported at the time of inspection.

Photograph No. 20: Fire riser system.
