August 25, 2023

Janette Barcena
The Landing Condominium Association, Inc.
953 Salt Pond Place
Altamonte Springs, Florida 32714

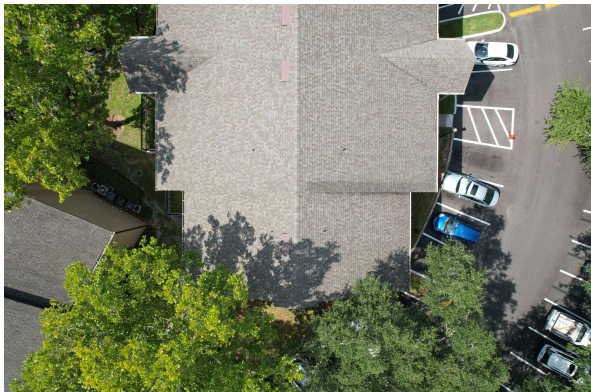
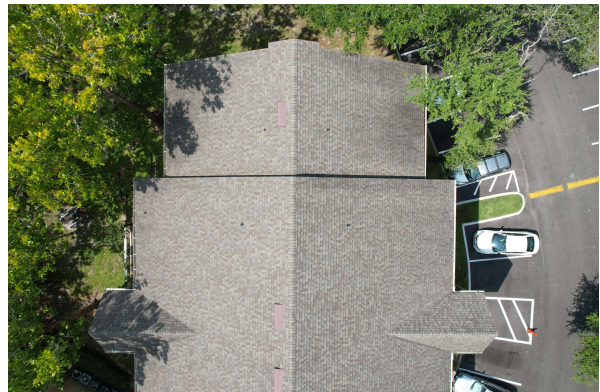
| Roofing - Total Current Cost | \$25,150 |

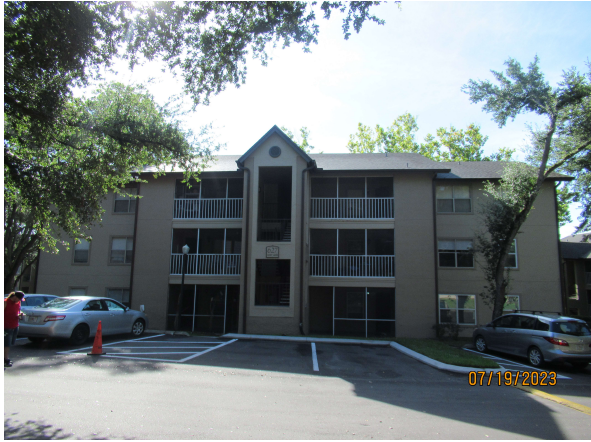
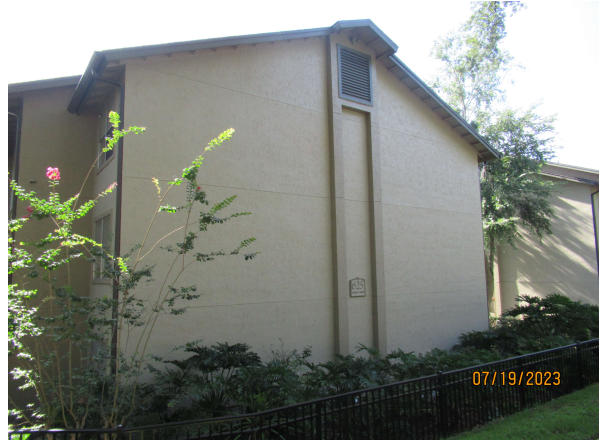
Stucco Repairs - 2030

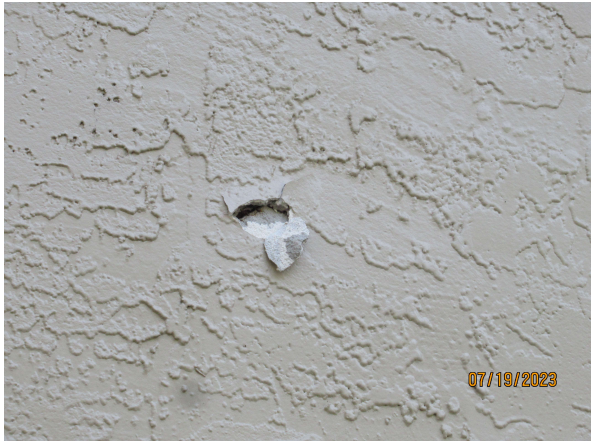
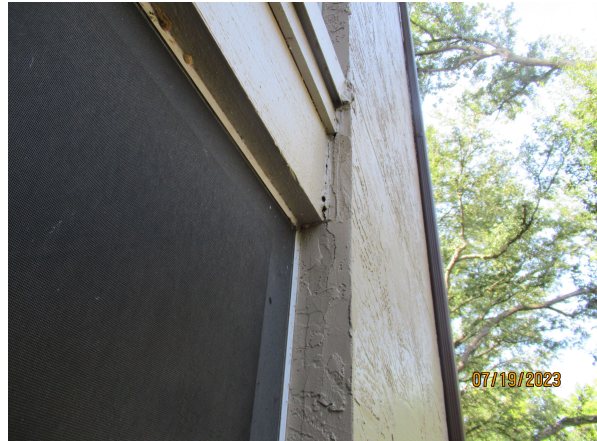
| Painting - Total Current Cost | \$17,000 |

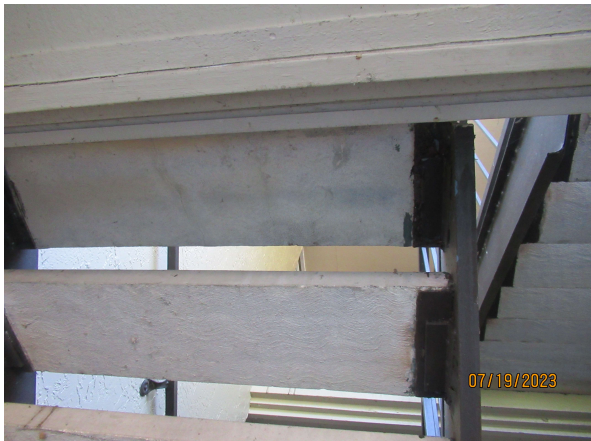
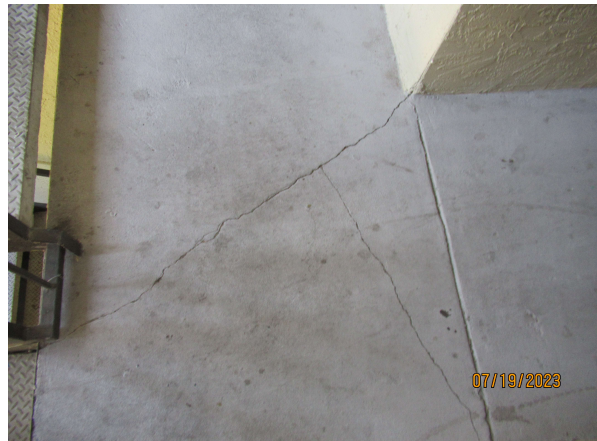
Concrete and Stairway Repairs for year 2024 shall include repairs to cracked concrete and corrosion to the steel framing referenced within this report.

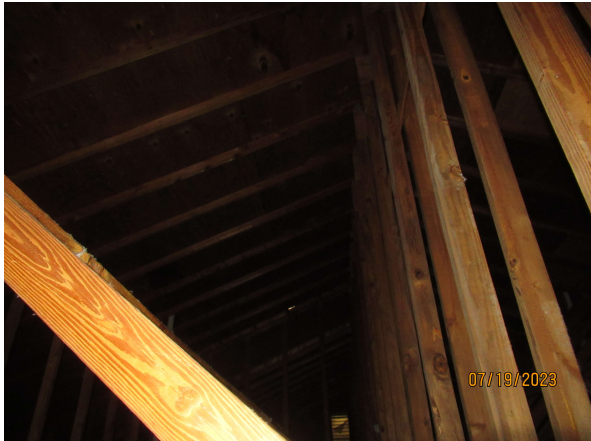
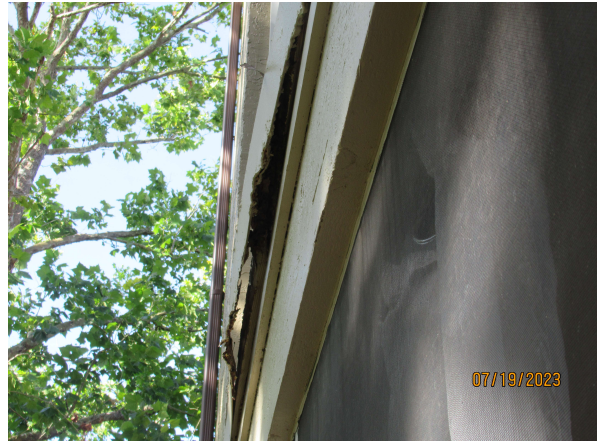
Wood Framing Repairs for year 2024 shall include repairs to the roof sheathing and wood beam referenced within this report.

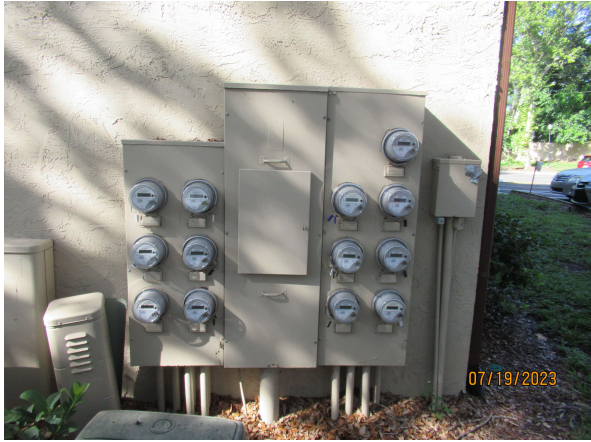
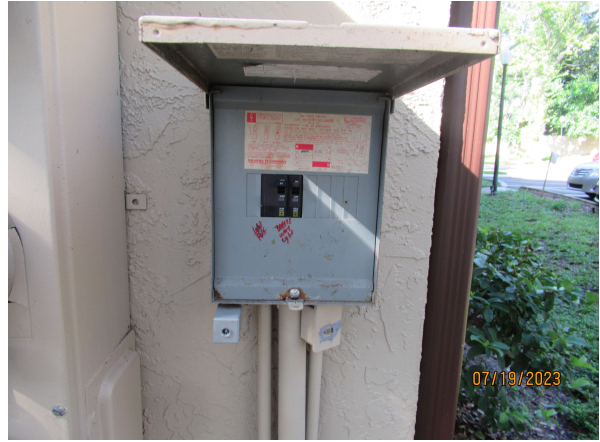
| Electrical Systems - Total Current Cost | \$2,500 |

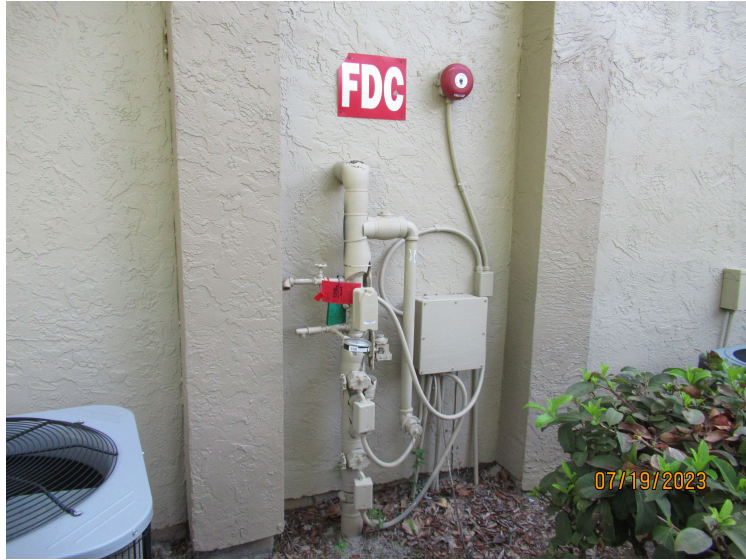
| Fire Protective Systems - Total Current Cost | \$2,500 |

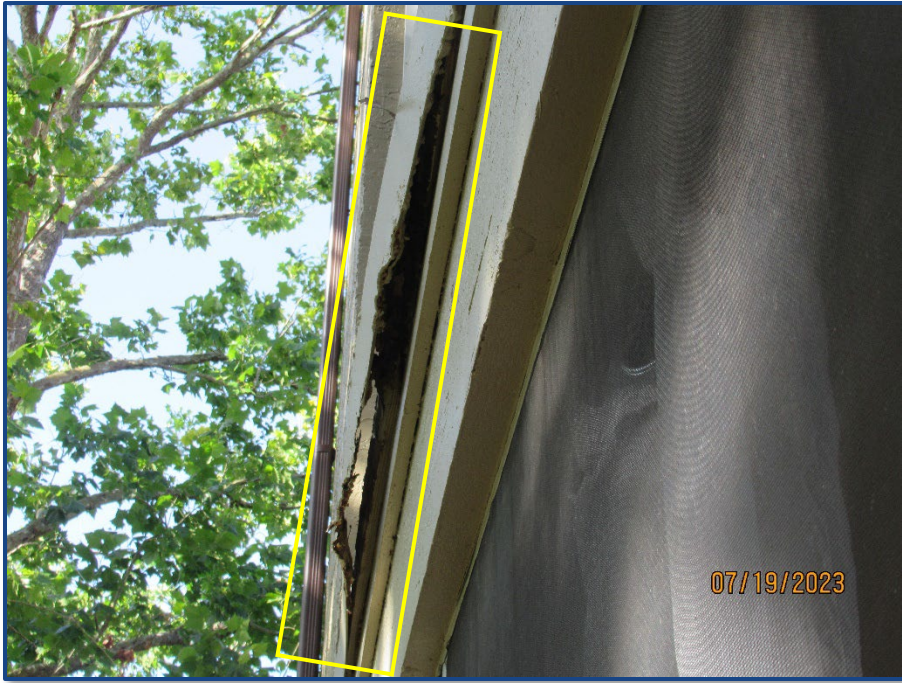
Photograph No. 9: Deterioration of the wood beam, corrosion, and separation of the metal flashing at the edge of the balcony slab on Unit 204.

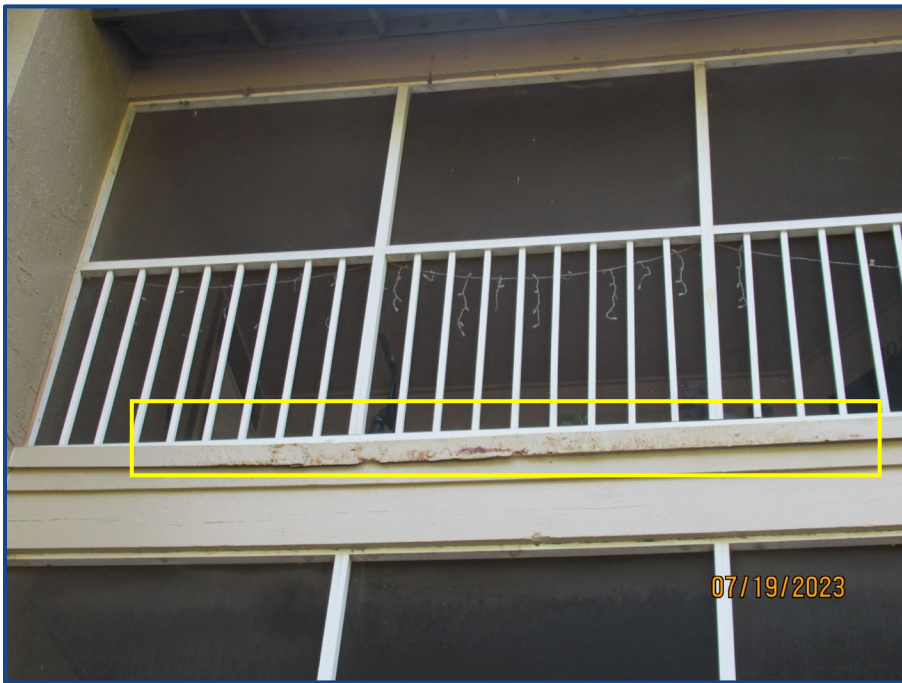
Photograph No. 10: Corrosion and separation of the metal flashing at the edge of the balcony slab on Unit 301.

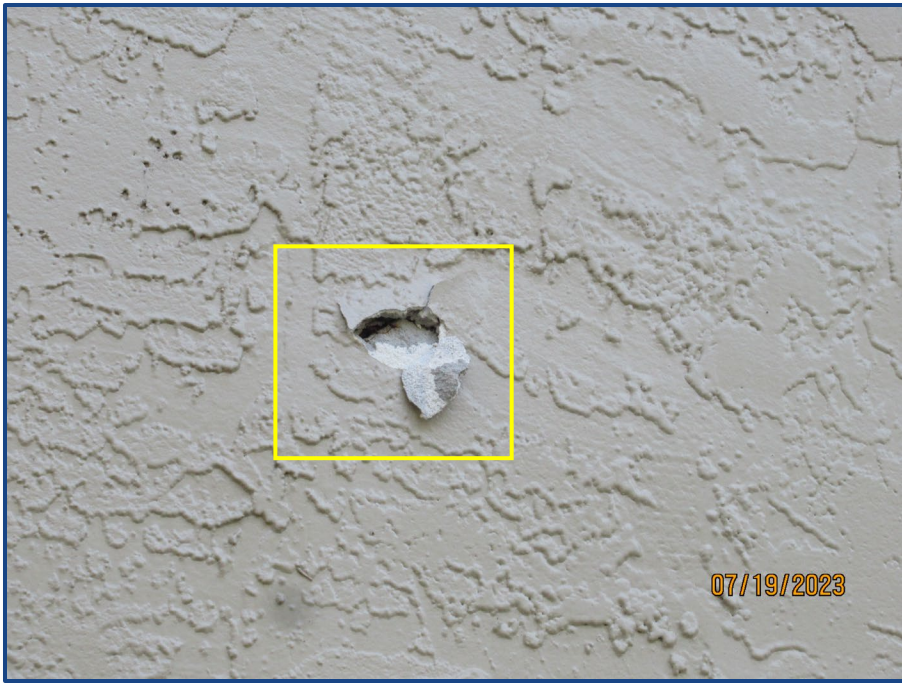
Photograph No. 11: Damage to the exterior wall stucco finish located above a window on Unit 102.

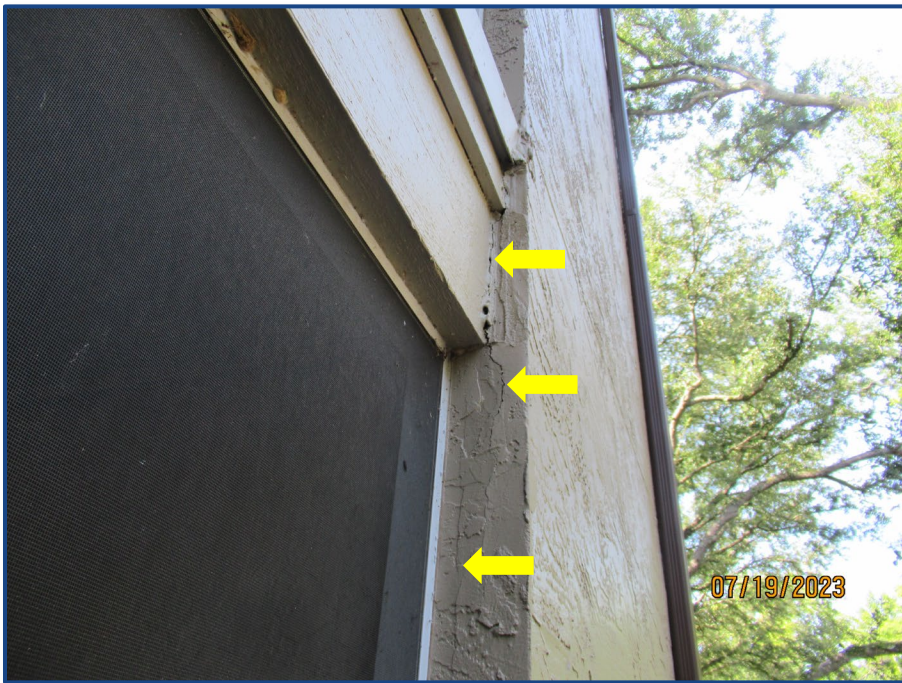
Photograph No. 12: Cracks in the exterior wall stucco finish located on the west side of the building.

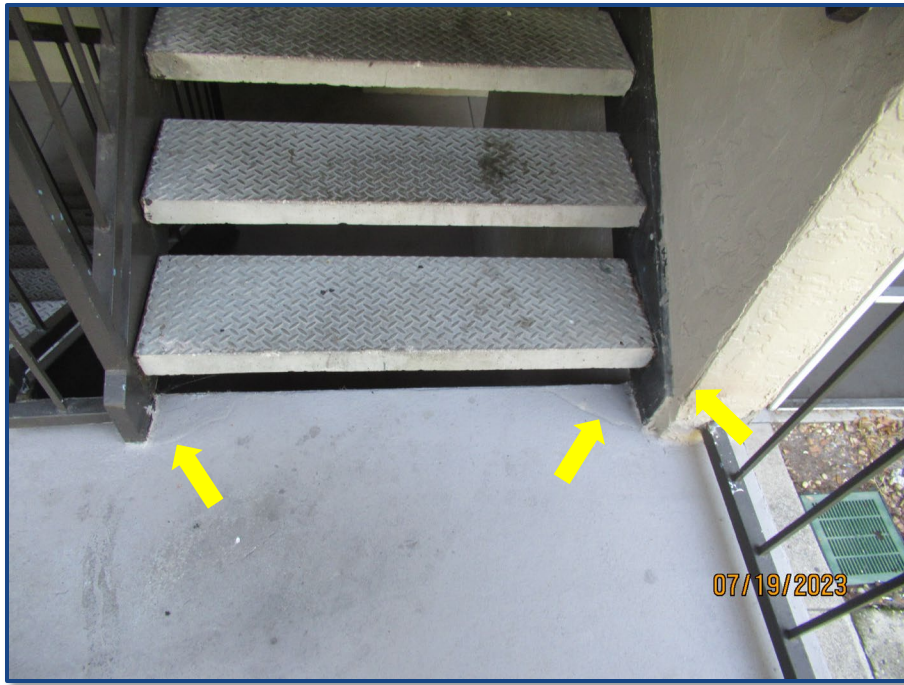
Photograph No. 13: Cracks in the exterior wall stucco finish and the stairway landing slab located in the west stairway.

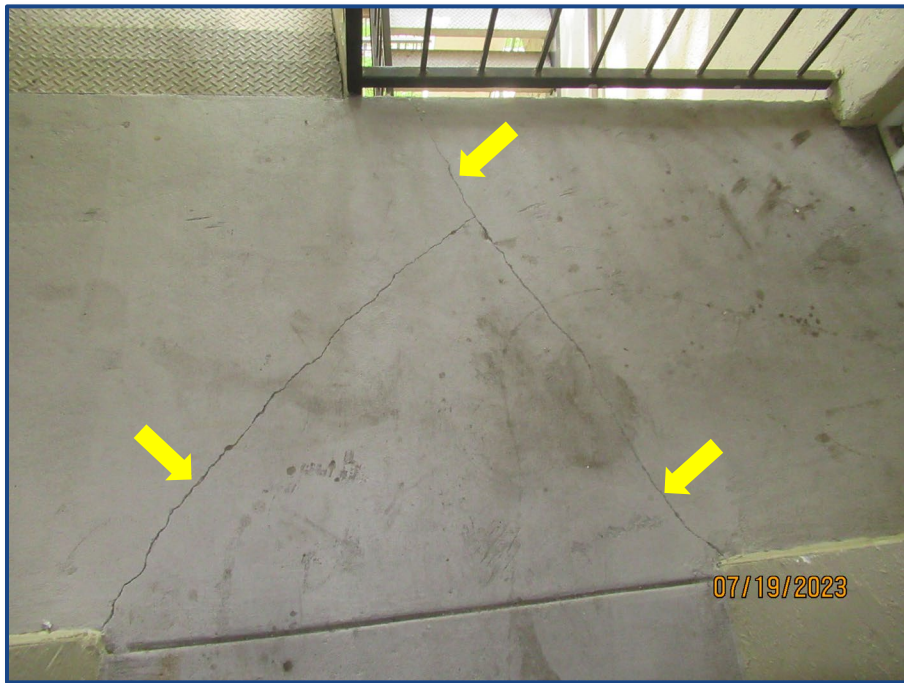
Photograph No. 14: Cracks in the concrete slab located on the 3rd floor.

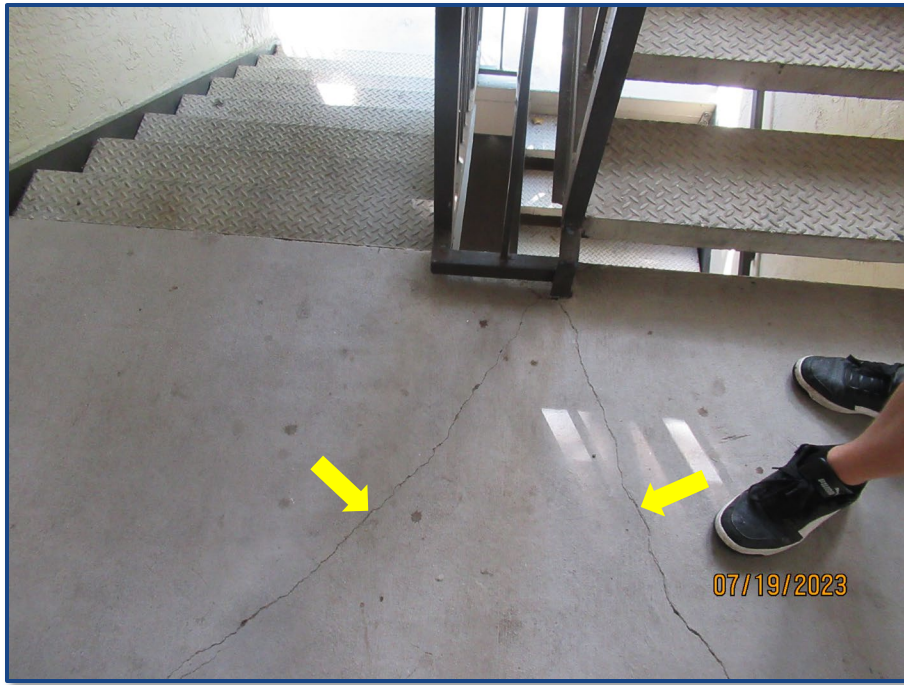
Photograph No. 15: Cracks in the concrete slab located on the 2nd floor.

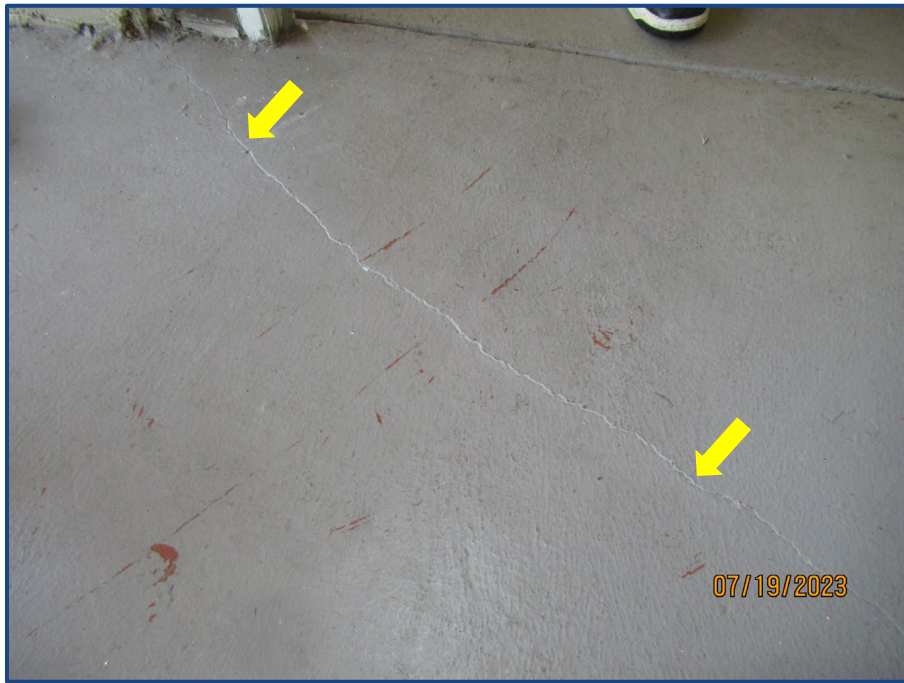
Photograph No. 16: Crack in the concrete balcony slab located on Unit 301.

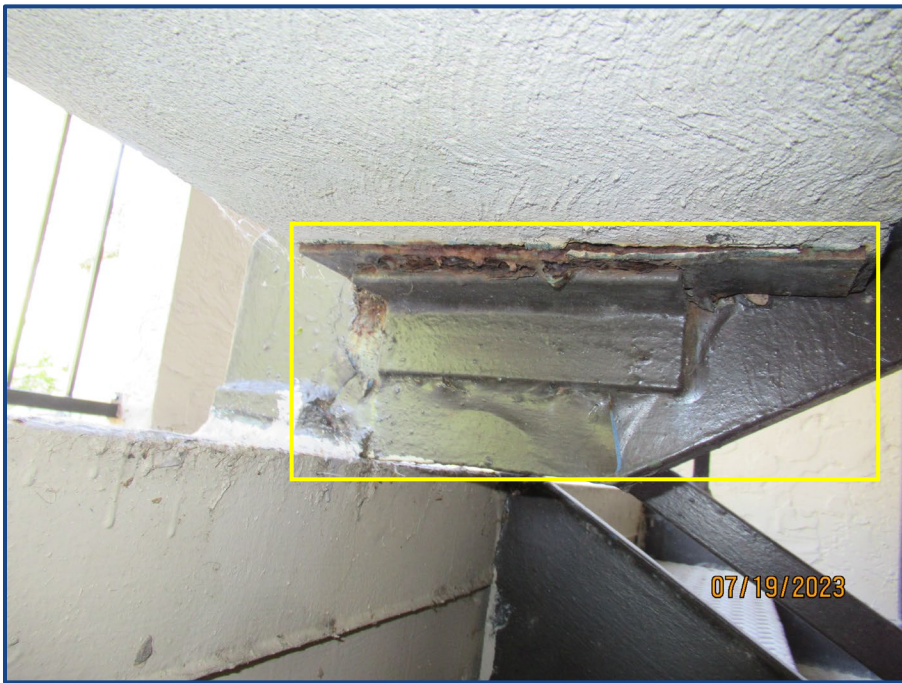
Photograph No. 18: Corrosion to the steel framing located in the west stairway.

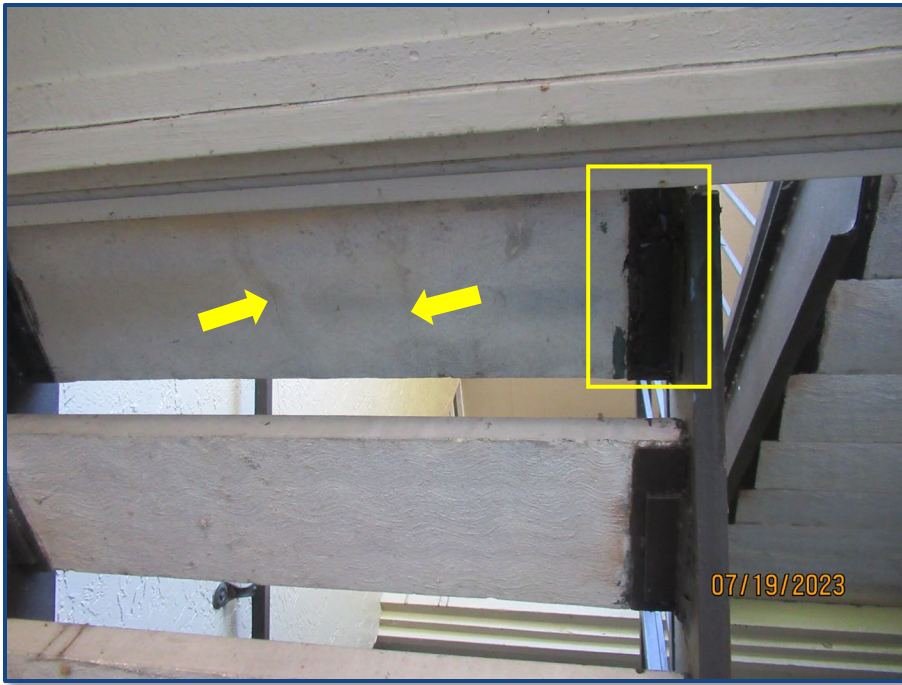
Photograph No. 19: Cracks in a concrete step and corrosion to the steel framing located in the west stairway.

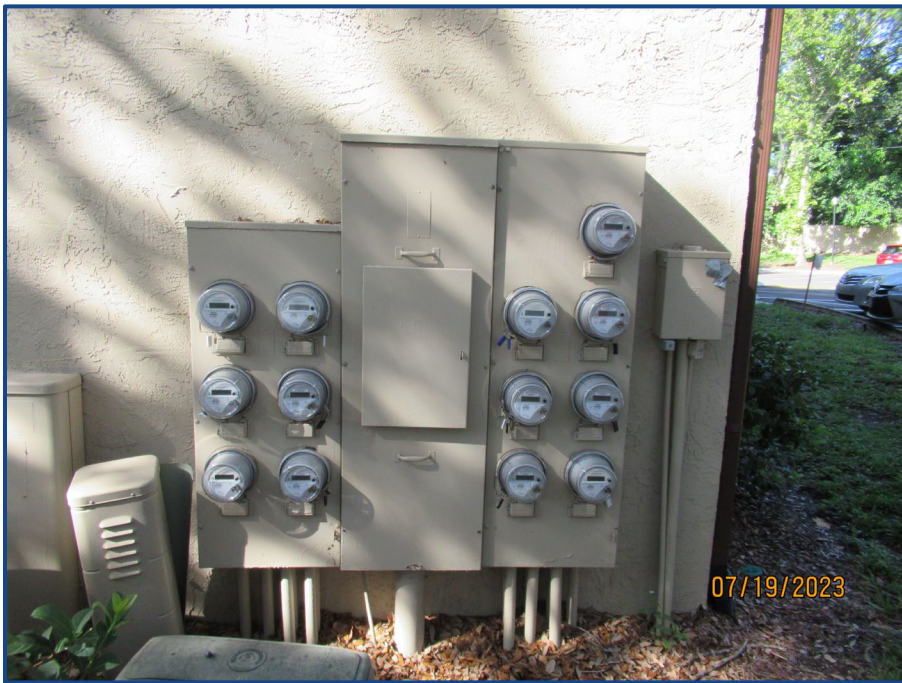
Photograph No. 20: Electrical meters.
