August 25, 2023

Re: The Landing Condominiums – Building 14  
Structural Integrity Reserve Study (SIRS)  
629 Dory Lane  
Altamonte Springs, FL 32714  
UES Project No: 0811.2300006.0000

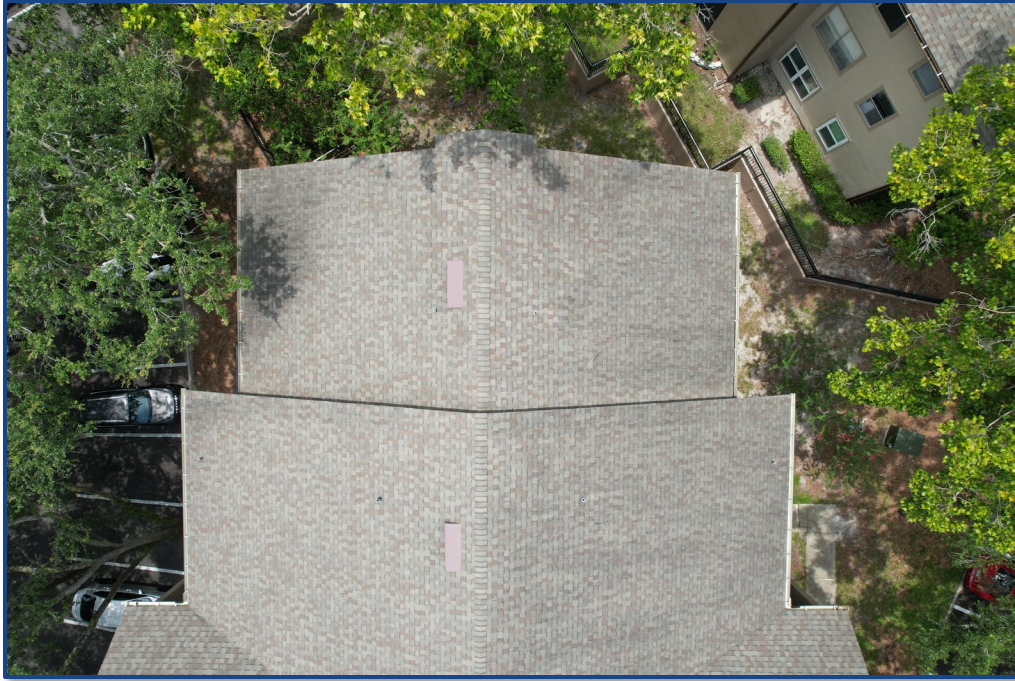
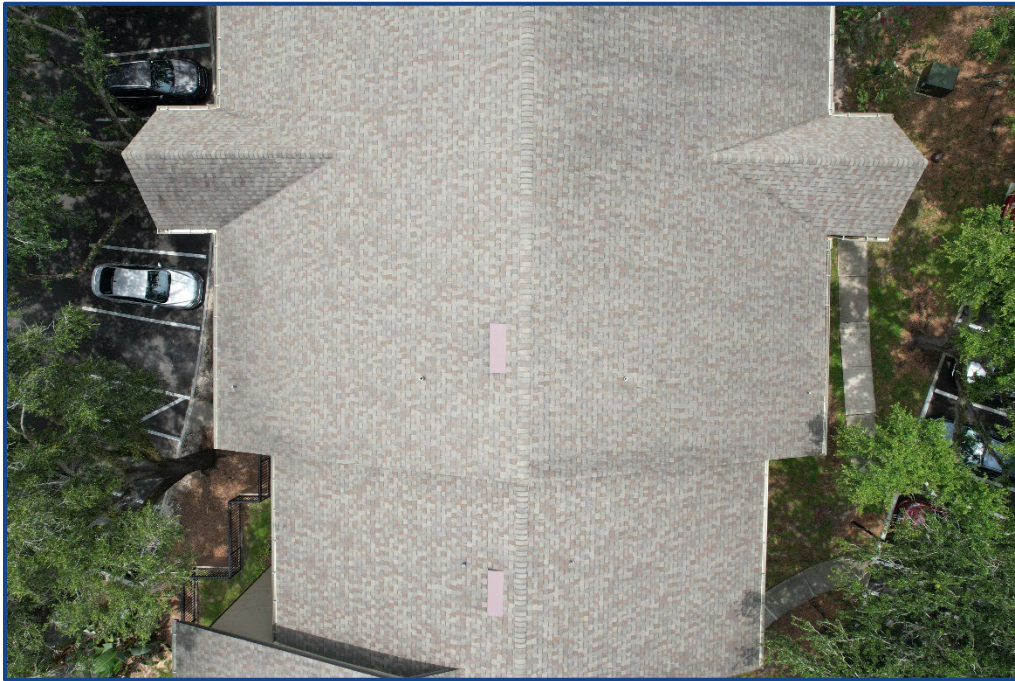
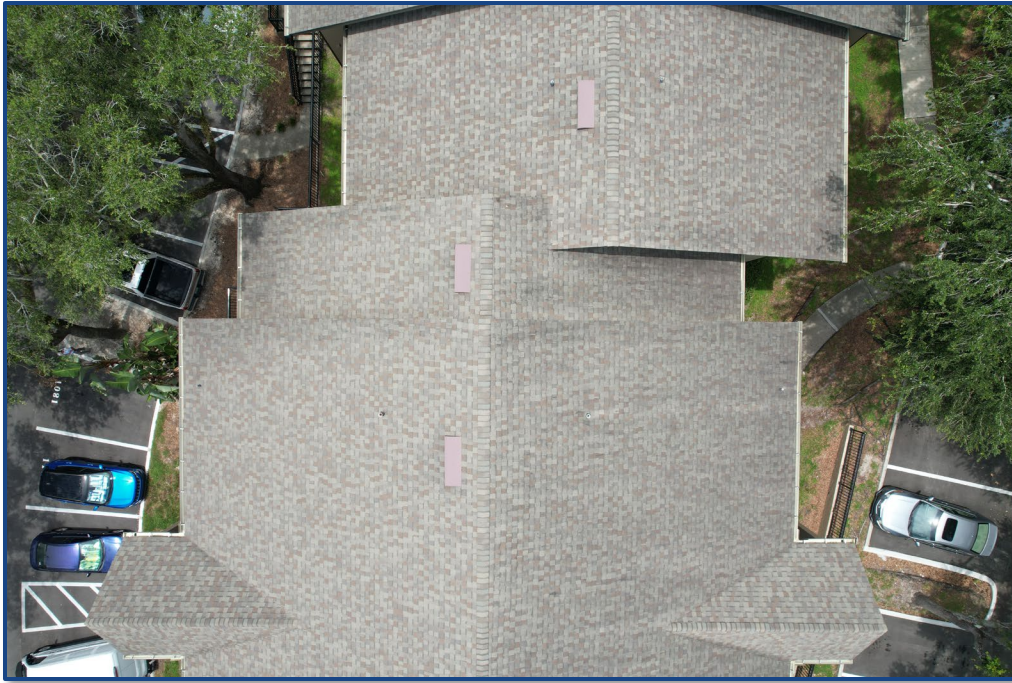
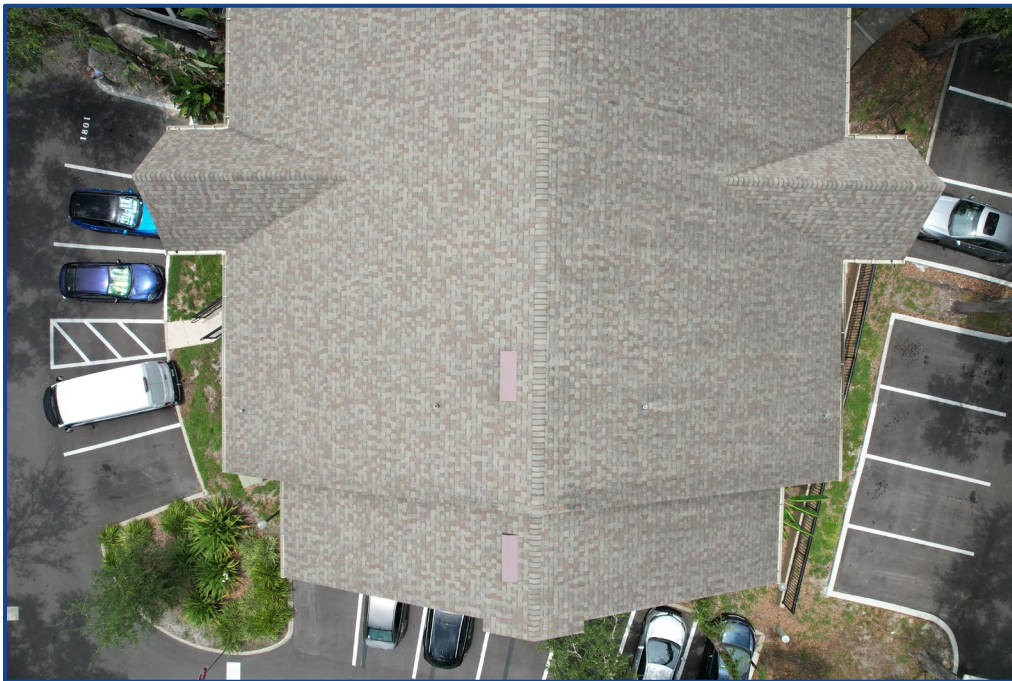
The roof system of the building is composed of architectural asphalt shingles. At the time of inspection, no damage was observed in the roof system. The roof system was observed to be in good condition.

Photograph No. 5: View of the roof.

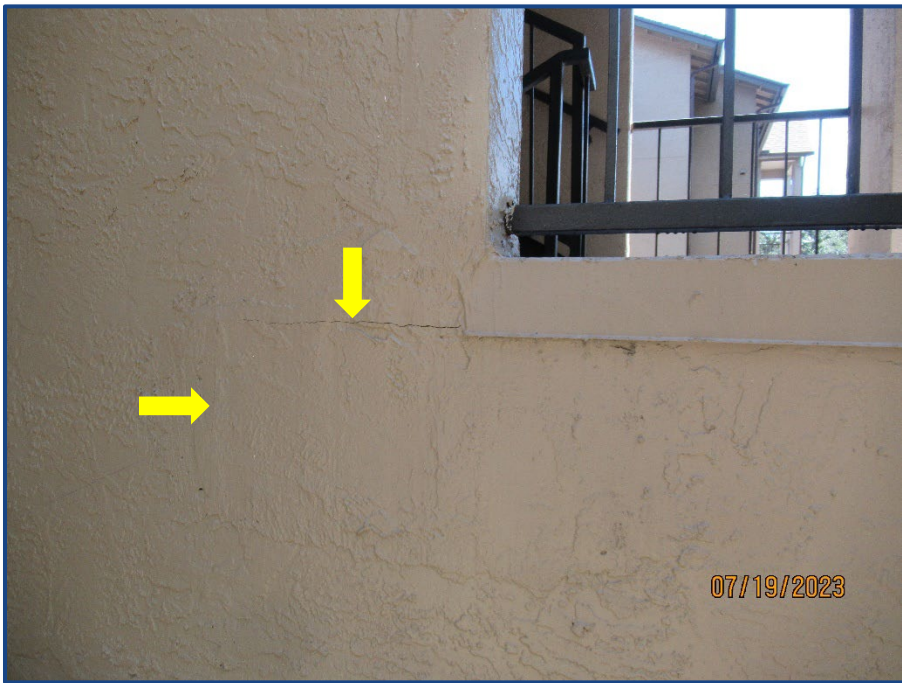
The exterior finishes of the building consists of painted stucco finishes. At the time of inspection, cracks were observed in the stucco finish in multiple locations (Photographs No. 12 through 16). Overall, the general condition of the exterior finishes is in good condition. See **Appendix C** for reference site photographs.

- Cracks in the exterior stucco finishes were observed in multiple locations. See **Appendix C** Photographs No. 12 through 16.
- Cracks in the elevated concrete slabs were observed in multiple locations. See **Appendix C** Photographs No. 17 and 18.
- Paint peeling and surface corrosion to the metal guardrails located in the southeast stairway. See **Appendix C** Photograph No. 19.

Photograph No. 12: Crack in the exterior wall stucco finish located on the southwest stairway.

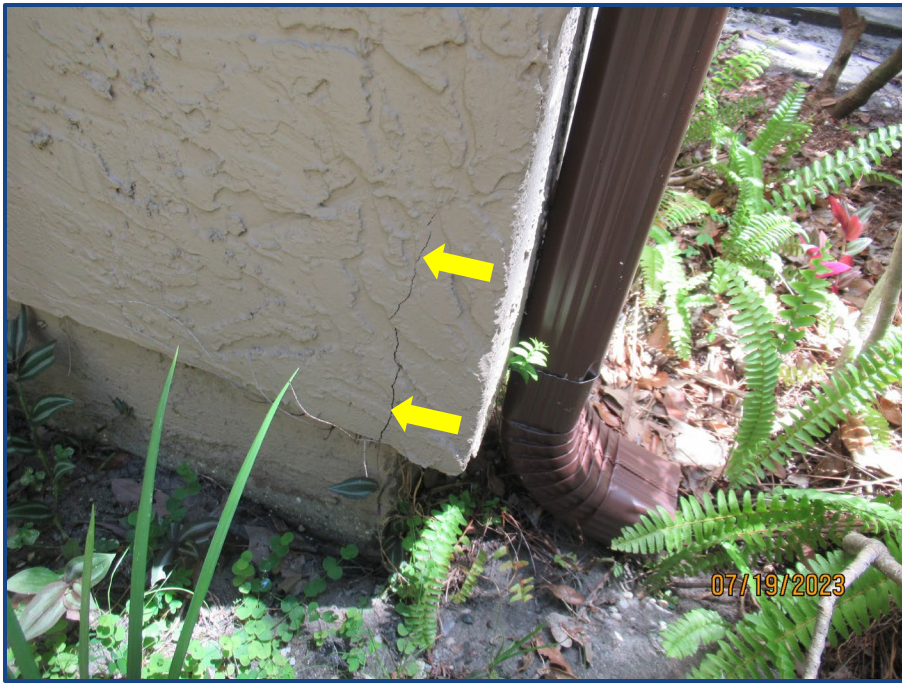
Photograph No. 13: Crack in the exterior wall stucco finish on the south side of the building.

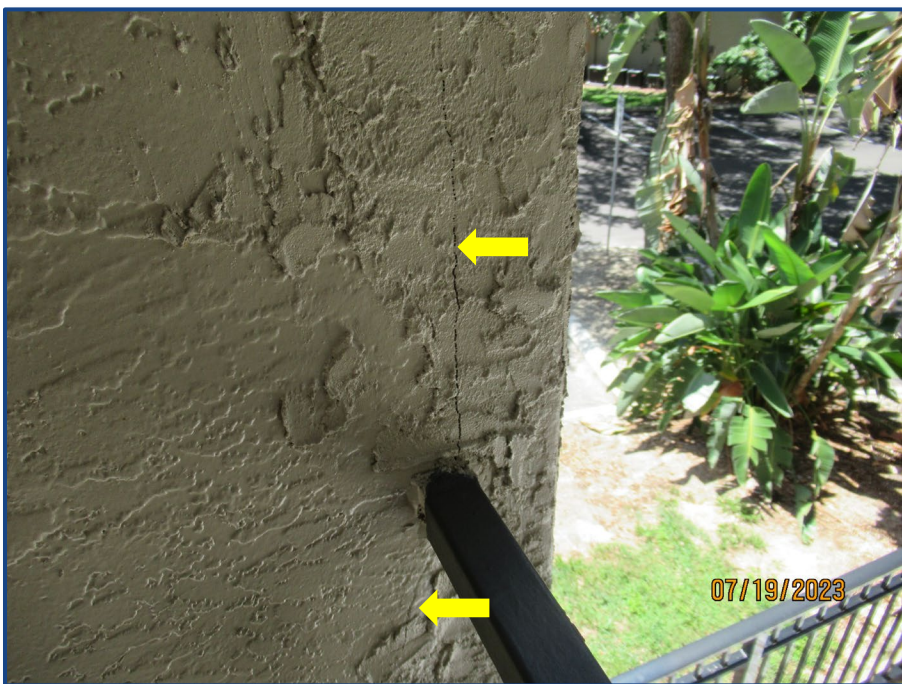
Photograph No. 14: Crack in the exterior wall stucco finish located in the southeast stairway.

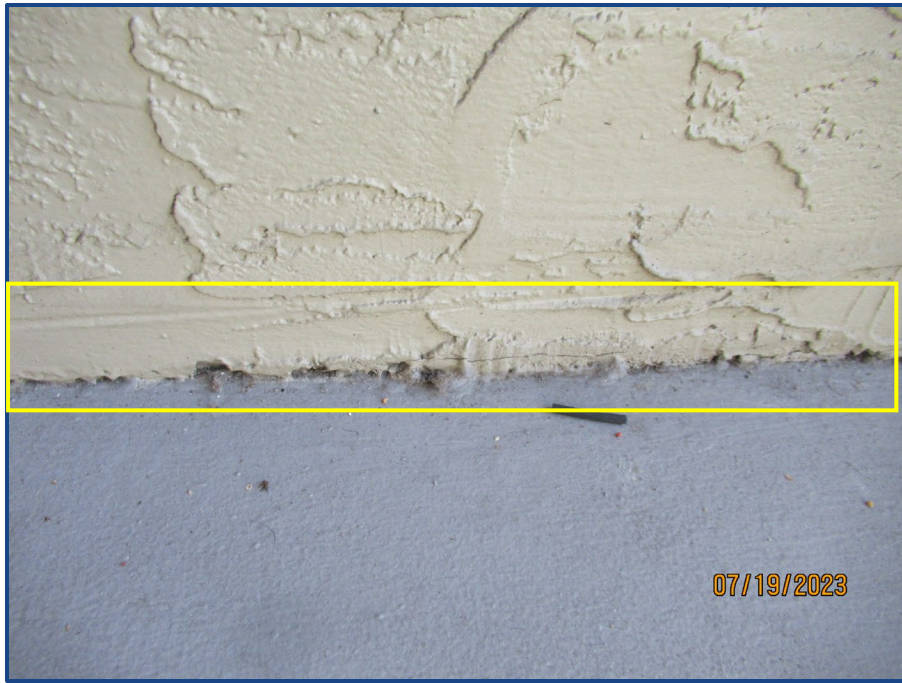
Photograph No. 15: Cracks and damage to the exterior wall stucco finish located on the balcony of Unit 206.

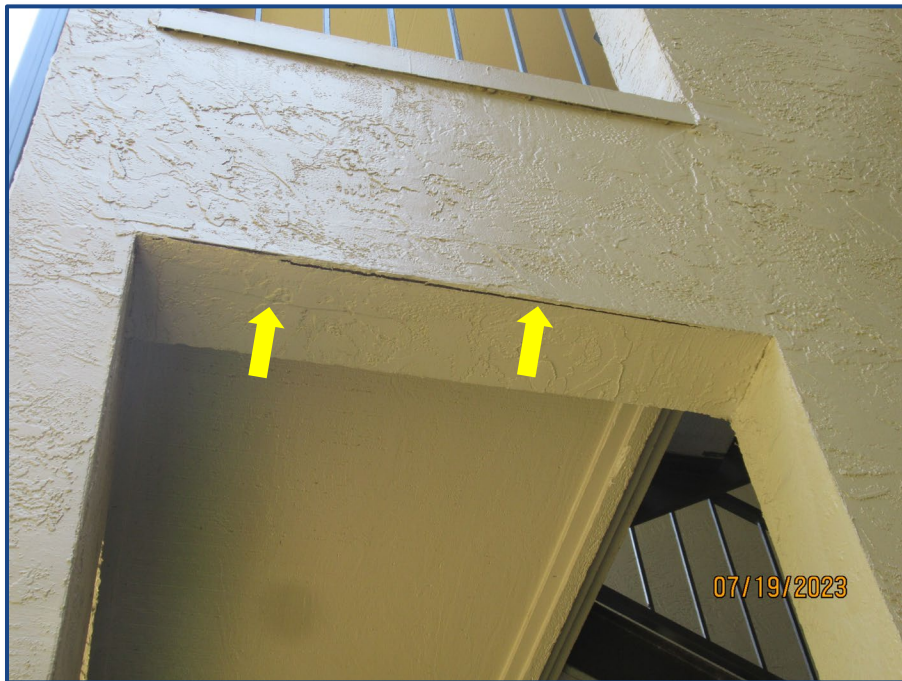
Photograph No. 16: Cracks in the exterior wall stucco finish located in the northeast stairway.

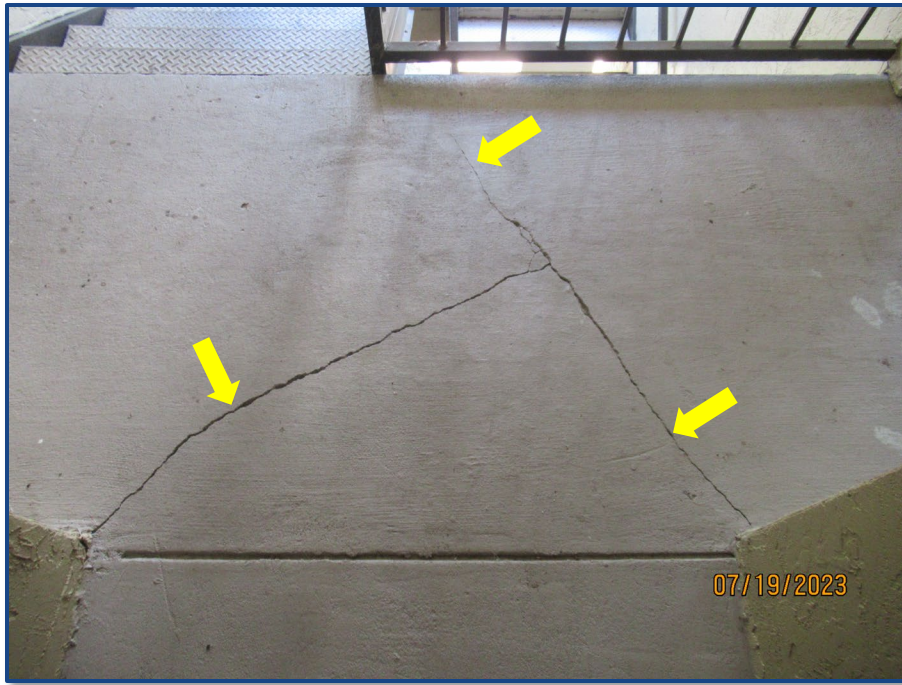
Photograph No. 17: Cracks in the concrete slab located on the 3rd floor.

Concrete and Stairway Repairs for year 2024 shall include repairs to cracked concrete and corrosion to the metal handrails referenced within this report.

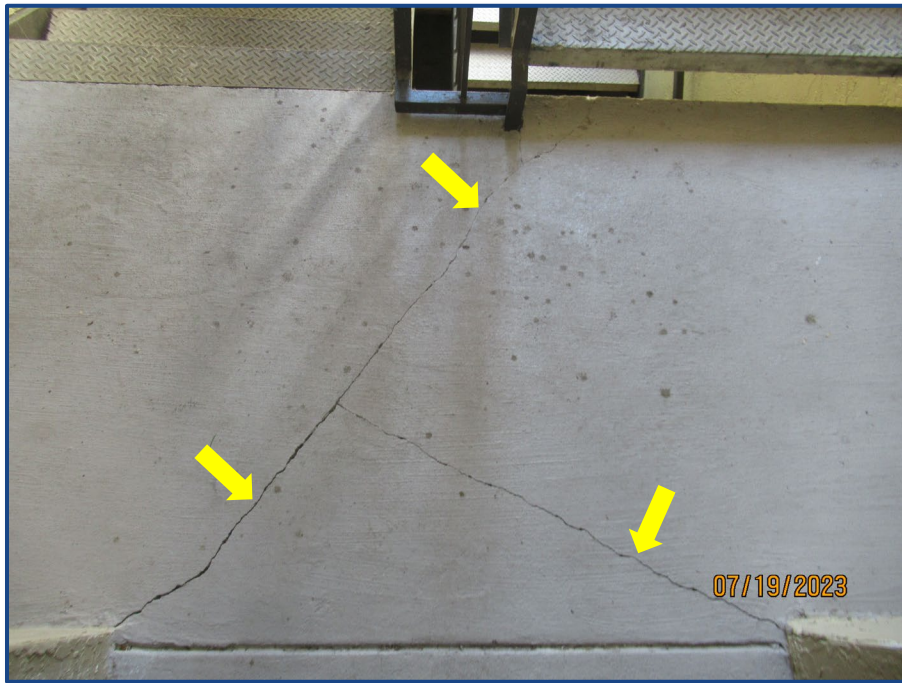
Photograph No. 18: Cracks in the concrete slab located on the 2nd floor.

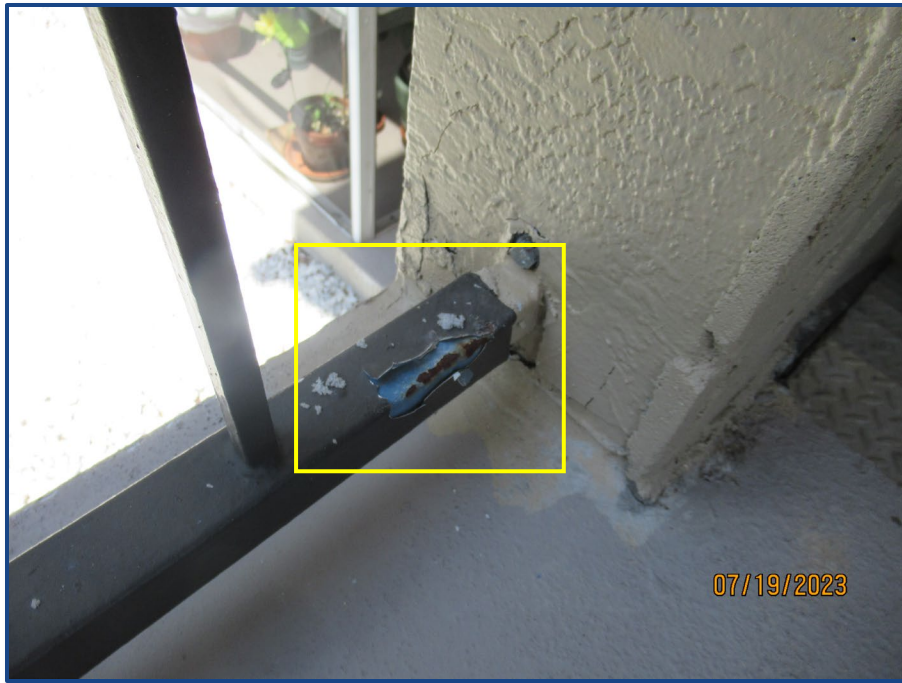
The building consists of exterior and interior wood framing walls and wood beams. The exterior walls are sheathed in plywood and stucco finished. The floor systems consist of prefabricated wooden floor trusses at the elevated units and reinforced concrete slabs at the elevated exterior stairway landings, walkways, and balconies. The roof framing system consists of prefabricated wooden roof trusses. The stairways consist of steel stringers with precast reinforced concrete steps. At the time of inspection, cracks in the elevated concrete slabs were observed in multiple locations (Photographs No. 17 and 18). Paint peeling and surface corrosion to the metal guardrails located in the southeast stairway (Photograph No. 19). See **Appendix C** for reference site photographs.

Photograph No. 19: Paint peeling and surface corrosion to the metal handrail located in the southeast stairway.

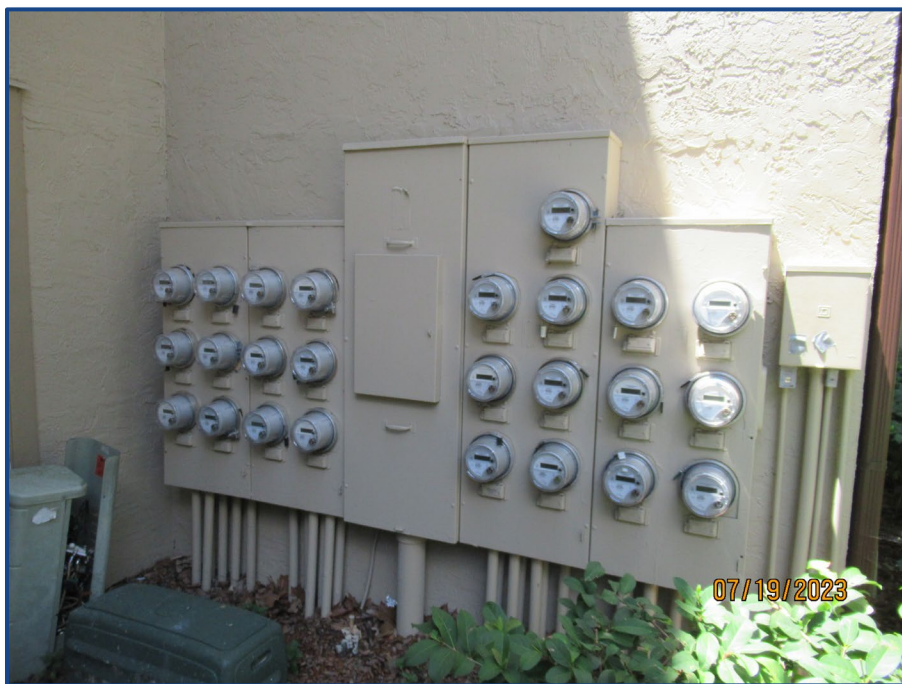
The visible electrical systems inspected at the time of inspection included electrical meters, main disconnects, air conditioning disconnects on each unit, and electrical conduits. At the time of inspection, no damage or deficiencies were observed to the electrical systems.

Photograph No. 20: Electrical panels.

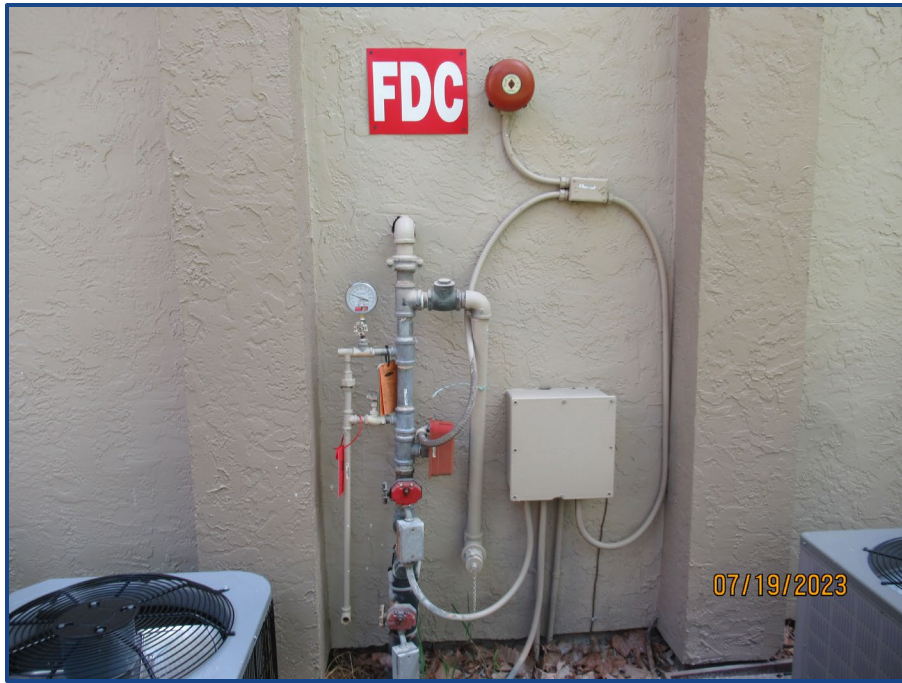
The fire protection system of the building consists of a wet pipe fire sprinkler system with sprinkler heads located in the units. In addition, a riser system and fire alarm are located at the exterior of the building. No issues or concerns were observed or reported at the time of inspection.

Photograph No. 21: Fire riser system and fire alarm.

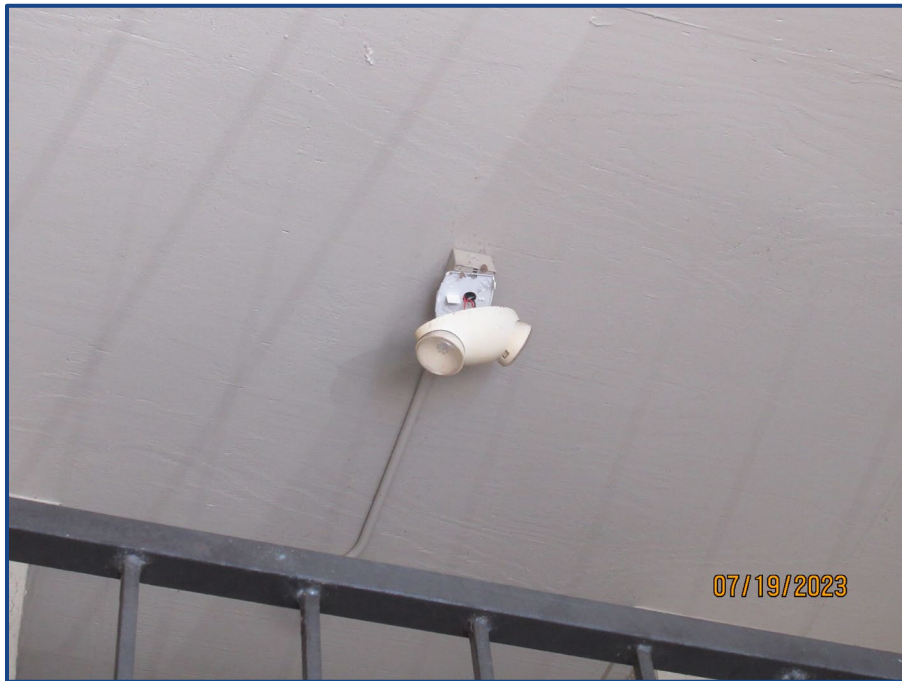
Photograph No. 22: Damaged emergency lighting fixture.
