Phase I Structural Assessments Phase II Structural Forensic Evaluations Structural Intergrity Reserve Studies

August 25, 2023

Re: The Landing Condominiums – Building 15 Structural Integrity Reserve Study (SIRS) 642 Dory Lane Altamonte Springs, FL 32714 UES Project No: 0811.2300006.0000

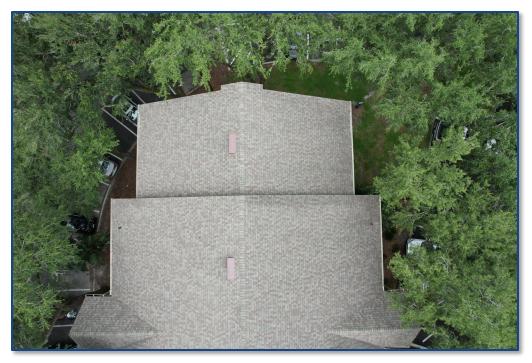
The roof system of the building is composed of architectural asphalt shingles. At the time of inspection, no damage was observed in the roof system. The roof system was observed to be in good condition.

Photograph No. 5: View of the west roof section.

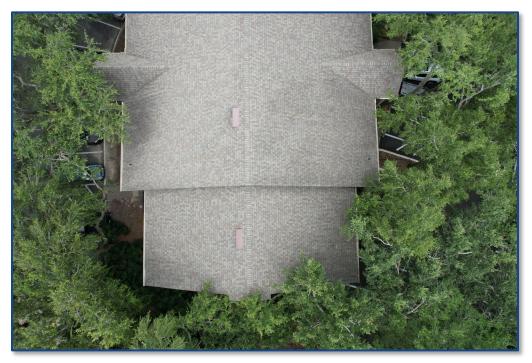
Photograph No. 6: View of the east roof section.

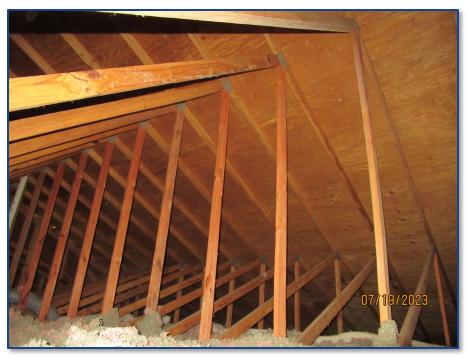
Photograph No. 7: General view of the prefabricated wooden roof trusses.

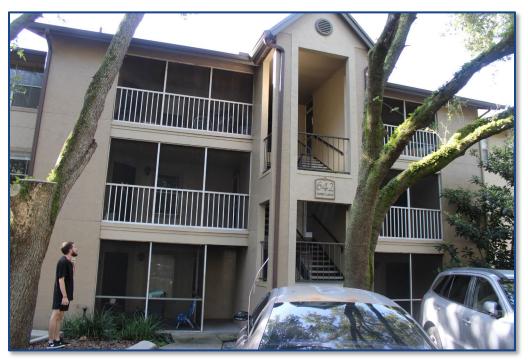
Photograph No. 8: View of the balconies and stairway on the north side of the building.

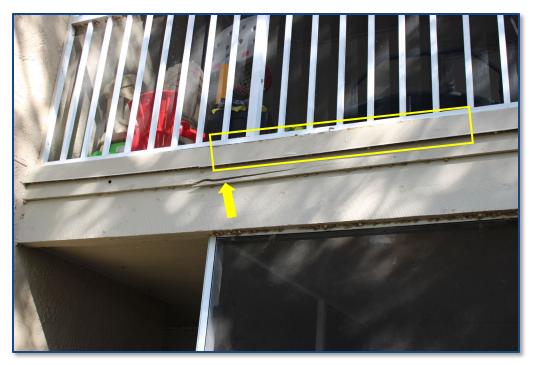
- Corrosion and separation were observed to the metal balcony edge flashing on Unit 203. See **Appendix C** Photograph No. 9.
- Damage and cracks in the exterior stucco finishes were observed in multiple locations. See **Appendix C** Photographs No. 10 through 12.
- Cracks in the elevated concrete slabs were observed in multiple locations. See **Appendix C** Photographs No. 13 through 15.
- Peeling paint was observed on the guardrails in the south stairway. See **Appendix C** Photograph No. 16.

Photograph No. 9: A cracked decorative board and corrosion and separation of the metal flashing located at the balcony edge on Unit 203.

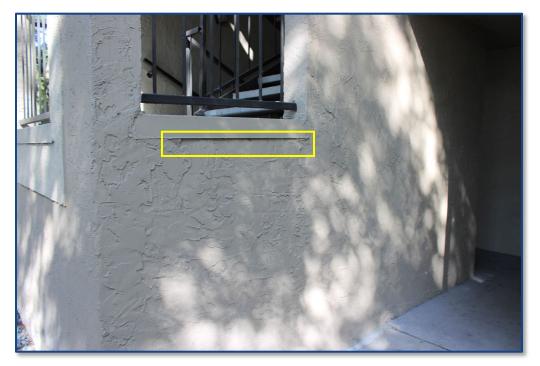
The exterior finishes of the building consists of painted stucco finishes. At the time of inspection, damage and cracks in the exterior stucco finishes were observed in multiple locations (Photographs No. 10 through 12). Peeling paint was observed on the guardrails in the south stairway (Photograph No. 16). Overall, the general condition of the exterior finishes is in good condition. See **Appendix C** for referce site photographs.

Photograph No. 10: Damage to the exterior wall stucco finish located on the south stairway.

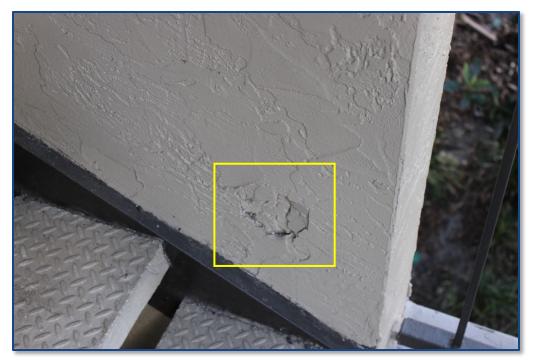
Photograph No. 11: Damage to the exterior wall stucco finish located in the south stairway.

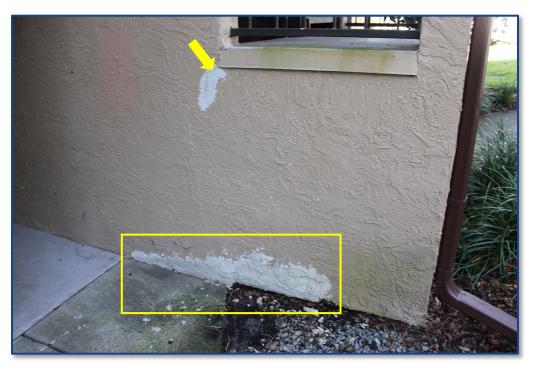
Photograph No. 12: Previous stucco repair and crack in the exterior wall stucco finish located on the north stairway.

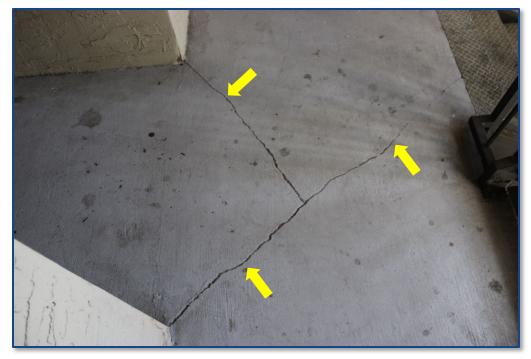
The building consists of exterior and interior wood framing walls and wood beams. The exterior walls are sheathed in plywood and stucco finished. The floor systems consist of prefabricated wooden floor trusses at the elevated units and reinforced concrete slabs at the elevated exterior stairway landings, walkways, and balconies. The roof framing system consists of prefabricated wooden roof trusses. The stairways consist of steel stringers with precast reinforced concrete steps. At the time of inspection, corrosion and separation were observed to the metal balcony edge flashing on Unit 203 (Photograph No. 9). Cracks in the elevated concrete slabs were observed in multiple locations (Photographs No. 13 through 15). See **Appendix C** for refence site photographs.

Photograph No. 13: Cracks in the concrete slab located on the 2nd floor.

Concrete and Stairway Repairs for year 2024 shall include repairs to cracked cocnrete and corrosion to the steel framing referenced within this report.

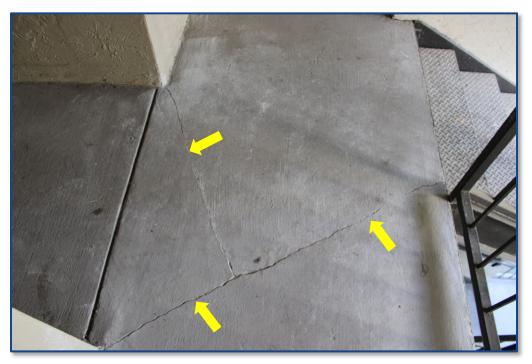
Photograph No. 14: Cracks in the concrete slab located on the 3rd floor.

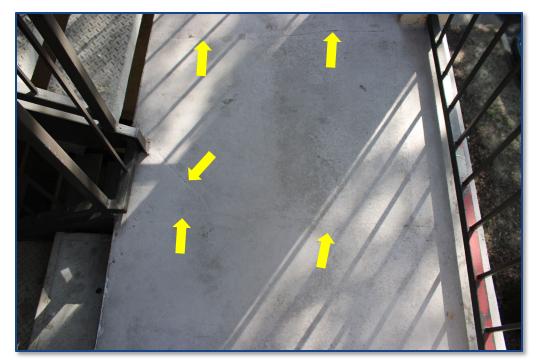
Photograph No. 15: Previously sealed cracks in the stairway landing located in the north stairway.

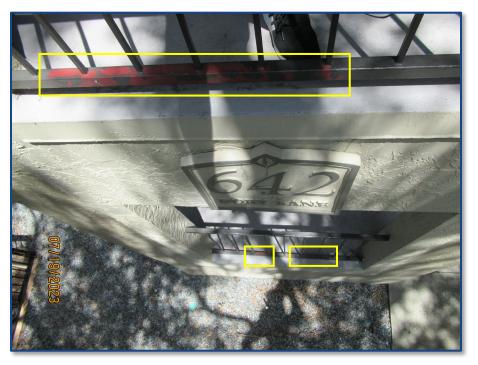
Photograph No. 16: Peeling paint located on the metal handrails in the south stairway.
