August 25, 2023

Re: The Landing Condominiums – Building 16
Structural Integrity Reserve Study (SIRS)
643 Dory Lane
Altamonte Springs, FL 32714
UES Project No: 0811.2300006.0000

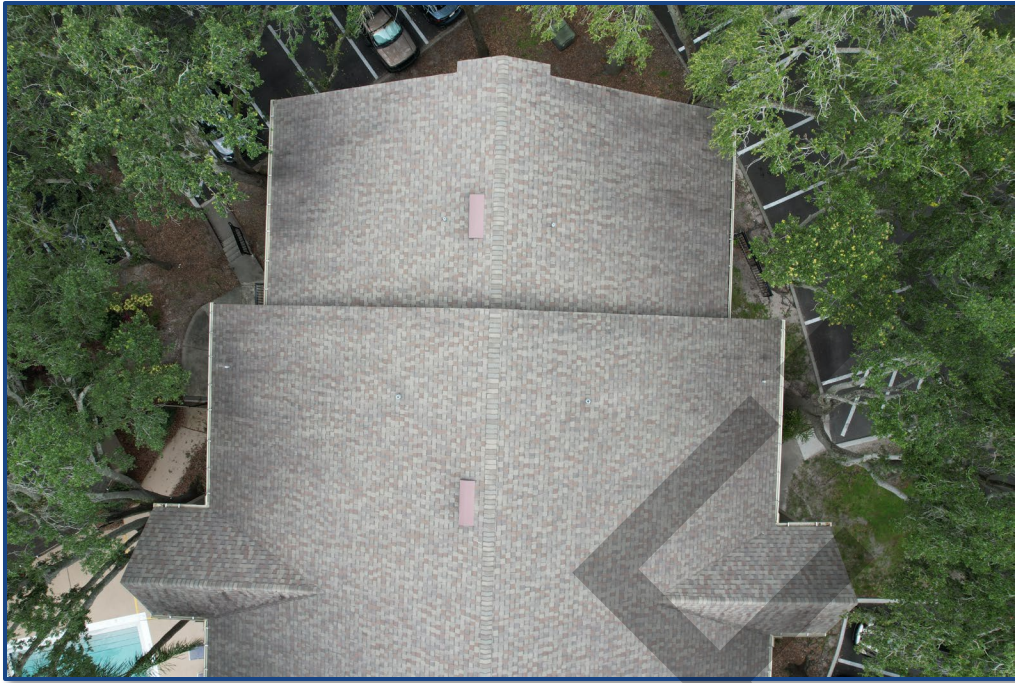
The roof system of the building is composed of architectural asphalt shingles. At the time of inspection, no damage was observed in the roof system. The roof system was observed to be in good condition.

Photograph No. 5: View of the south roof section.

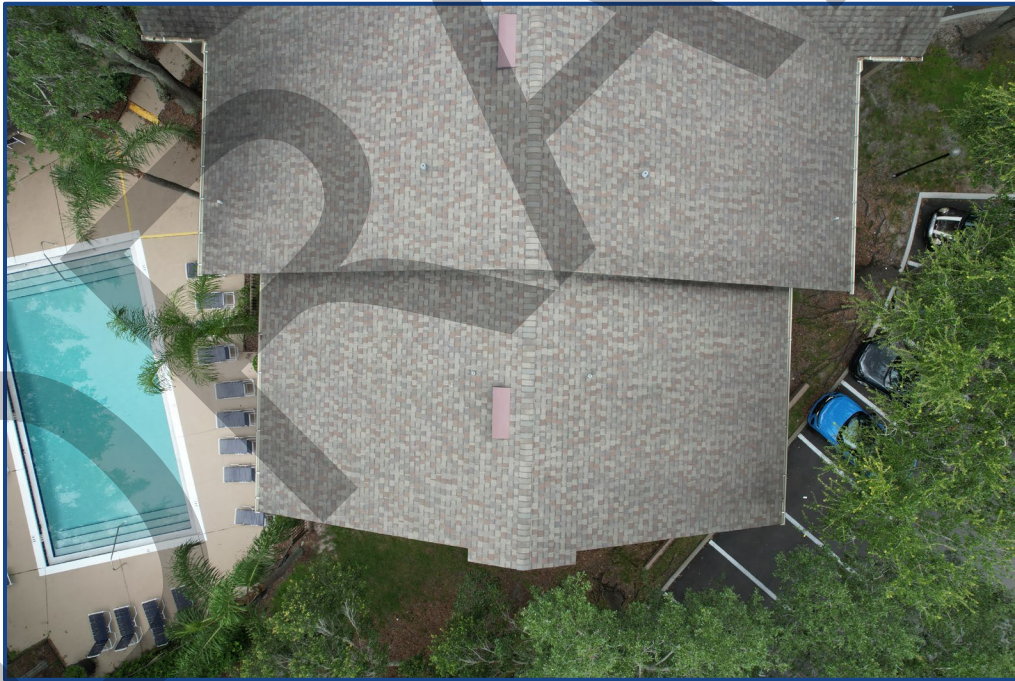
Photograph No. 6: View of the north roof section.

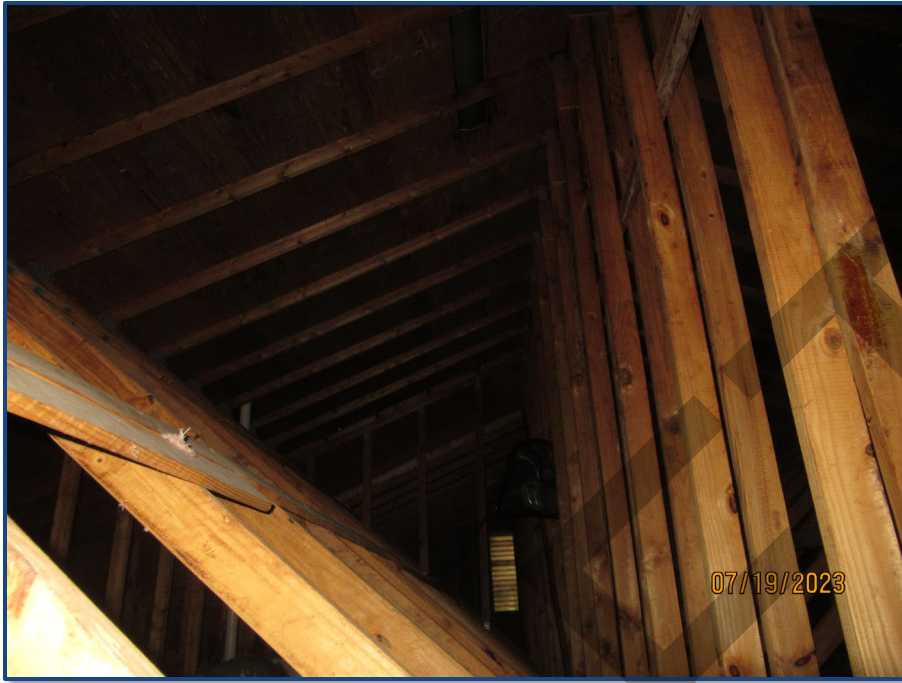
Photograph No. 7: General view of the prefabricated wooden trusses.

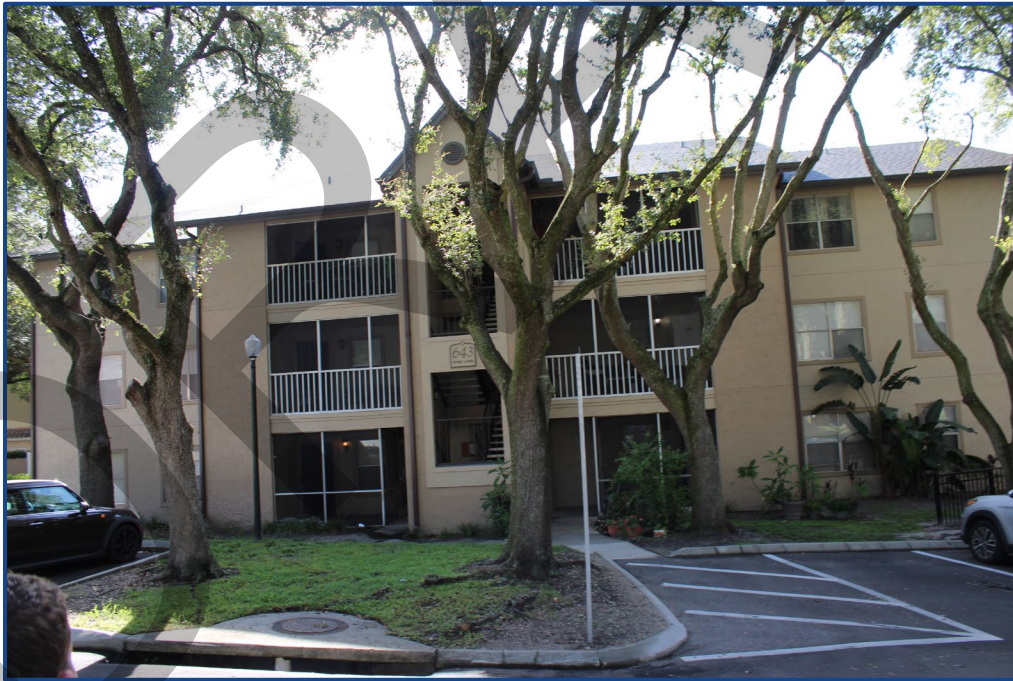
Photograph No. 8: View of the balconies and stairway on the west side of the building.

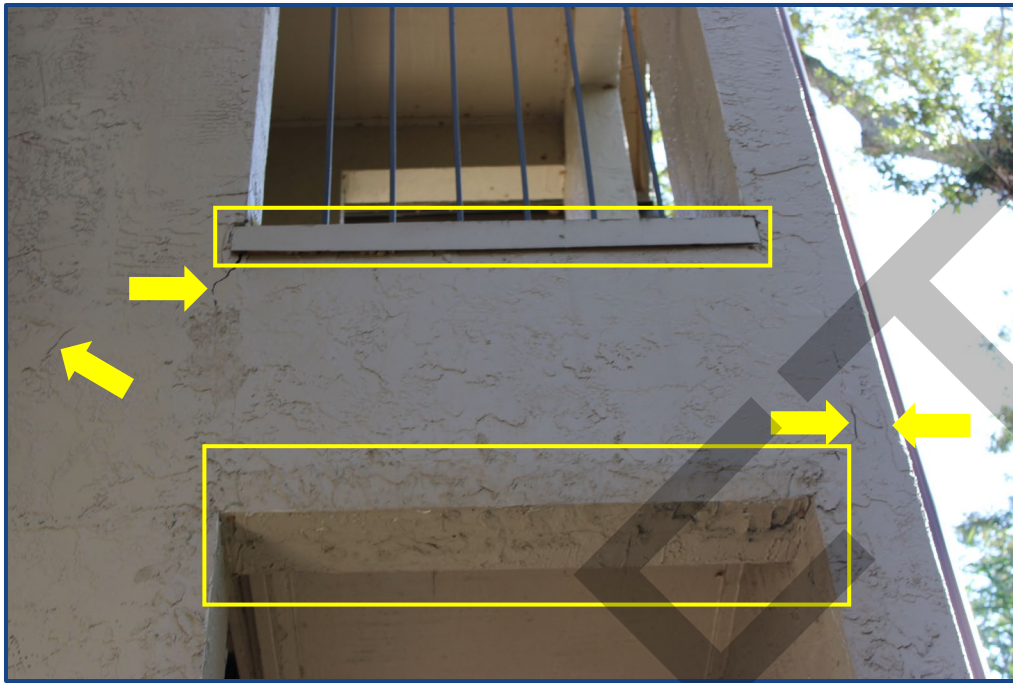
- Damage and cracks in the exterior stucco finishes were observed in multiple locations. See **Appendix C** Photographs No. 9 through 12.
- Corrosion was observed to the metal stairway landing edge flashing in multiple locations. See **Appendix C** Photographs No. 9, 13, and 14.
- Cracks in the elevated concrete slabs were observed in multiple locations. See **Appendix C** Photograph No. 12.
- Corrosion to the steel framing was observed in multiple locations in the stairways. See **Appendix C** Photographs No. 13 through 15.

Photograph No. 9: Cracks and damage to the exterior wall stucco finish and the metal flashing located on the west stairway.

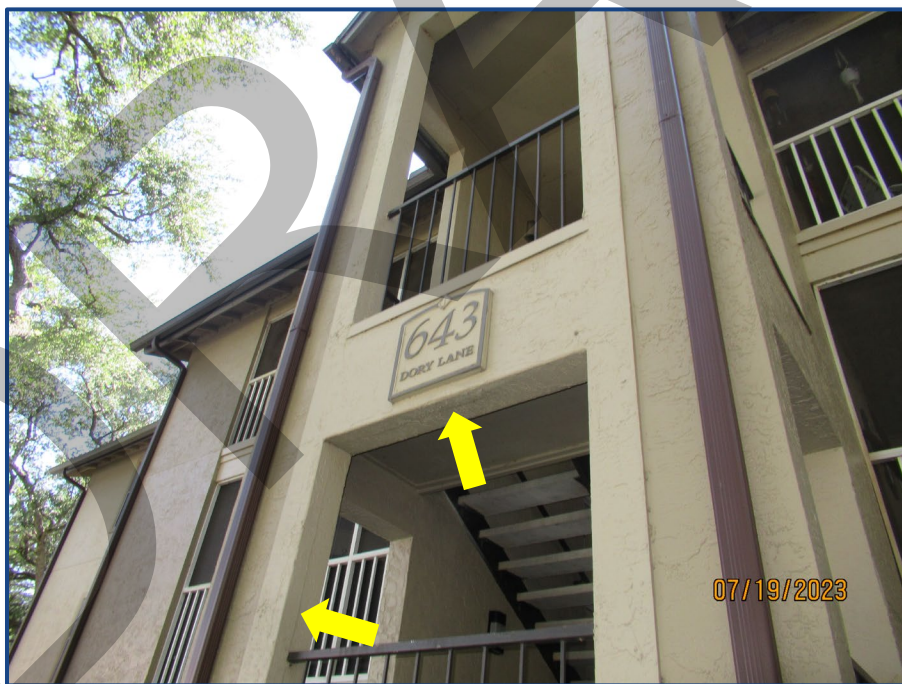
Photograph No. 10: Cracks in the exterior wall stucco finish located on the west stairway.

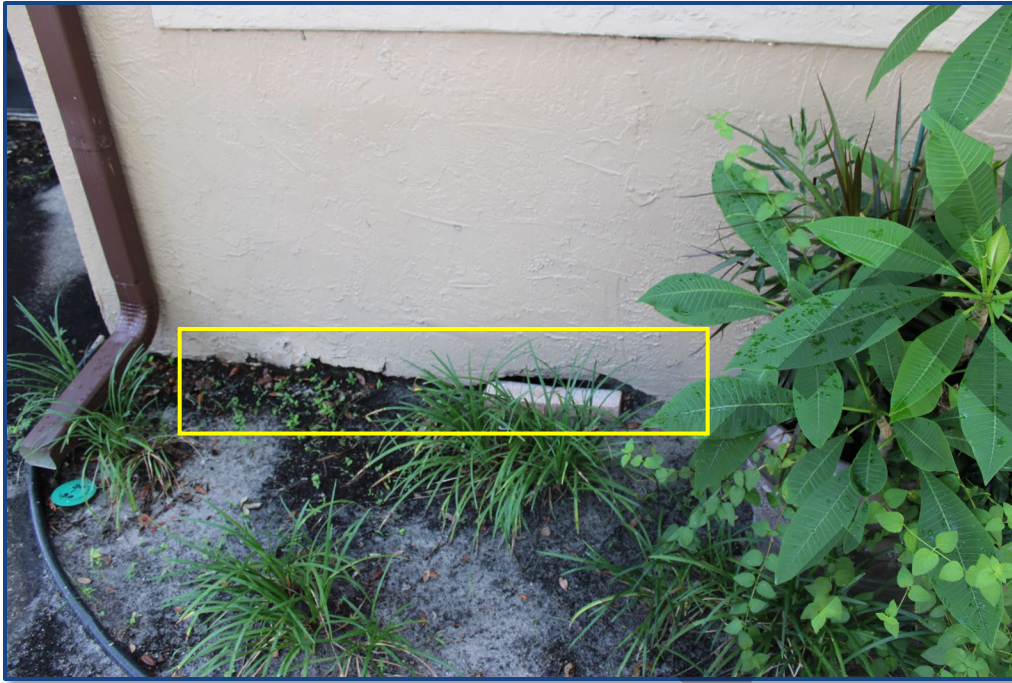
Photograph No. 11: Damage to the exterior wall stucco finish located on the west stairway.

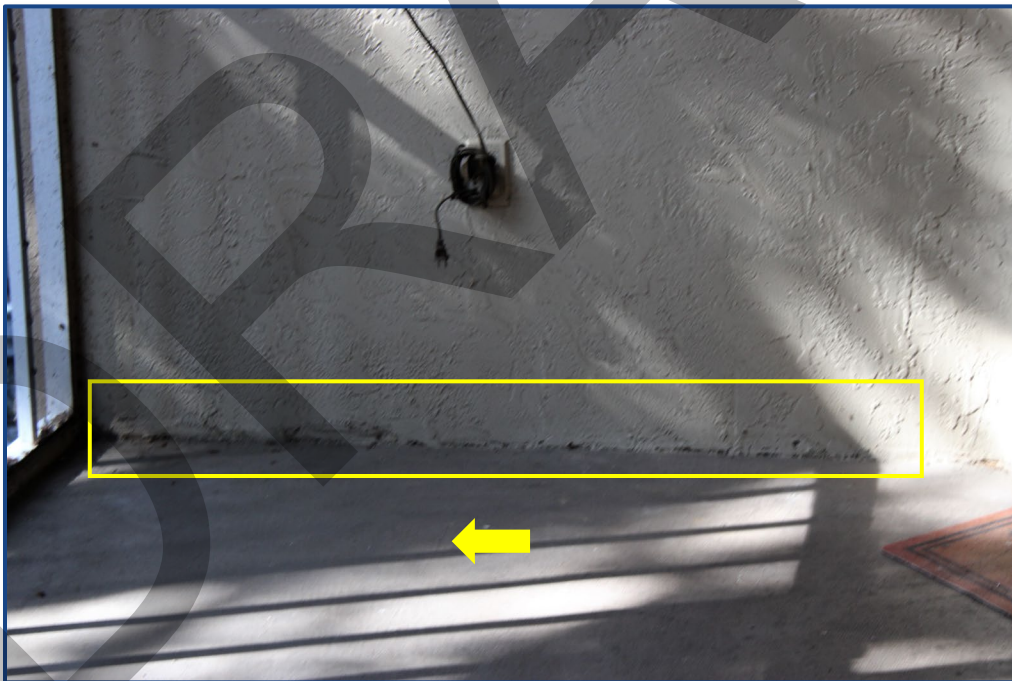
Photograph No. 12: Damage to the exterior wall stucco finish and crack in the balcony slab on Unit 204.

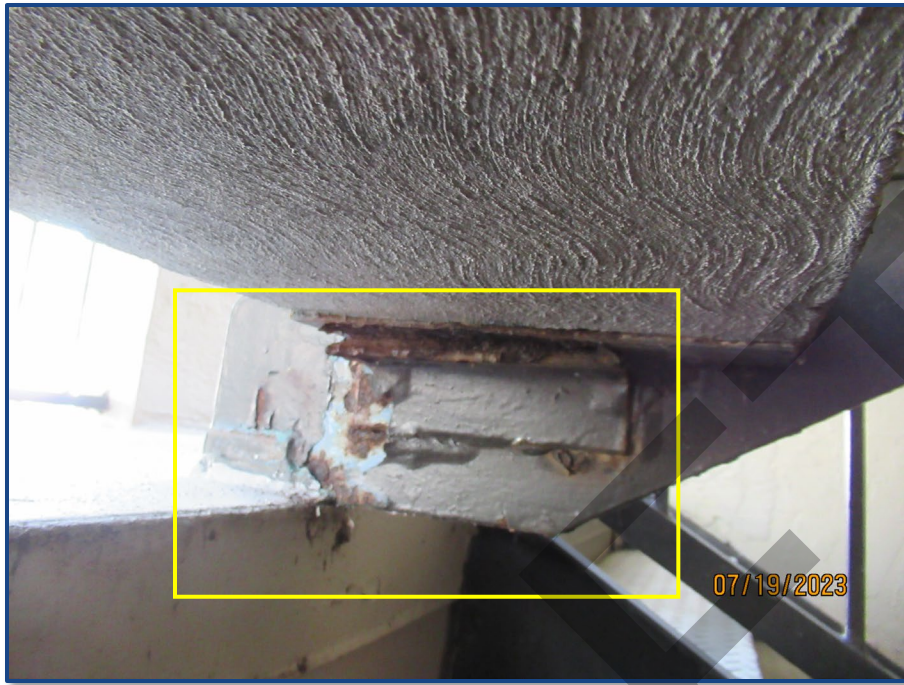
Photograph No. 13: Corrosion to the steel framing and metal flashing located in the west stairway.

Concrete and Stairway Repairs for year 2024 shall include repairs to cracked concrete and corrosion to the steel framing referenced within this report.

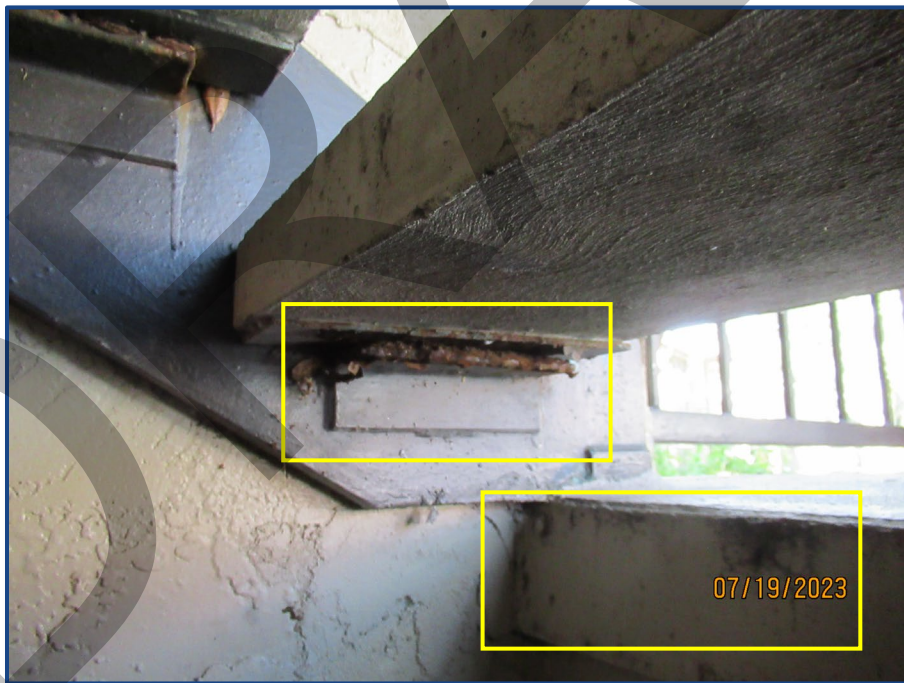
Photograph No. 14: Corrosion to the steel framing and metal flashing located in the west stairway.

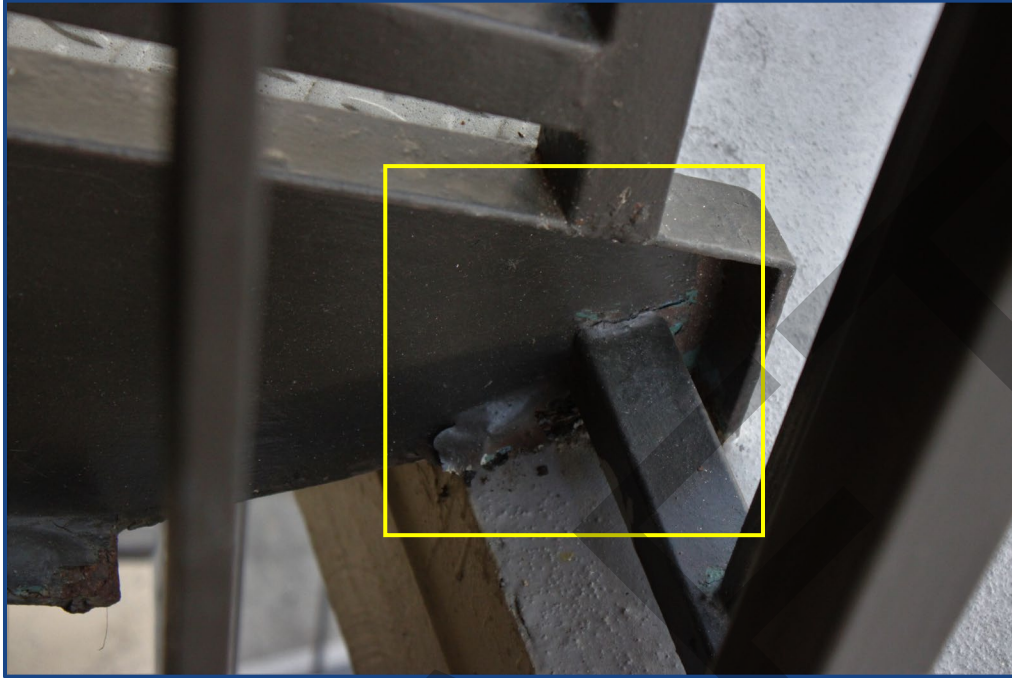
Photograph No. 15: Corrosion to the steel framing located in the west stairway.

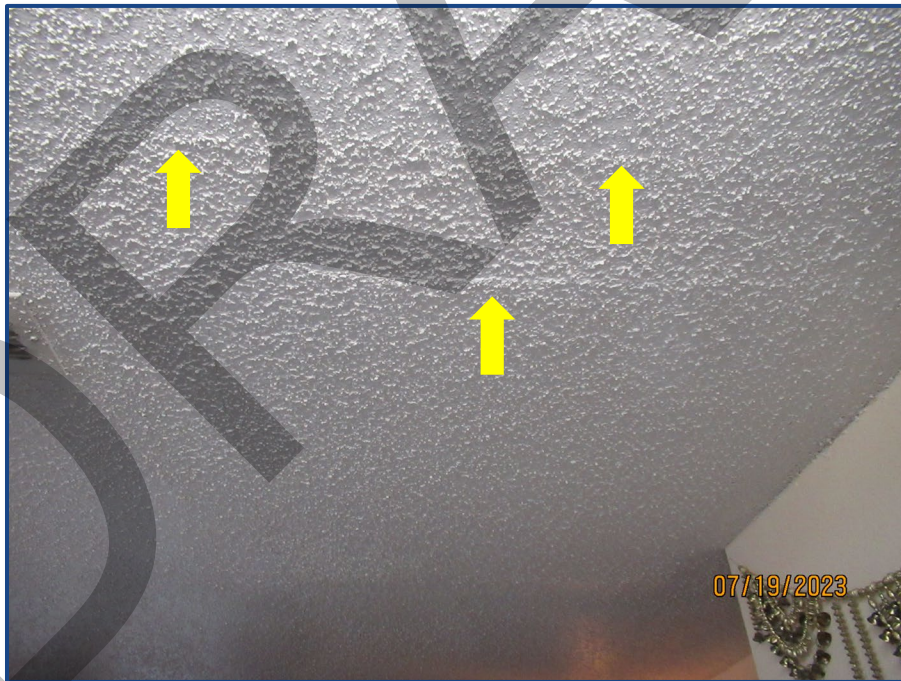
Photograph No. 16: Cracks in the ceiling in Unit 203 due to water leak.

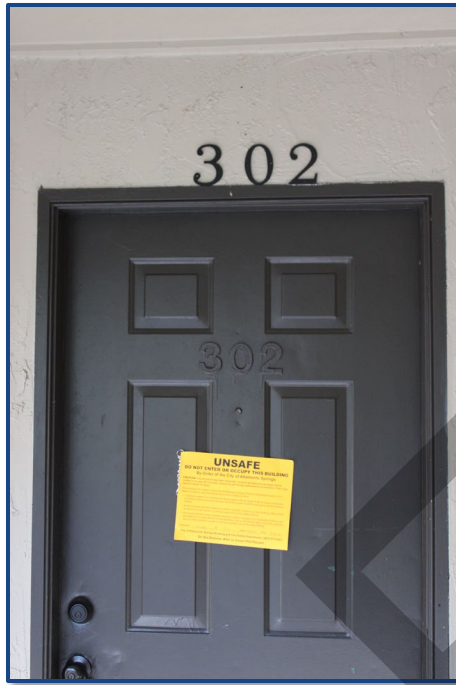
Photograph No. 17: Unsafe conditions declaration by order of the City of Altamonte Springs due to the broken fire sprinkler pipe in Unit 302.

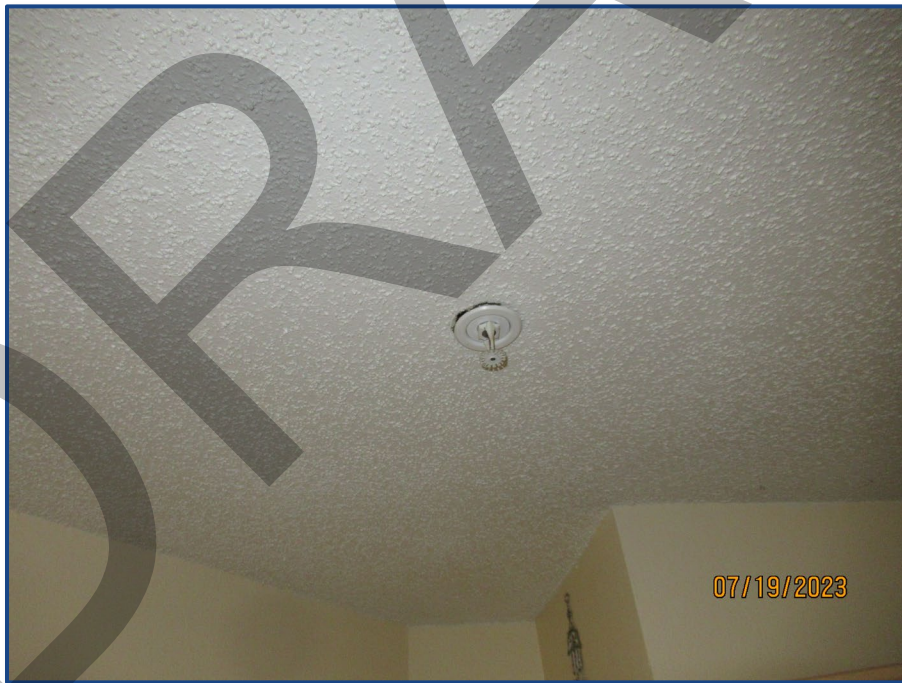
Photograph No. 18: Fire sprinkler head located in Unit 203.

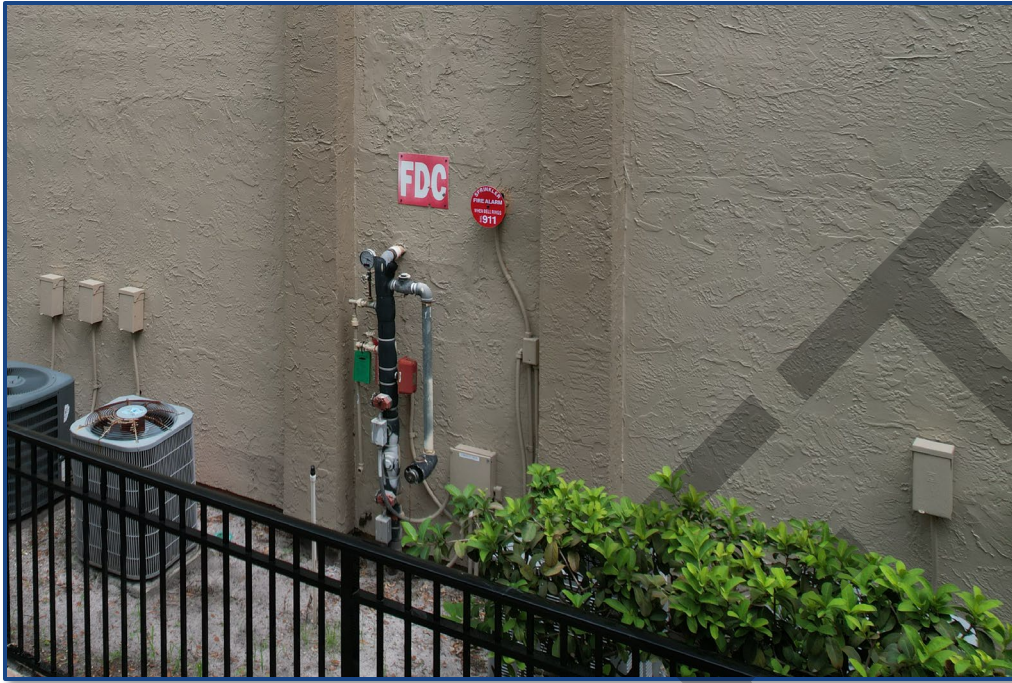
Photograph No. 19: Fire riser system and fire alarm.
