August 25, 2023

Re: The Landing Condominiums – Building 17  
Structural Integrity Reserve Study (SIRS)  
974 Leeward Place  
Altamonte Springs, FL 32714  
UES Project No: 0811.2300006.0000

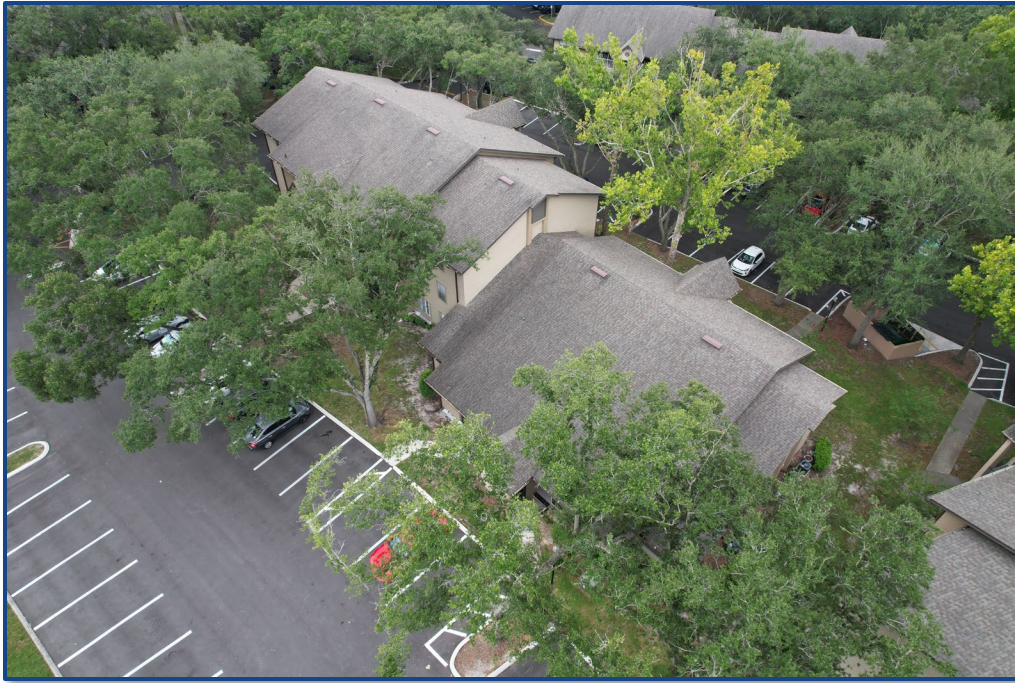
Photograph No. 1: North elevation.

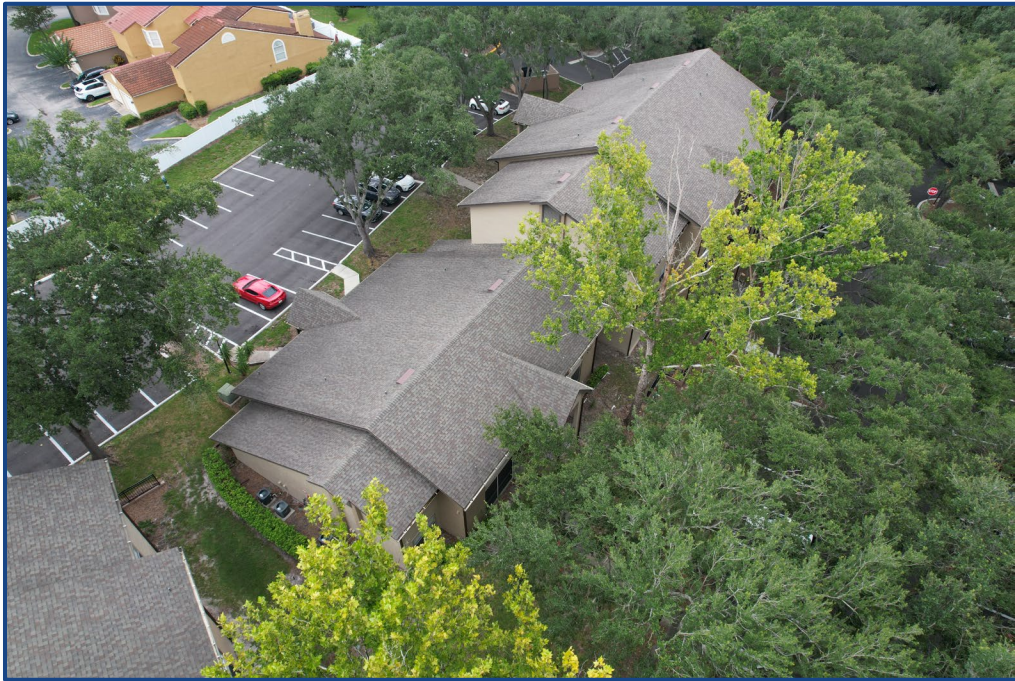
Photograph No. 2: West elevation.

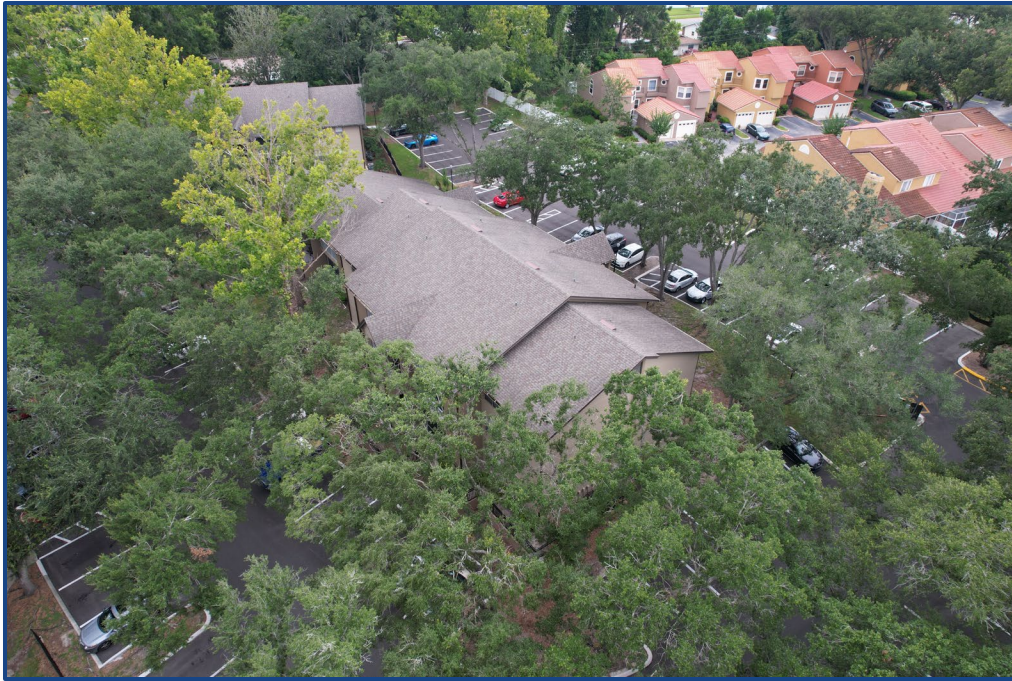
Photograph No. 3: South elevation.

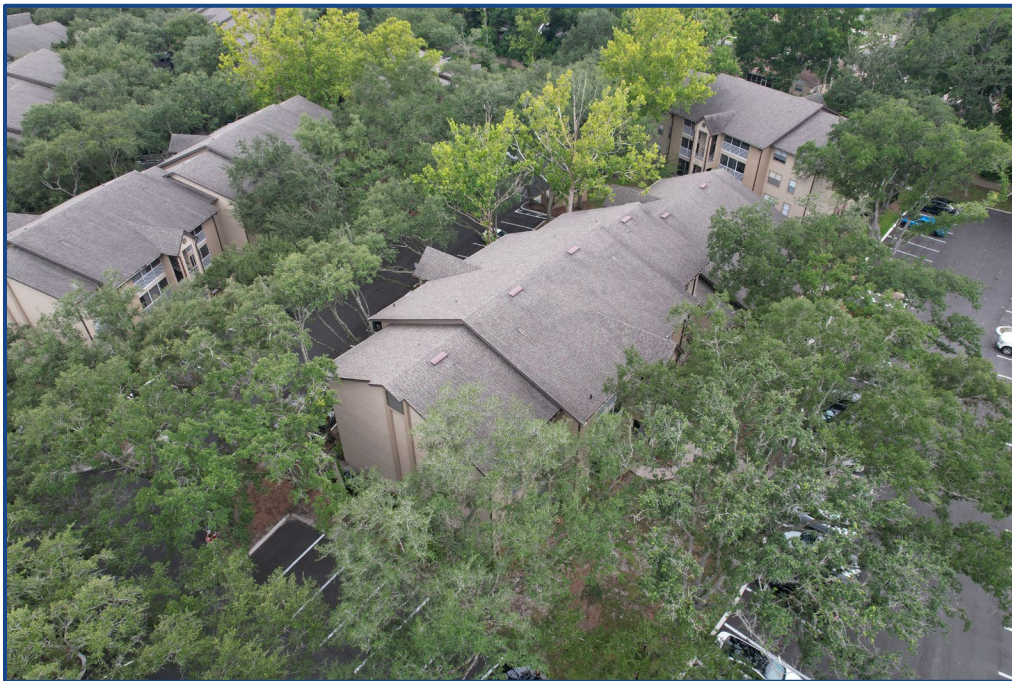
Photograph No. 4: East elevation.

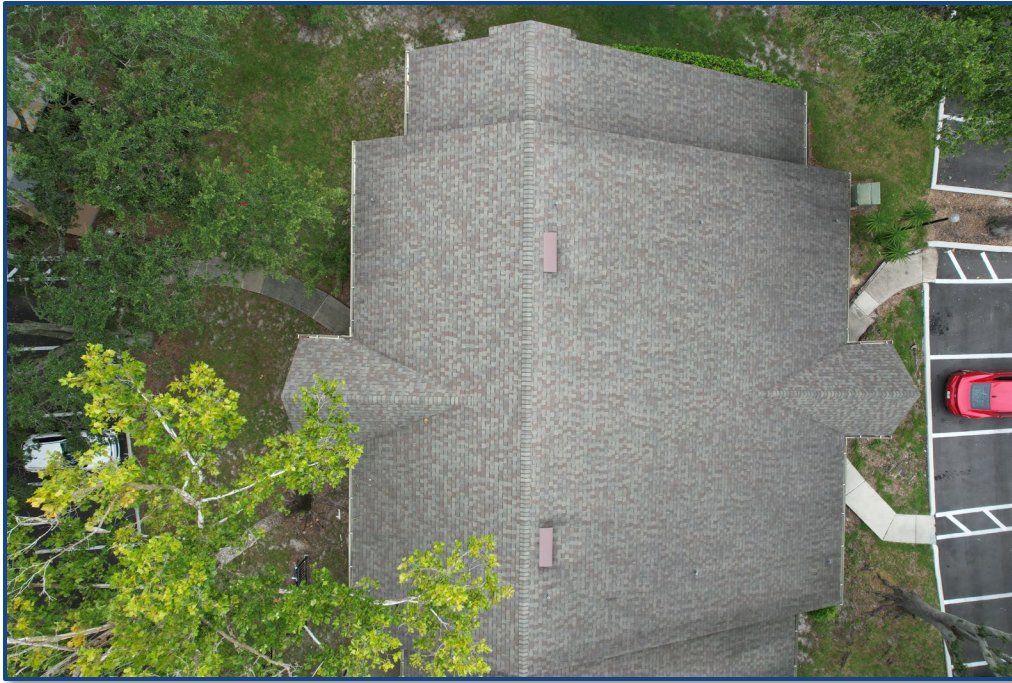
The roof system of the building is composed of architectural asphalt shingles. At the time of inspection, no damage was observed in the roof system. The roof system was observed to be in good condition.

Photograph No. 5: View of the west roof section.

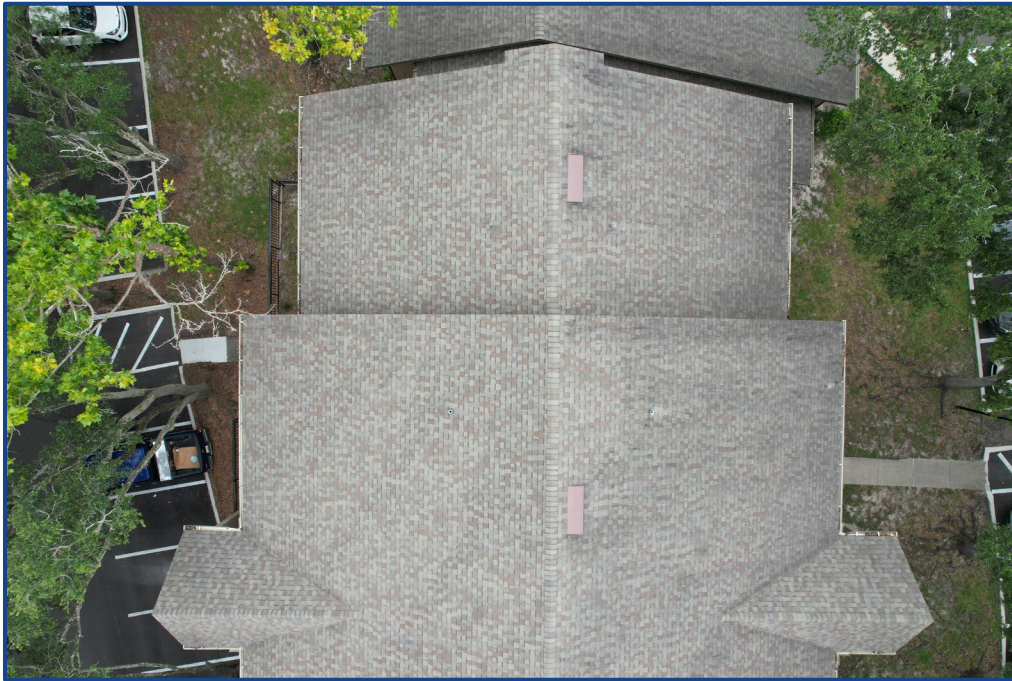
Photograph No. 6: View of the central roof section.

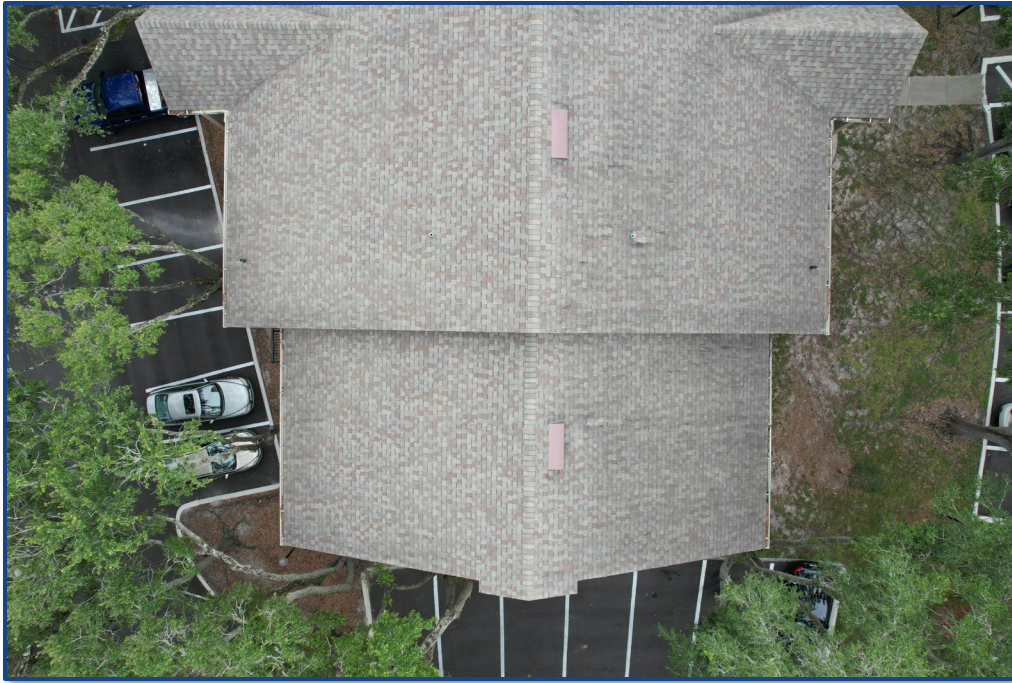
Photograph No. 7: View of the east roof section.

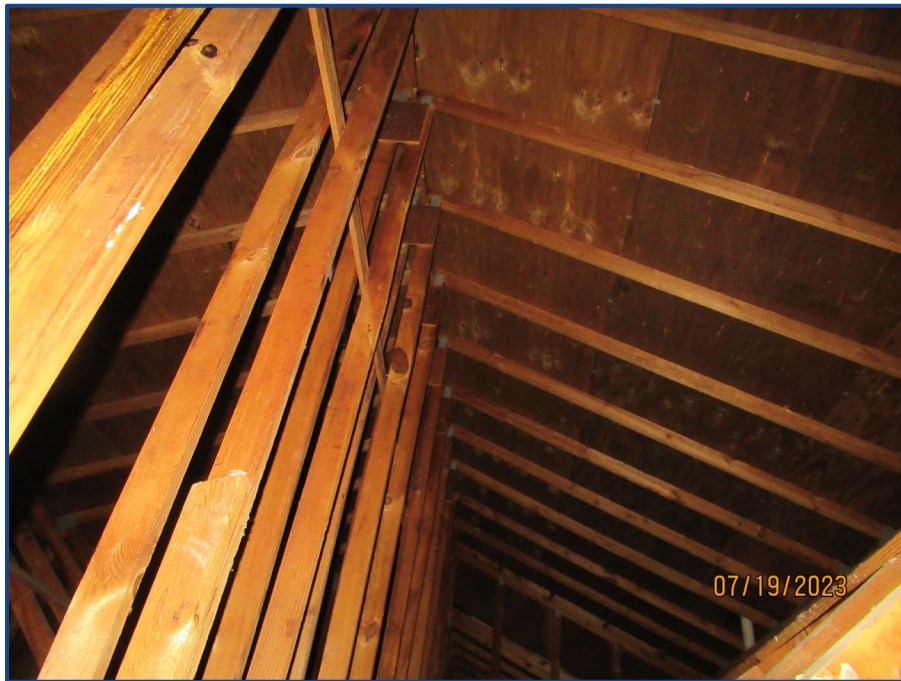
Photograph No. 8: General view of the prefabricated wooden roof trusses.

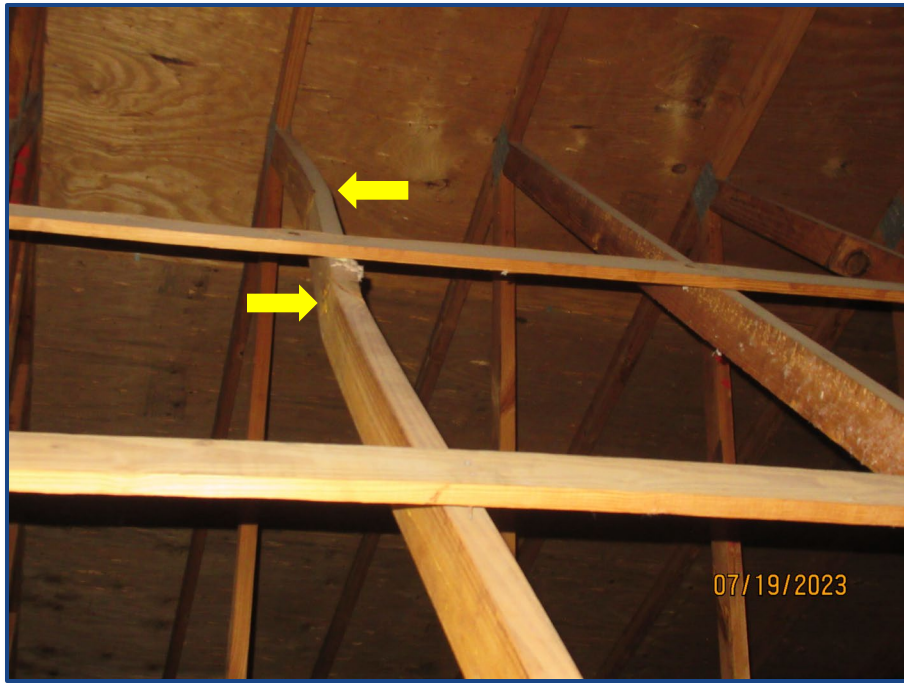
- A broken prefabricated wooden roof truss was observed in the east roof framing system. See **Appendix C** Photograph No. 9.
- Damage was observed to the metal balcony edge flashing in multiple locations. See **Appendix C** Photographs No. 12 and 13.
- Cracks in the exterior stucco finishes were observed in multiple locations. See **Appendix C** Photographs No. 21 and 16.
- Cracks in the elevated concrete slabs were observed in multiple locations. See **Appendix C** Photographs No. 12, 17, and 18.
- Peeling of the exterior paint finishes was observed in multiple locations. See **Appendix C** Photograph No. 13 through 15.
- Exposed steel reinforcement was observed in the drainage scupper located in the northeast stairway. See **Appendix C** Photograph No. 19.

Photograph No. 9: A broken roof truss located in the east roof section attic.

Wood Framing Repair for year 2024 shall include repairs to the broken roof truss referenced within this report.

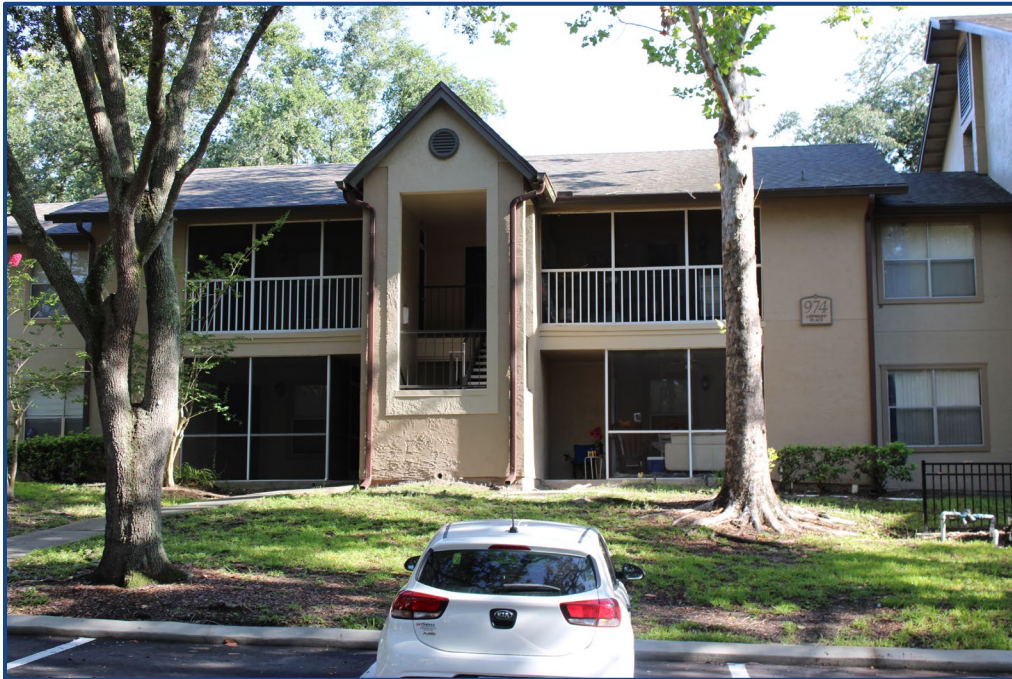
Photograph No. 10: View of the balconies and stairway on the southwest side of the building.

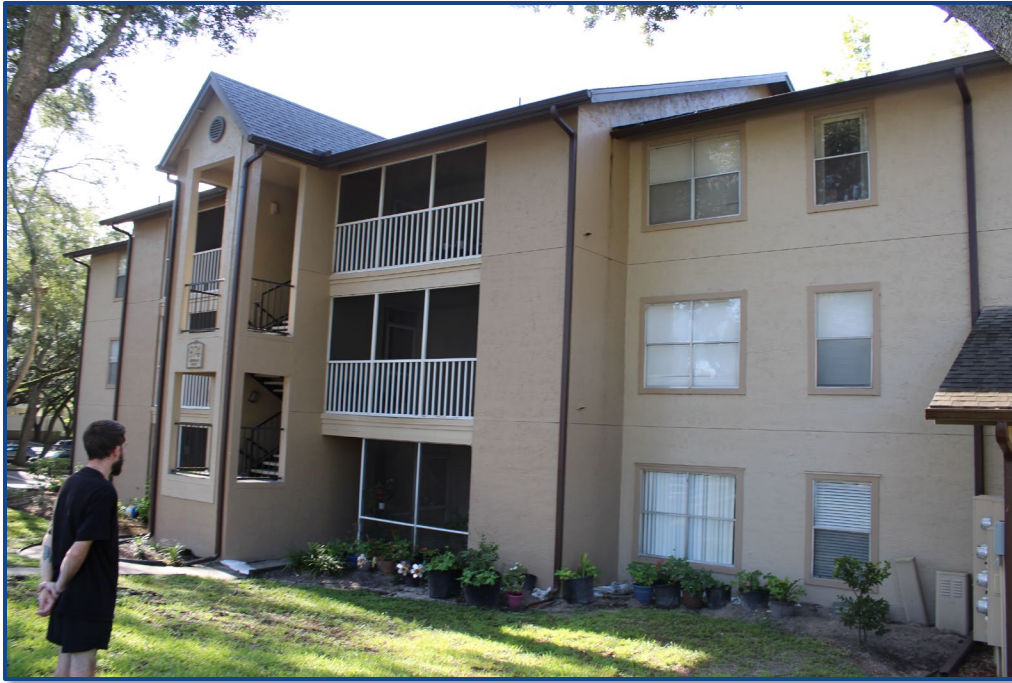
Photograph No. 11: View of the balconies and stairway on the northeast side of the building.

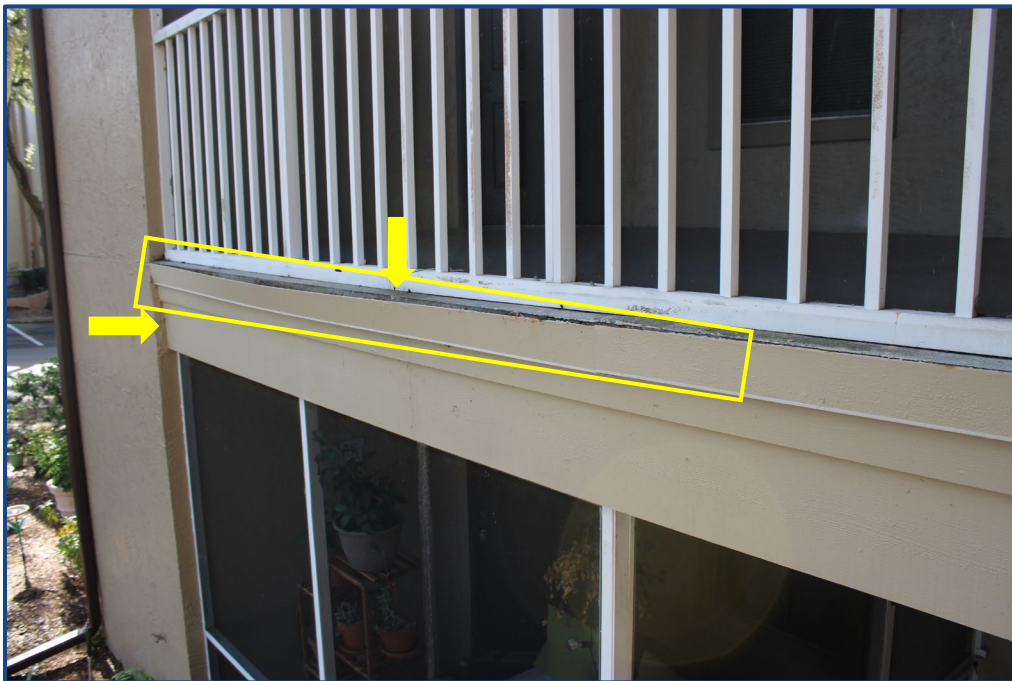
Photograph No. 12: Cracks in the stucco finish, crack in the concrete slab, and corrosion and separation of the metal flashing at the edge of the balcony slab on Unit 204.

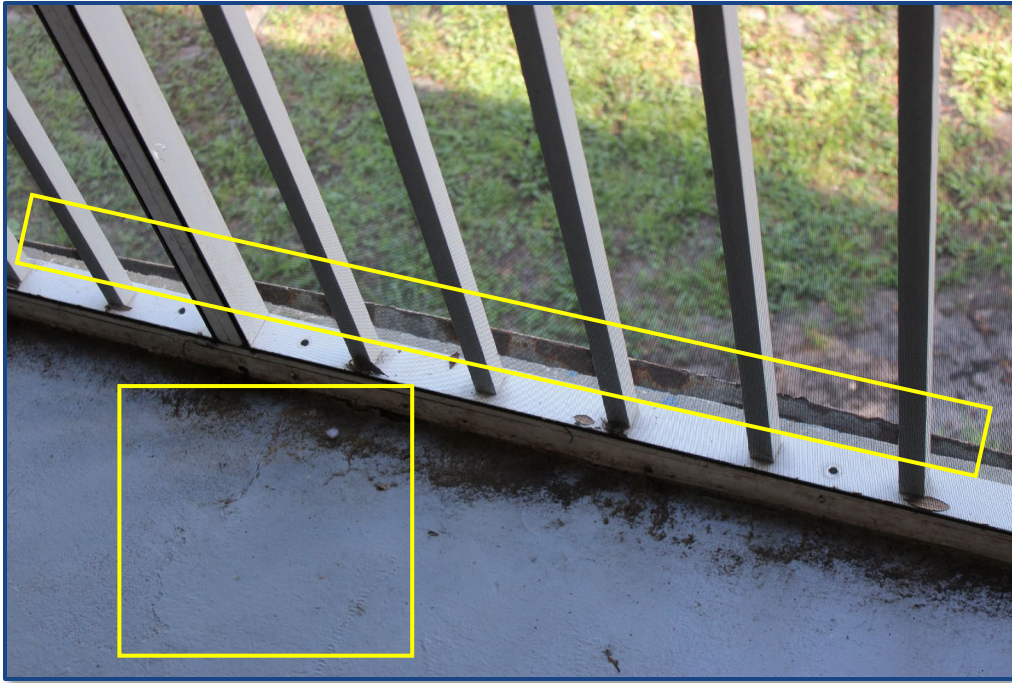
Photograph No. 13: Peeling of the balcony slab paint finish and corrosion and separation of the metal flashing at the edge of the balcony slab on Unit 203.

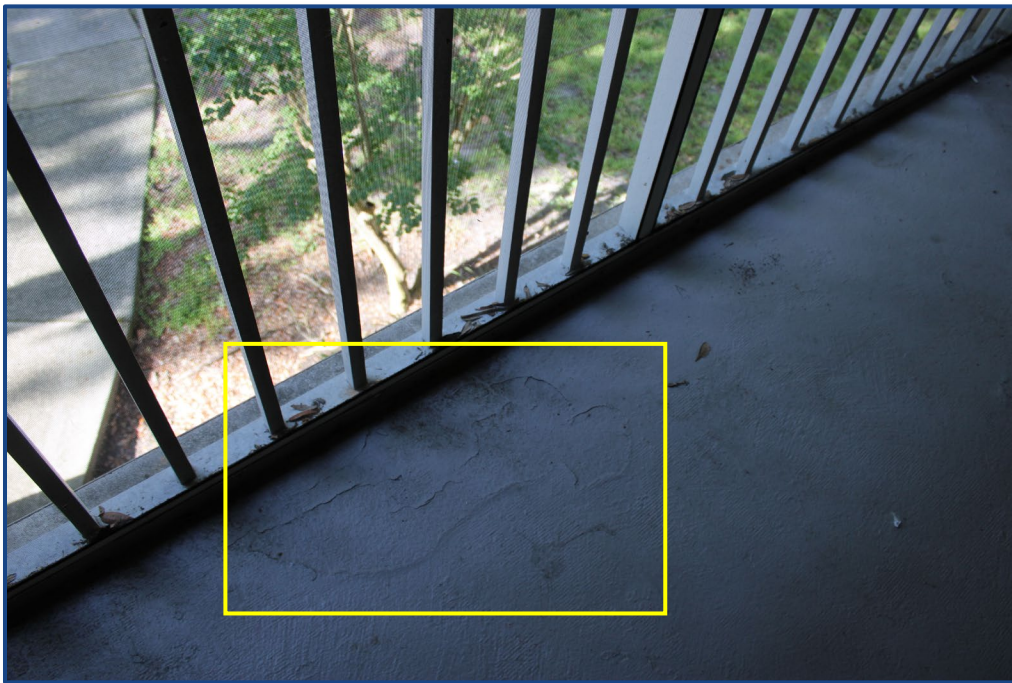
Photograph No. 14: Peeling of the balcony slab paint finish located on Unit 208.

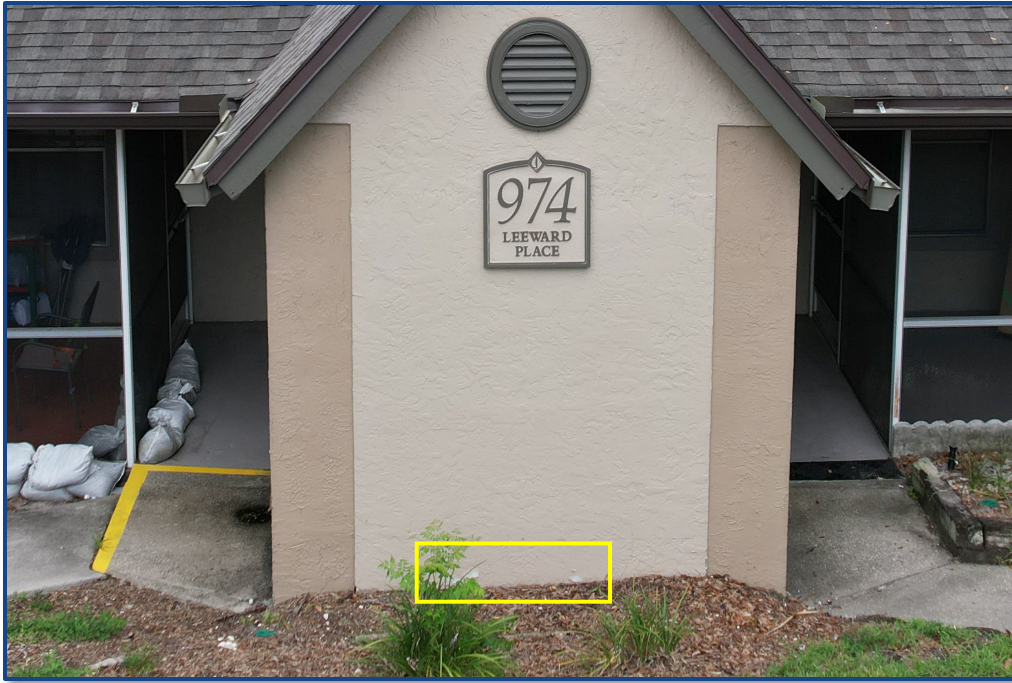
Photograph No. 15: Peeling of the exterior wall paint finish located on the northwest side of the building.

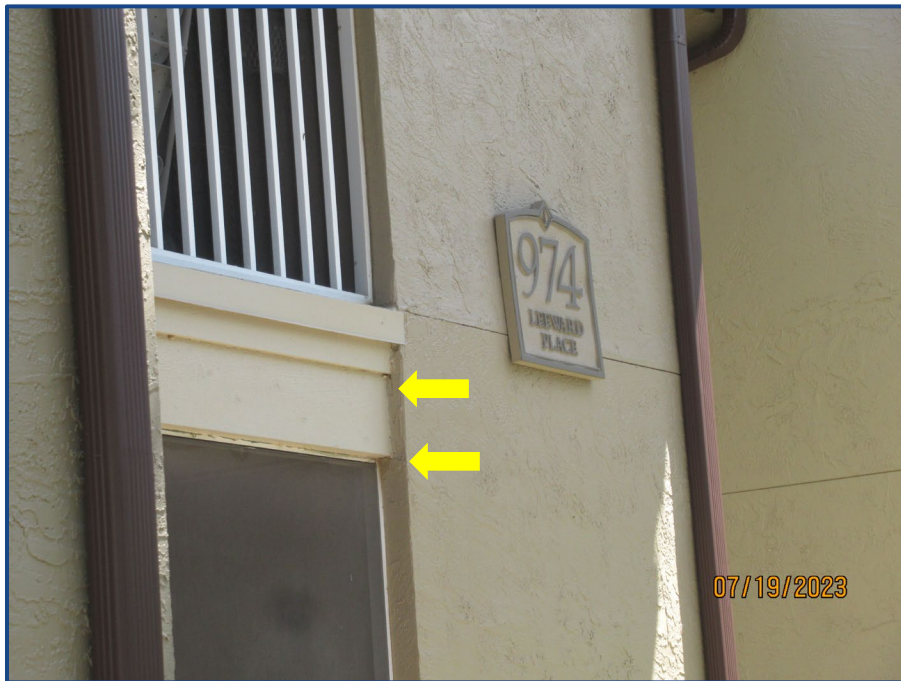
The exterior finishes of the building consists of painted stucco finishes. At the time of inspection, cracks in the exterior stucco finishes were observed in multiple locations (Photographs No. 21 and 16). Peeling of the exterior paint finishes was observed in multiple locations (Photograph No. 13 through 15). Overall, the general condition of the exterior finishes is in good condition. See **Appendix C** for reference site photographs.

Photograph No. 16: Cracks in the exterior wall stucco finish on the southwest side of the building.

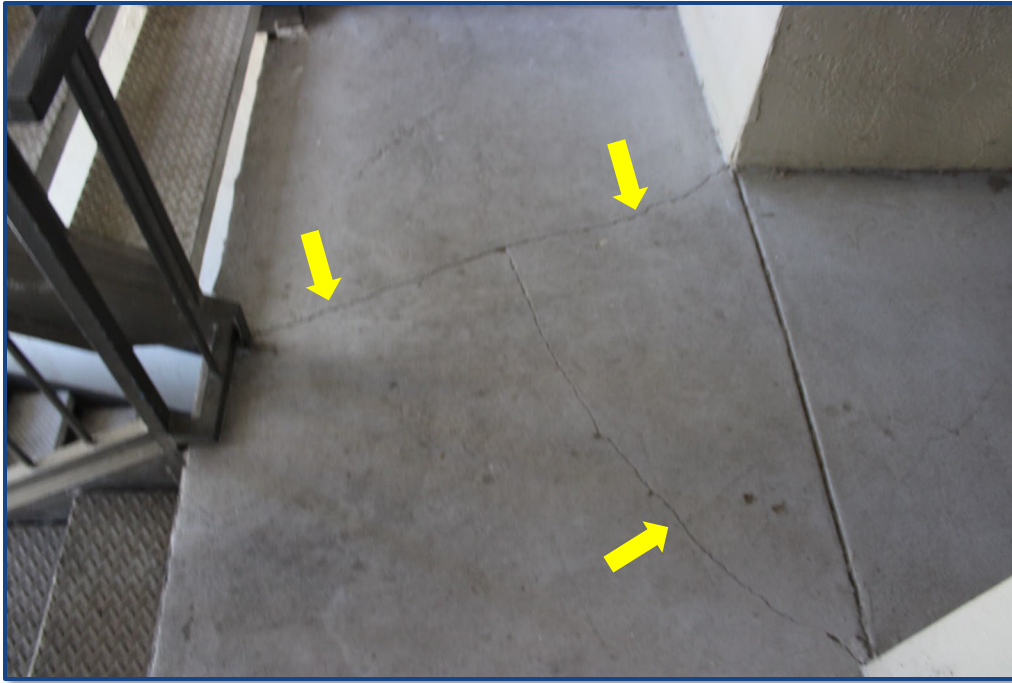
Photograph No. 17: Cracks in the concrete slab located on the 2nd floor.

Concrete and Stairway Repairs for year 2024 shall include repairs to cracked concrete and exposed reinforcement steel referenced within this report.

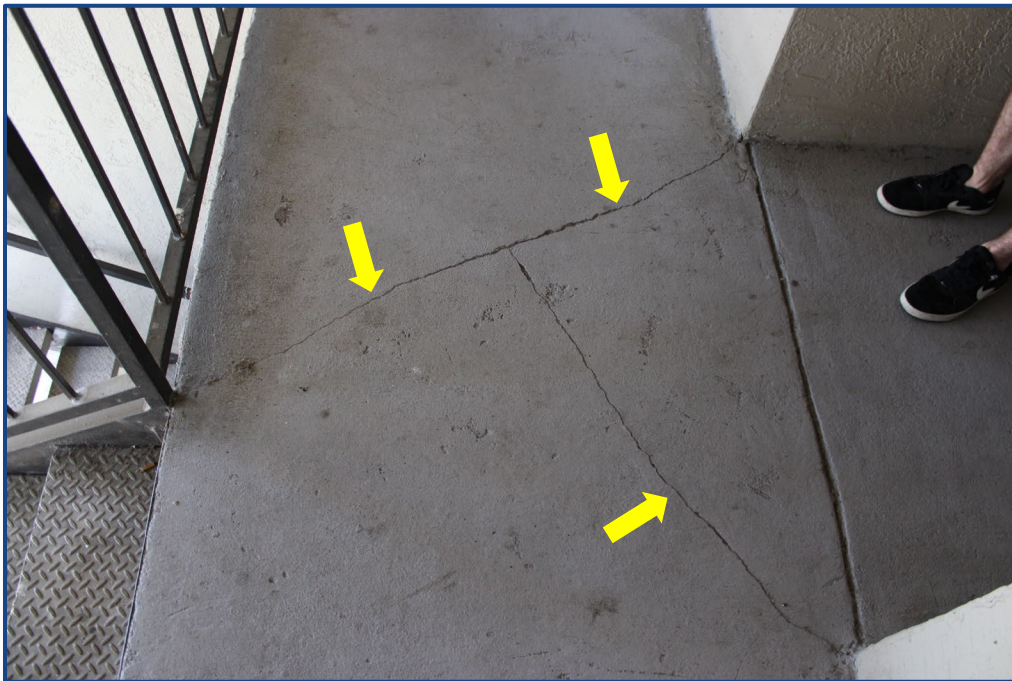
Photograph No. 18: Cracks in the concrete slab located on the 3rd floor

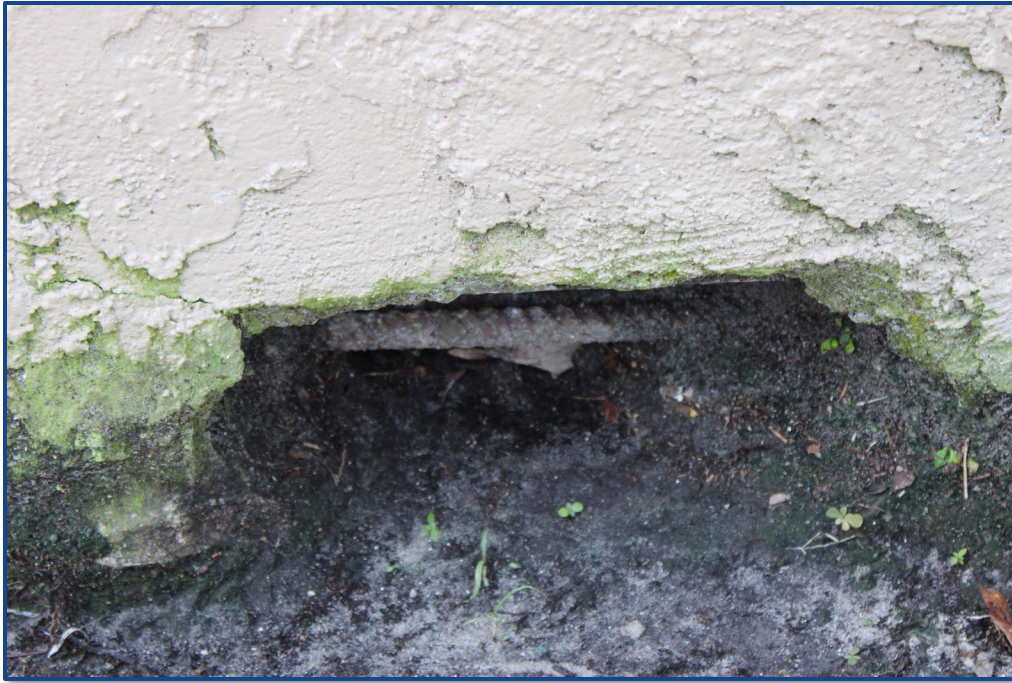
The building consists of exterior and interior wood framing walls and wood beams. The exterior walls are sheathed in plywood and stucco finished. The floor systems consist of prefabricated wooden floor trusses at the elevated units and reinforced concrete slabs at the elevated exterior stairway landings, walkways, and balconies. The roof framing system consists of prefabricated wooden roof trusses. The stairways consist of steel stringers with precast reinforced concrete steps. At the time of inspection, a broken prefabricated wooden roof truss was observed in the east roof framing system (Photograph No. 9). Damage was observed to the metal balcony edge flashing in multiple locations (Photographs No. 12 and 13). Cracks in the elevated concrete slabs were observed in multiple locations (Photographs No. 12, 17, and 18). Exposed steel reinforcement was observed in the drainage scupper located in the northeast stairway (Photograph No. 19). See **Appendix C** for reference site photographs.

Photograph No. 19: Exposed reinforcement steel located in the drainage scupper located in the northeast stairway.

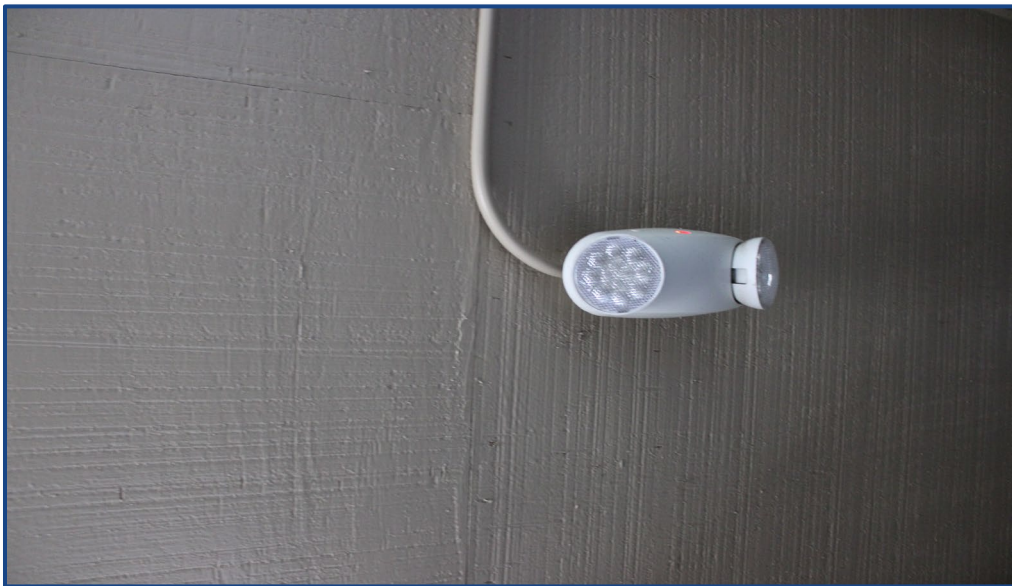
Photograph No. 20: Emergency lighting fixture.

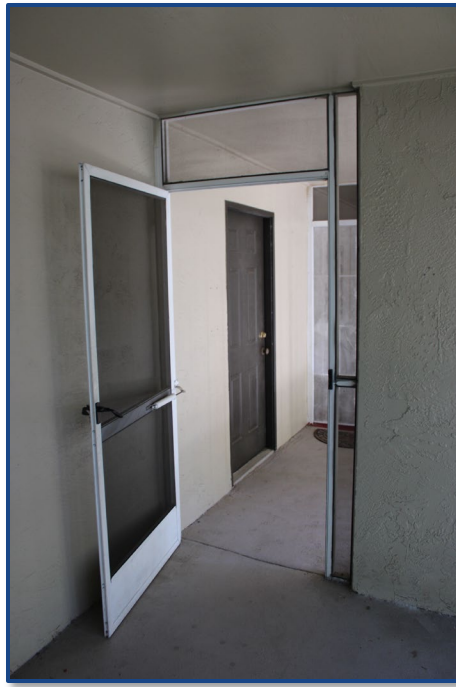
The building has one common door and no common windows. All windows and exterior unit doors are the unit owner's responsibility. At the time of inspection, the common door was observed to be in good condition.

Photograph No. 21: View of the storage room door.
