August 25, 2023

Re: The Landing Condominiums – Building 18
Structural Integrity Reserve Study (SIRS)
976 Leeward Place
Altamonte Springs, FL 32714
UES Project No: 0811.2300006.0000

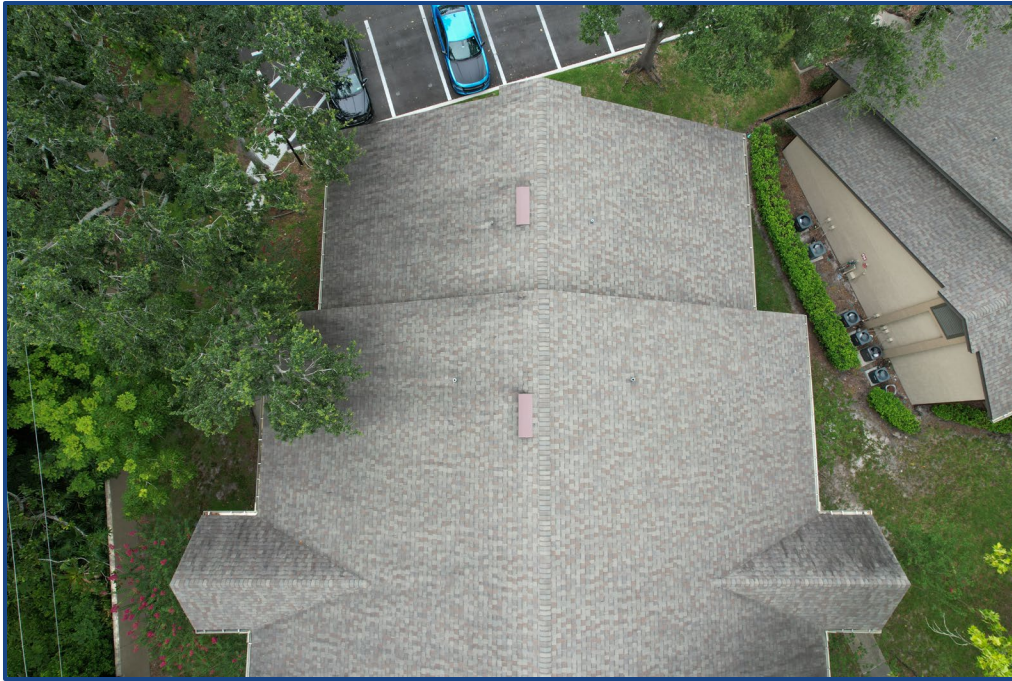
The roof system of the building is composed of architectural asphalt shingles. At the time of inspection, no damage was observed in the roof system. The roof system was observed to be in good condition.

Photograph No. 5: View of the north roof section.

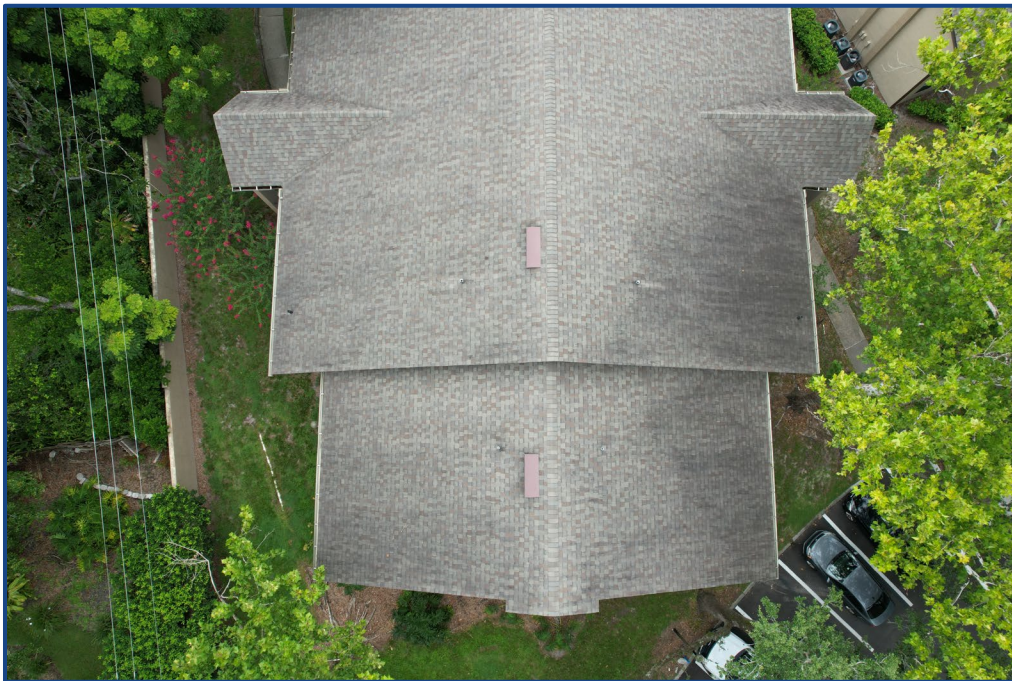
Photograph No. 6: View of the south roof section.

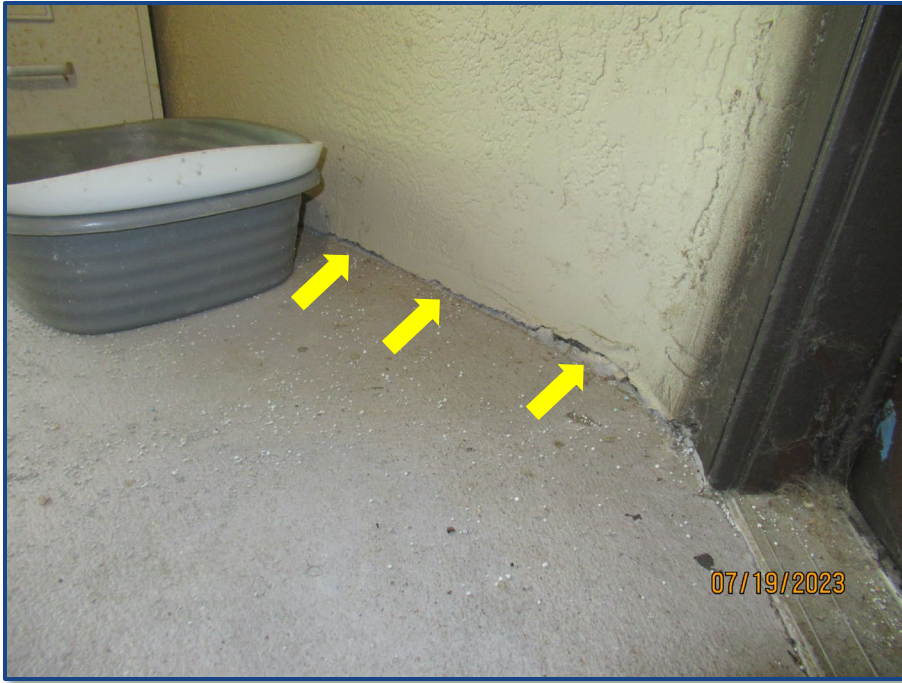
- Cracks and damage to the exterior stucco finishes were observed in multiple locations. See **Appendix C** Photographs No. 9 through 13.
- Cracks in the elevated concrete slabs were observed in multiple locations. See **Appendix C** Photographs No. 14 through 16.

Photograph No. 9: Damage to the exterior wall stucco finish located on the balcony of Unit 302.

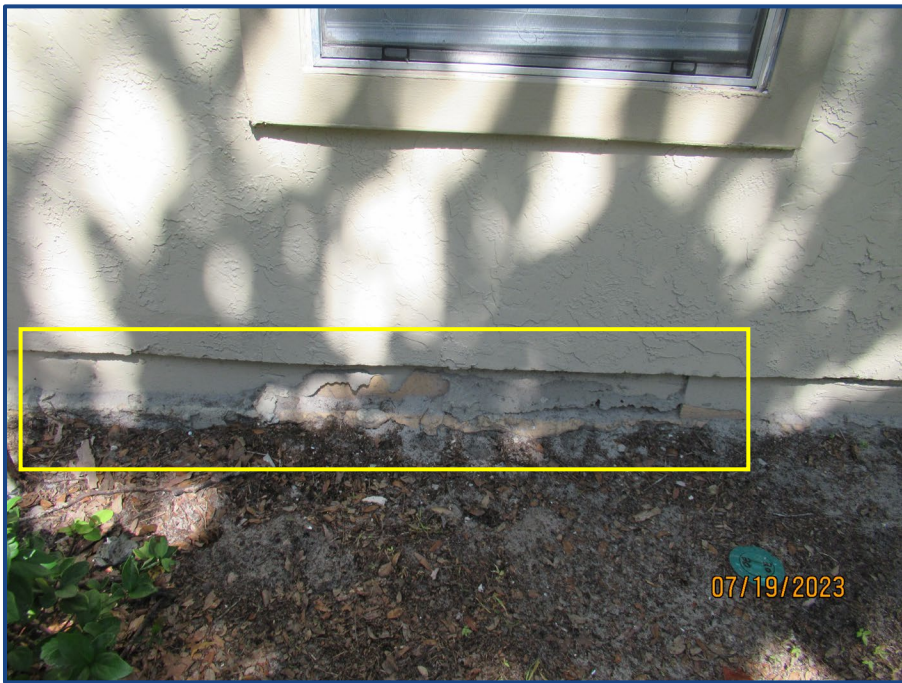
Photograph No. 10: Damage to the exterior wall stucco finish located on the east side of the building.

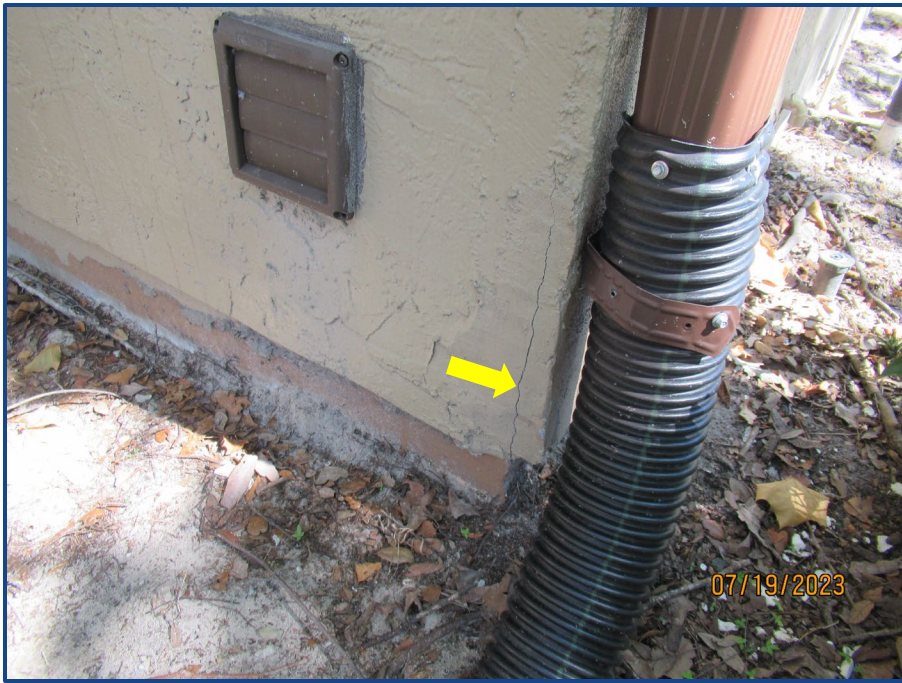
Photograph No. 11: Crack in the exterior wall stucco finish located on the east side of the building.

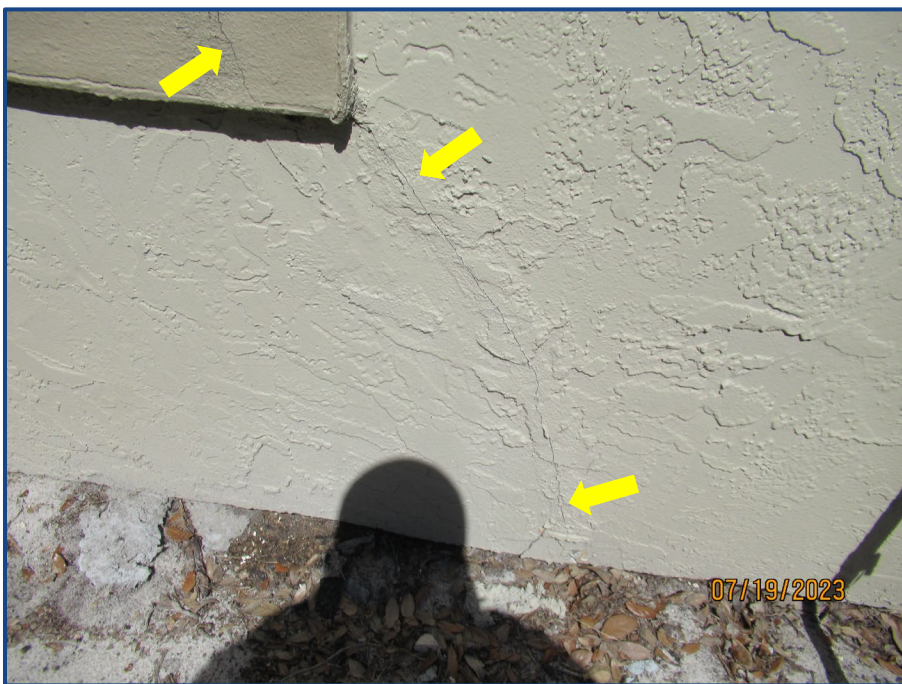
Photograph No. 12: Cracks in the exterior wall stucco finish located on the east side of the building.

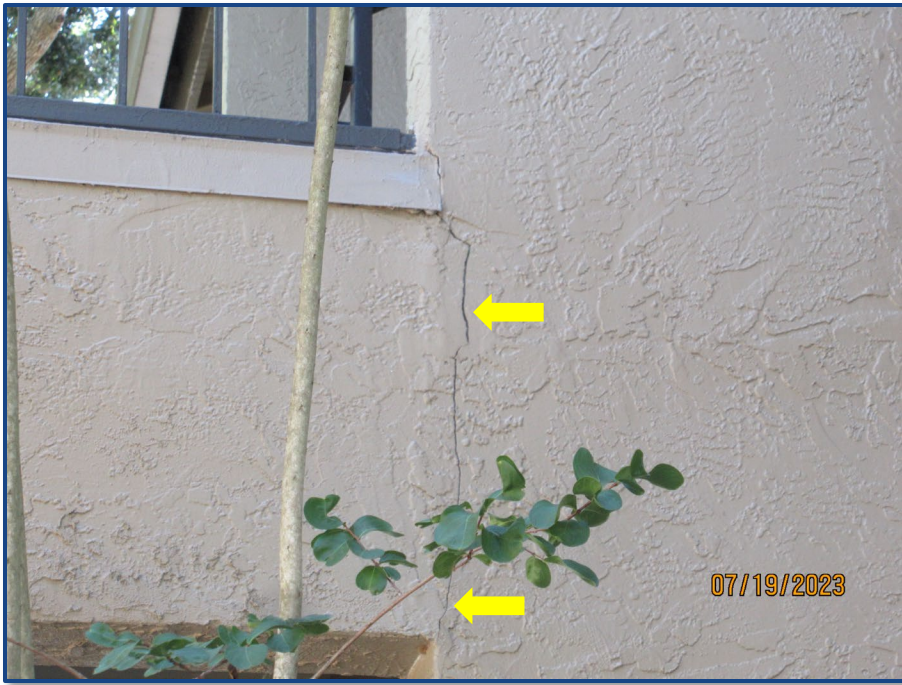
Photograph No. 13: Crack in the exterior wall stucco finish located on the west stairway.

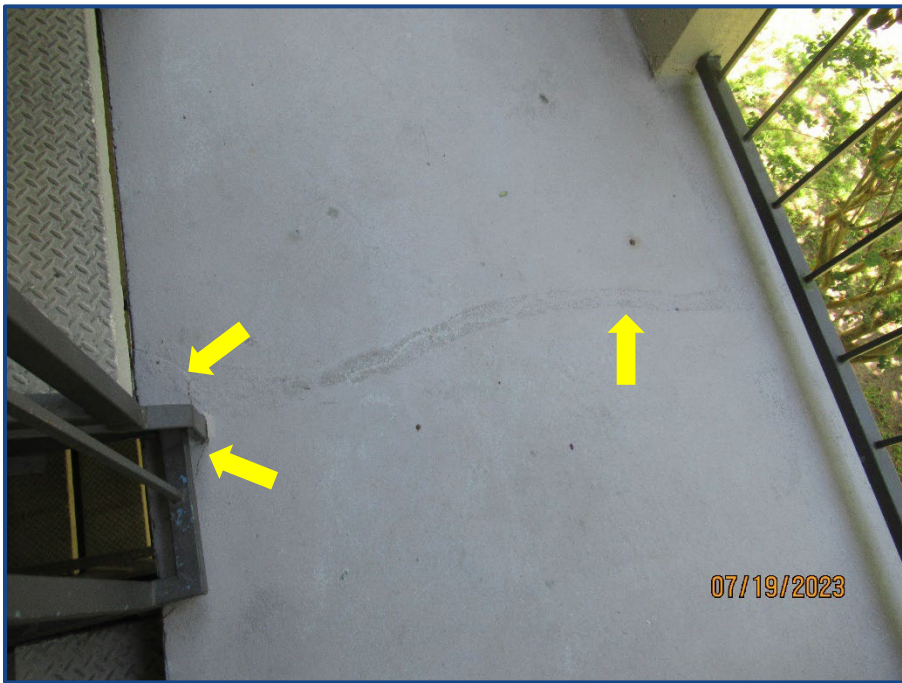
Photograph No. 14: Previously sealed cracks in the stairway landing located in the west stairway.

Concrete and Stairway Repairs for year 2024 shall include repairs to cracked concrete referenced within this report.

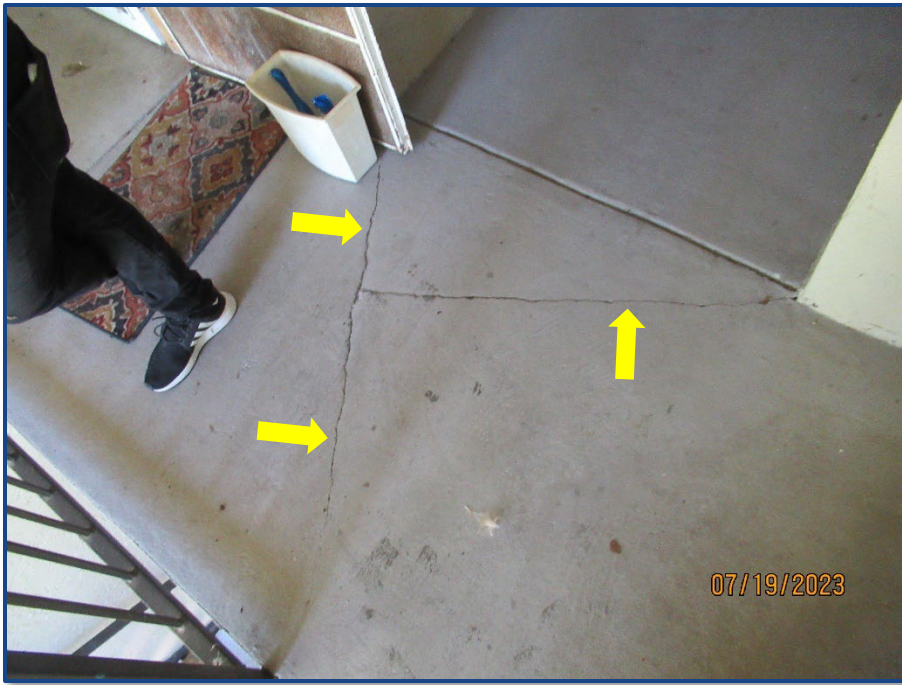
Photograph No. 15: Cracks in the concrete slab located on the 3rd floor.

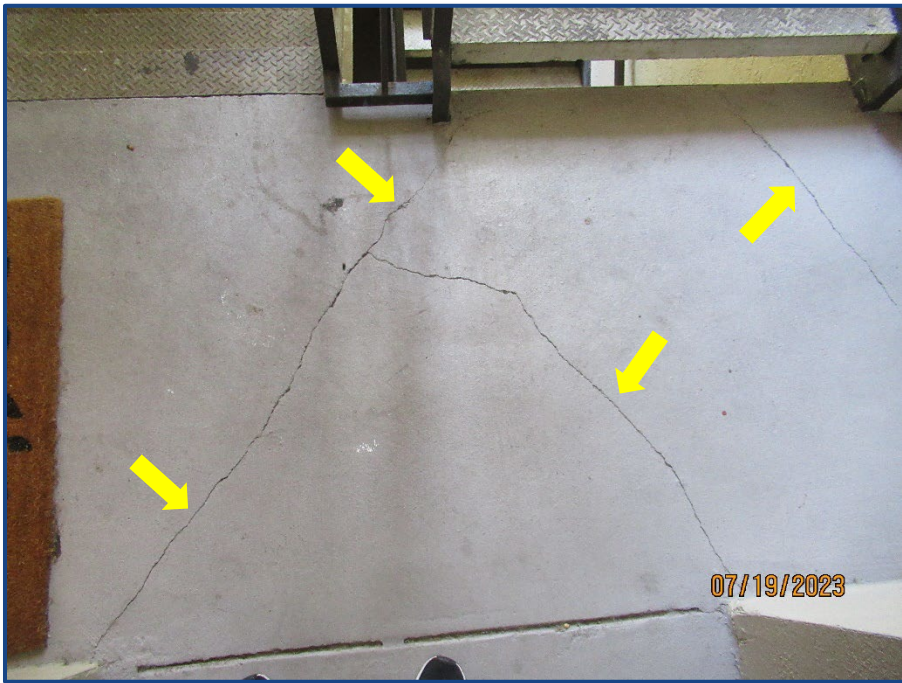
Photograph No. 16: Cracks in the concrete slab located on the 2nd floor

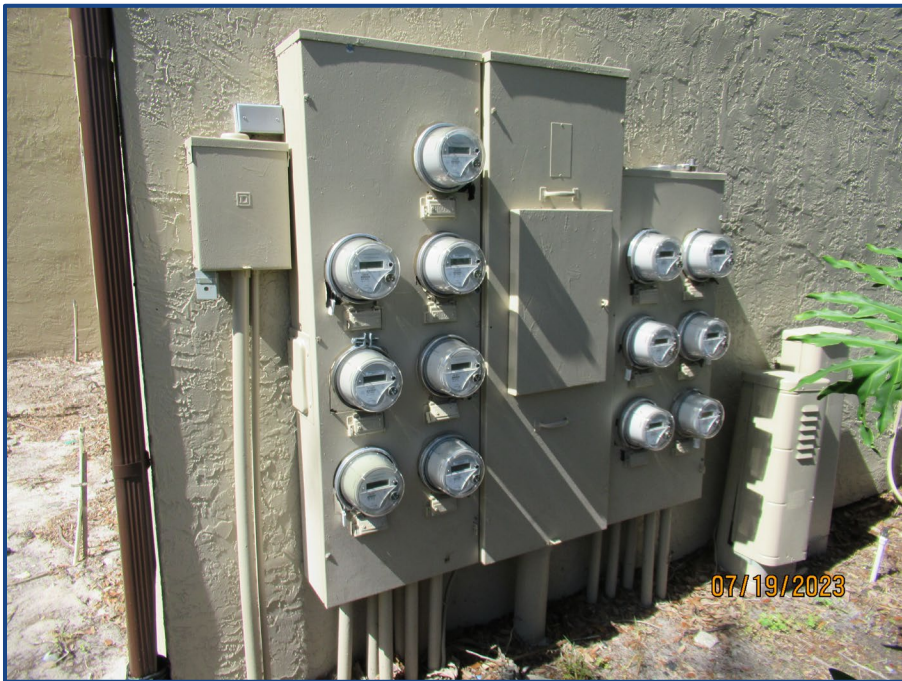
The visible electrical systems inspected at the time of inspection included electrical meters, main disconnects, air conditioning disconnects on each unit, and electrical conduits. At the time of inspection, no damage or deficiencies were observed to the electrical systems.

Photograph No. 18: Electrical meters.
