August 25, 2023

Janette Barcena  
The Landing Condominium Association, Inc.  
953 Salt Pond Place  
Altamonte Springs, Florida 32714

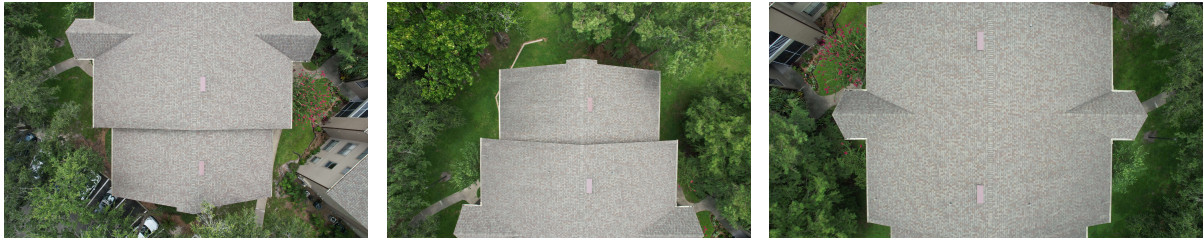
<b>Roofing - Total Current Cost</b>	<b>\$25,150</b>
<b>Assigned Reserves</b>	<b>\$25,150</b>
<b>Fully Funded Reserves</b>	<b>\$6,287</b>

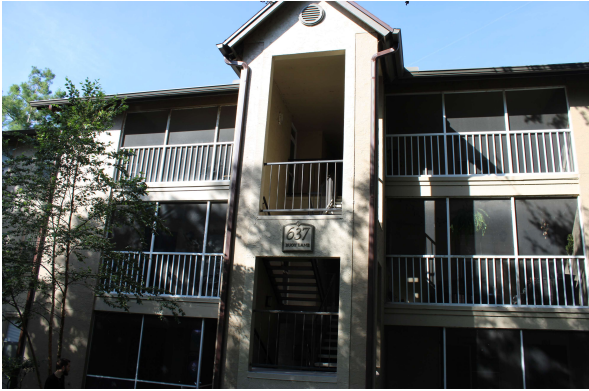
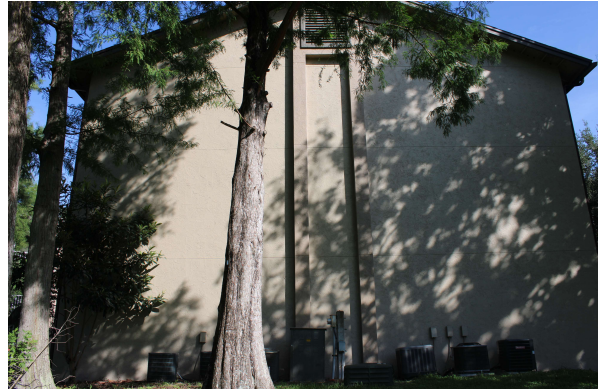
**Stucco Repairs - 2030**

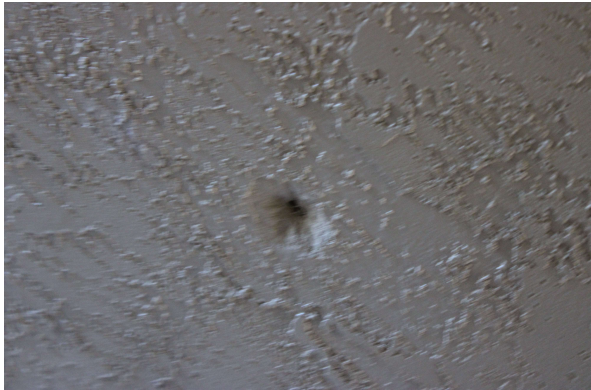
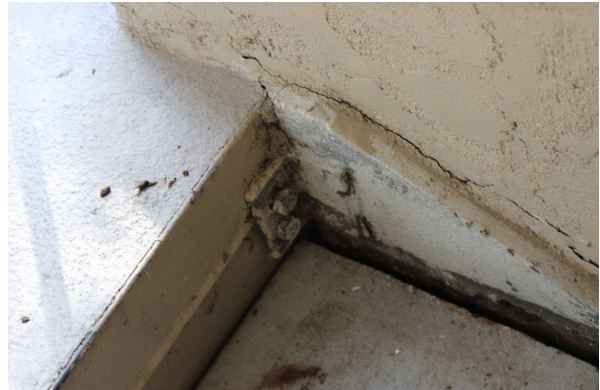
<b>Painting - Total Current Cost</b>	<b>\$17,000</b>
<b>Assigned Reserves</b>	<b>\$17,000</b>
<b>Fully Funded Reserves</b>	<b>\$8,514</b>

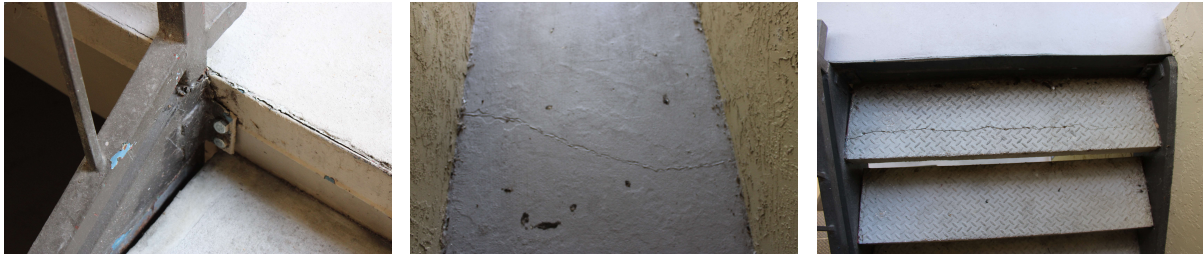
Concrete and Stairway Repair for year 2024 shall include repairs to cracked concrete and corrosion to the steel framing referenced within this report.

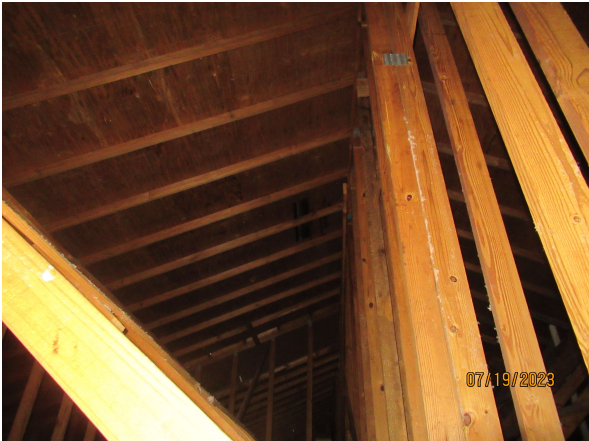
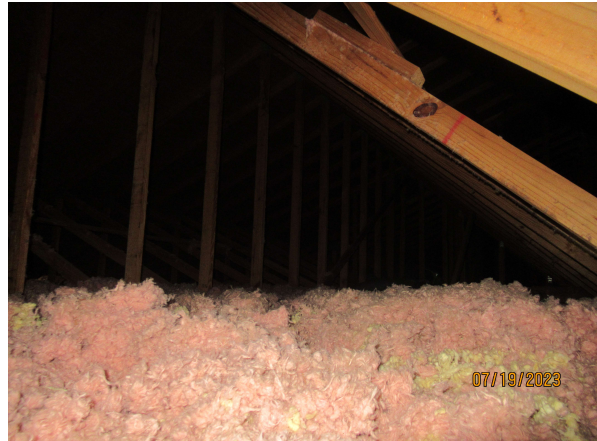
<b>Structural Components - Total Current Cost</b>	<b>\$6,000</b>
<b>Assigned Reserves</b>	<b>\$9,000</b>
<b>Fully Funded Reserves</b>	<b>\$3,300</b>

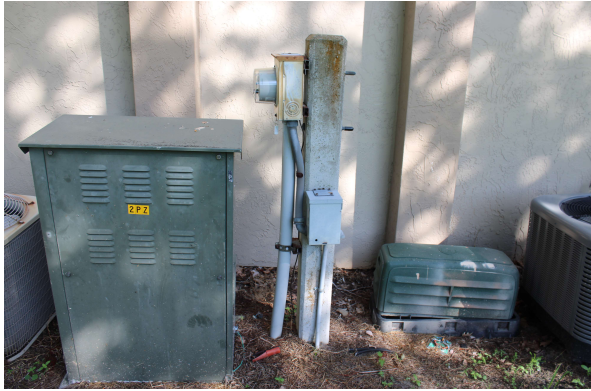
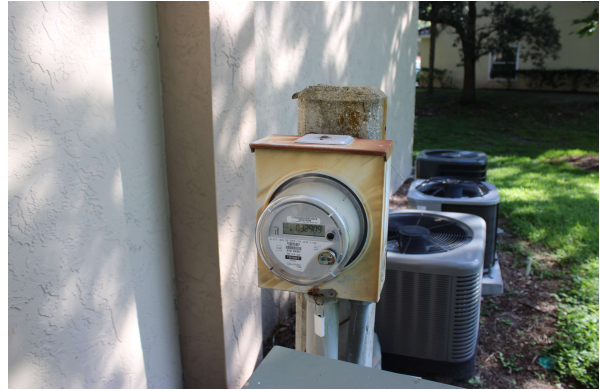
<b>Electrical Systems - Total Current Cost</b>	<b>\$2,500</b>
<b>Assigned Reserves</b>	<b>\$5,000</b>
<b>Fully Funded Reserves</b>	<b>\$2,500</b>

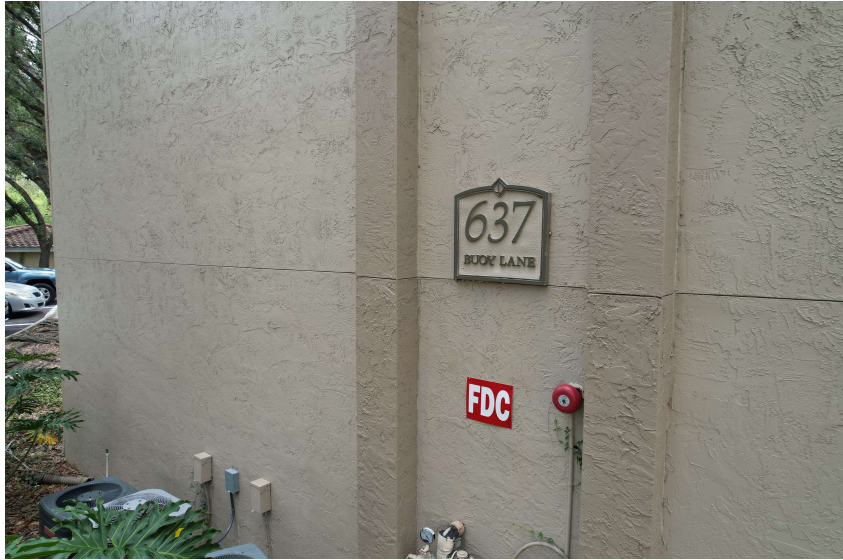
<b>Fire Protective Systems - Total Current Cost</b>	<b>\$2,500</b>
<b>Assigned Reserves</b>	<b>\$5,000</b>
<b>Fully Funded Reserves</b>	<b>\$2,500</b>

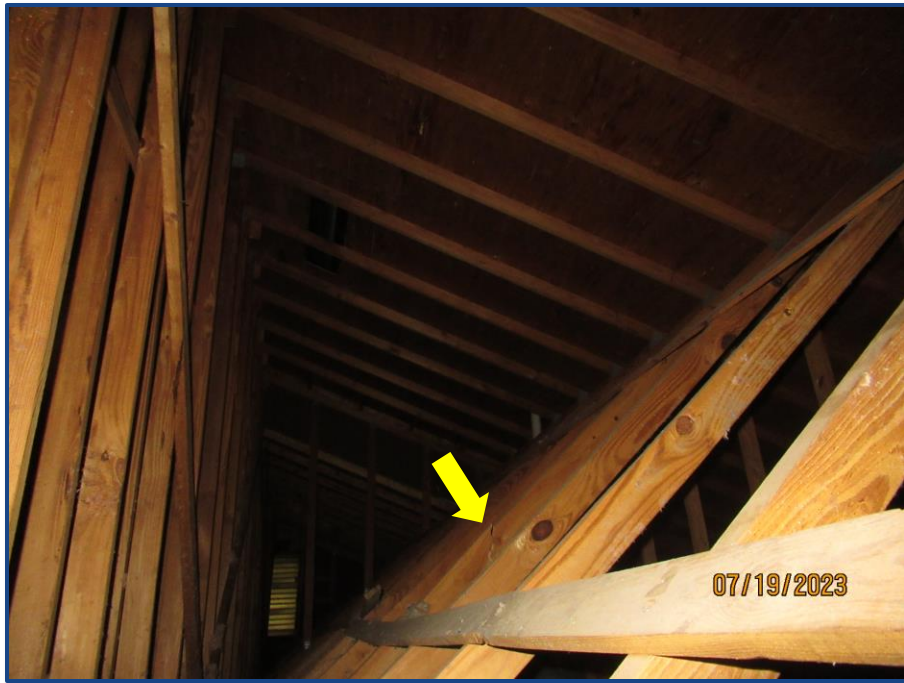
Photograph No. 7: View of a broken prefabricated wooden roof truss.

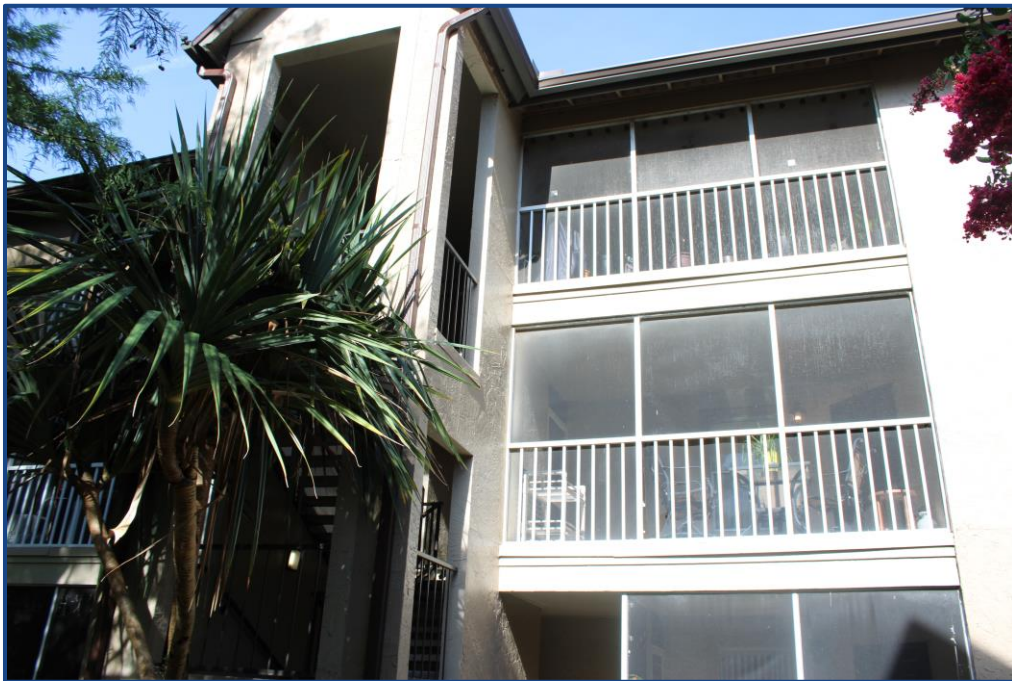
Photograph No. 8: View of the balconies and stairway on the east side of the building.

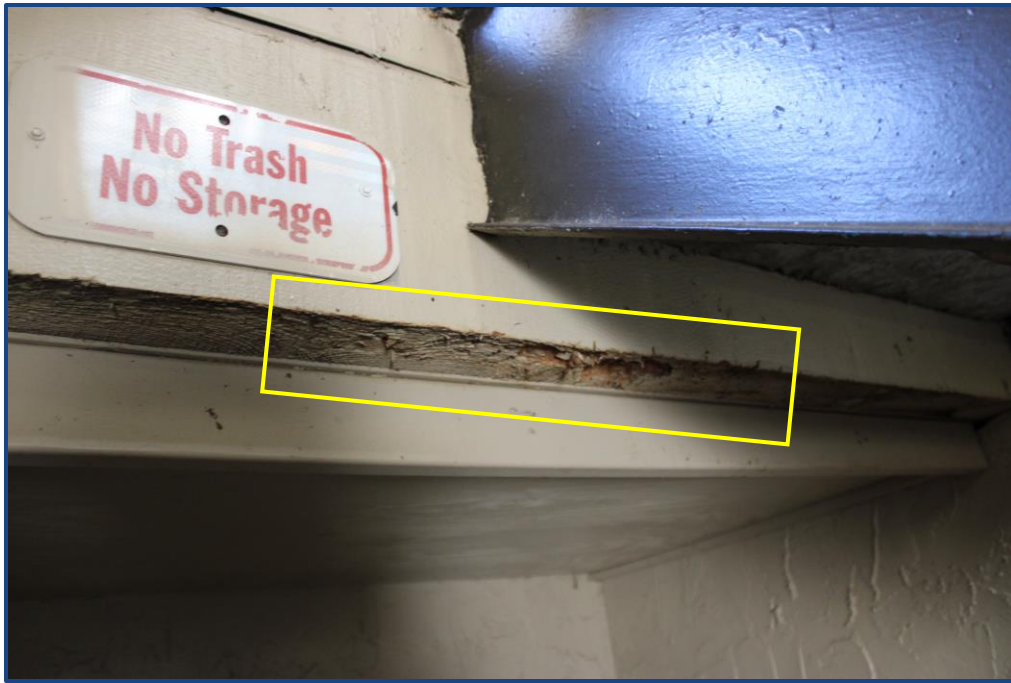
Photograph No. 9: Deterioration to the wood beam located at the 1st/2nd floor east stairway landing.

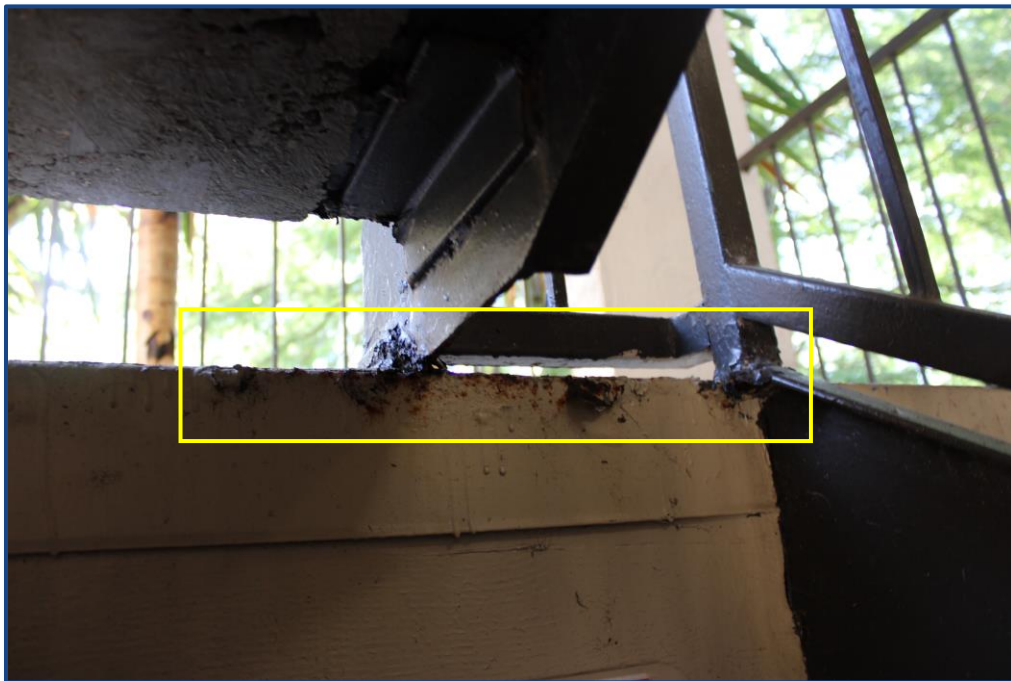
Photograph No. 10: Corrosion to the steel framing and metal flashing, located in the east stairway.

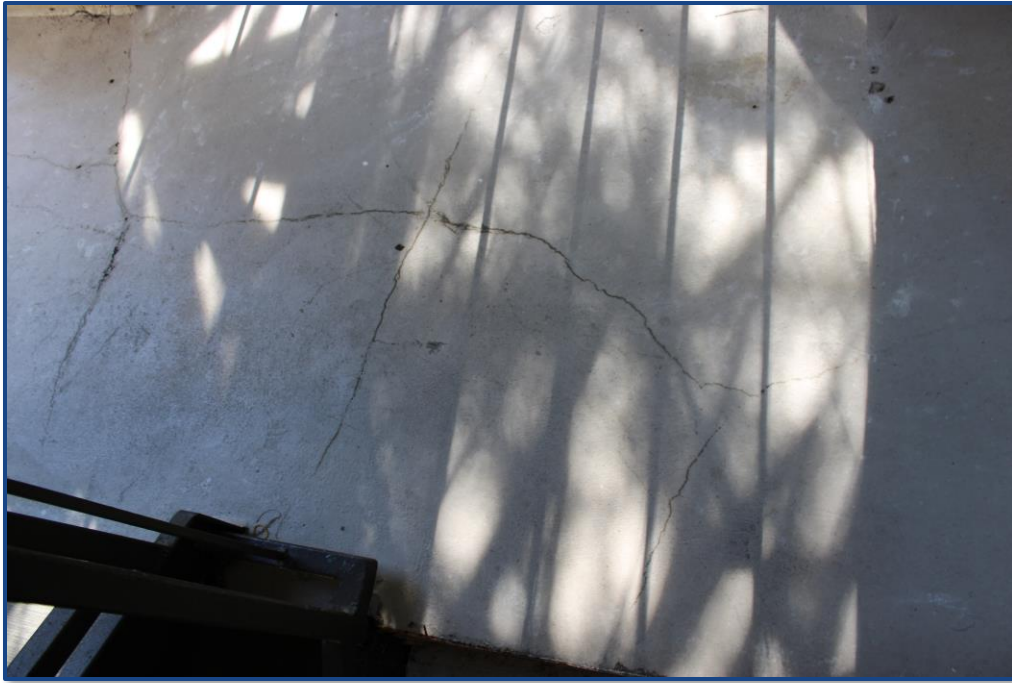
Photograph No. 11: Cracks in the concrete stairway landing.

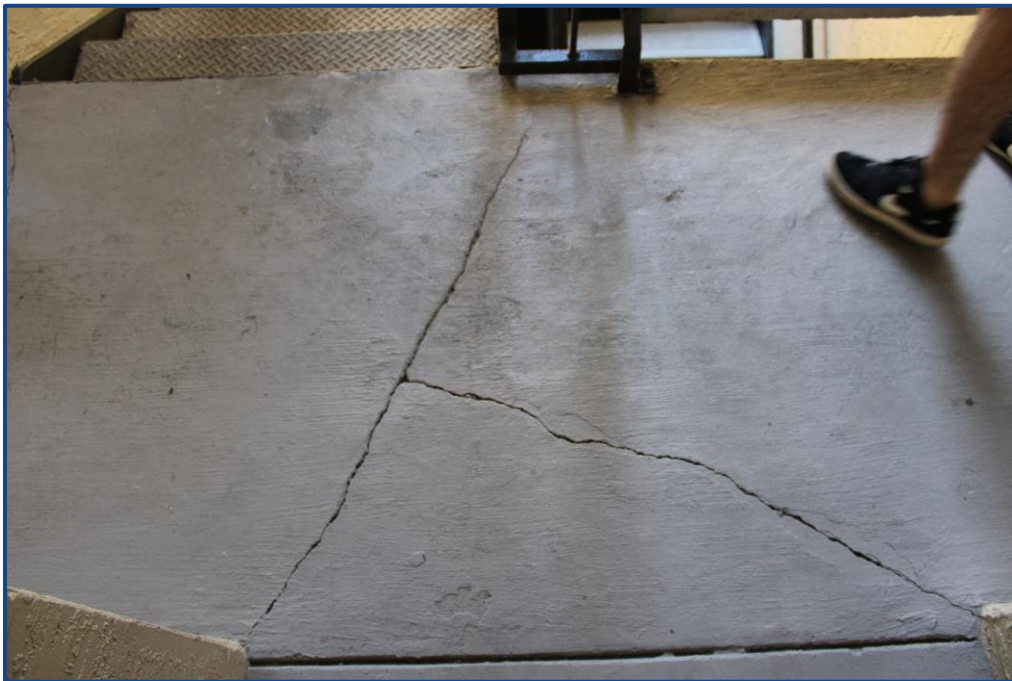
Photograph No. 12: Cracks in the concrete slab located on the 2nd floor.

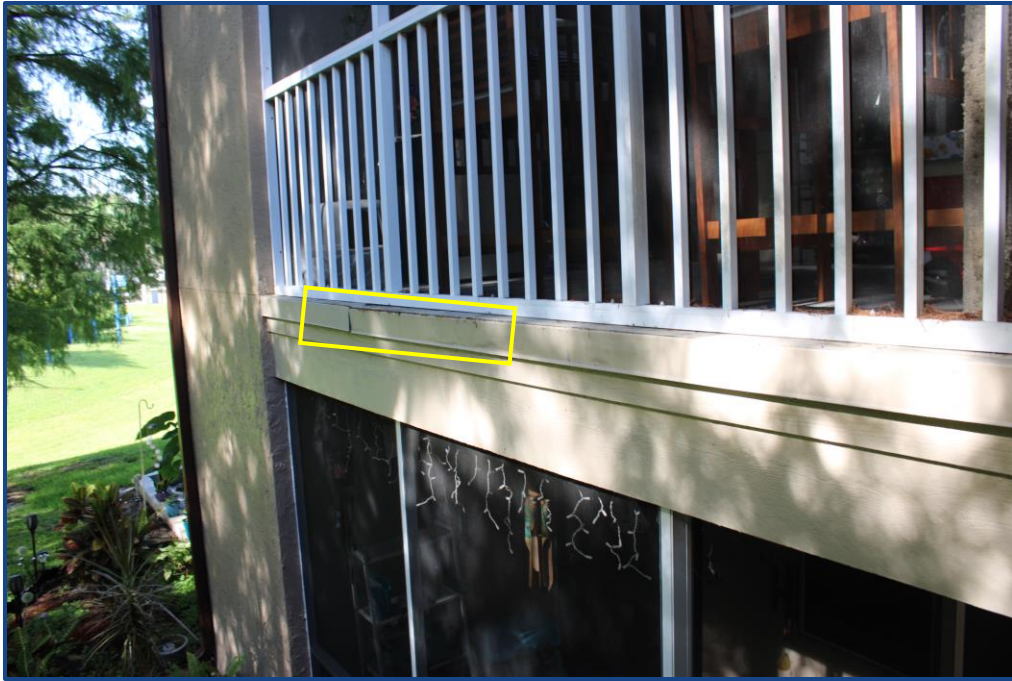
Photograph No. 13: Corrosion and separation of the metal flashing at the edge of the balcony slab on Unit 204.

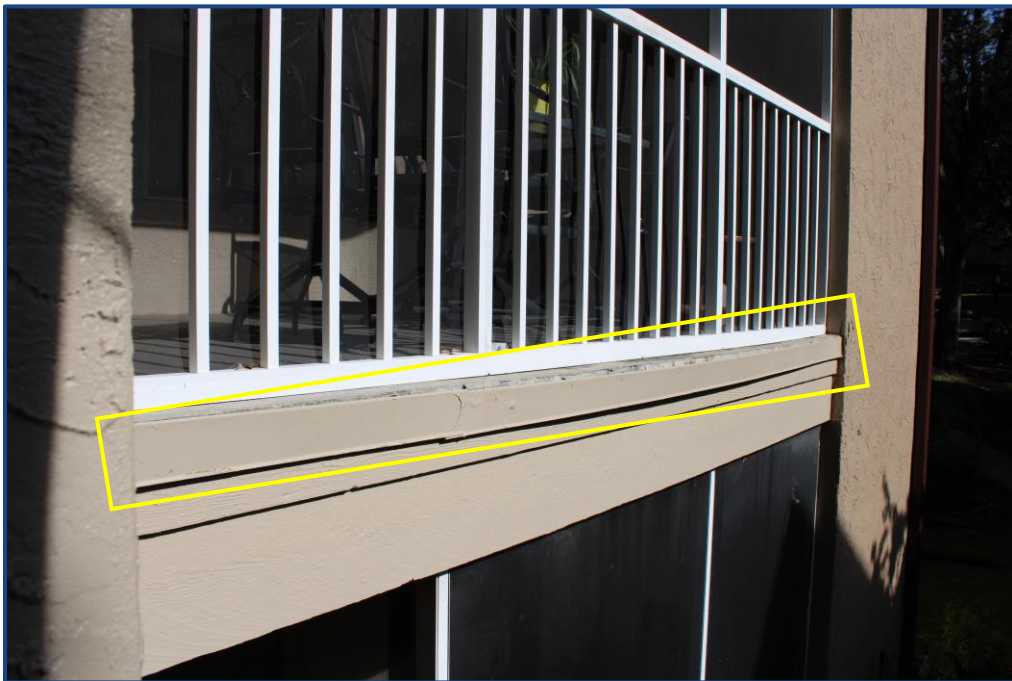
Photograph No. 14: Peeling and bubbling of the paint finish and separation of the metal flashing located at the edge of the balcony slab on Unit 203.

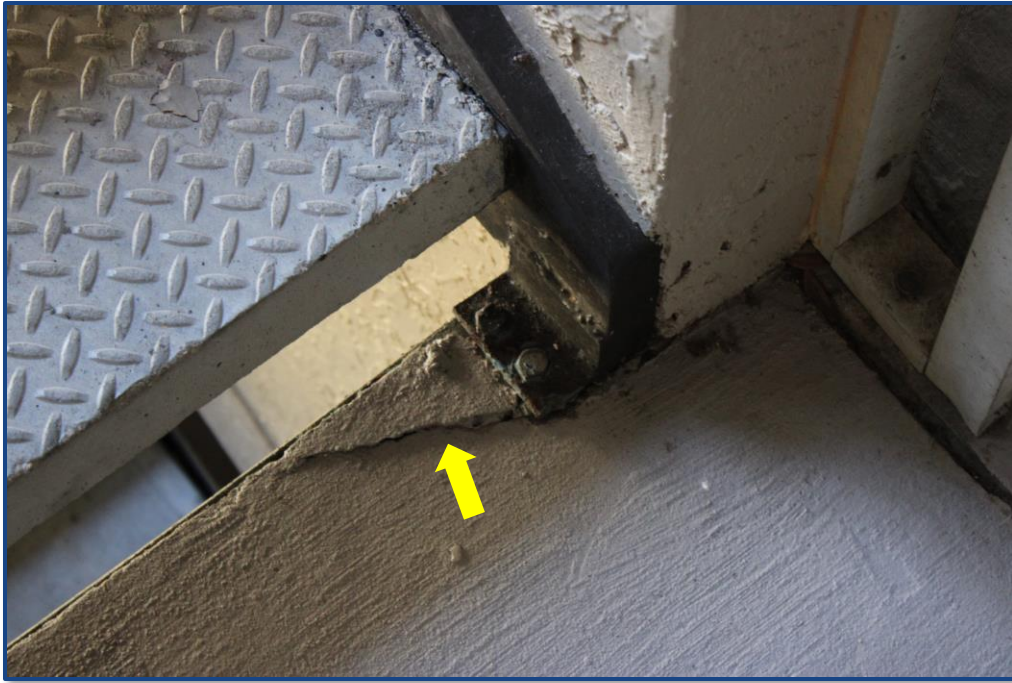
Photograph No. 15: Crack in the concrete slab located on the 2nd floor.

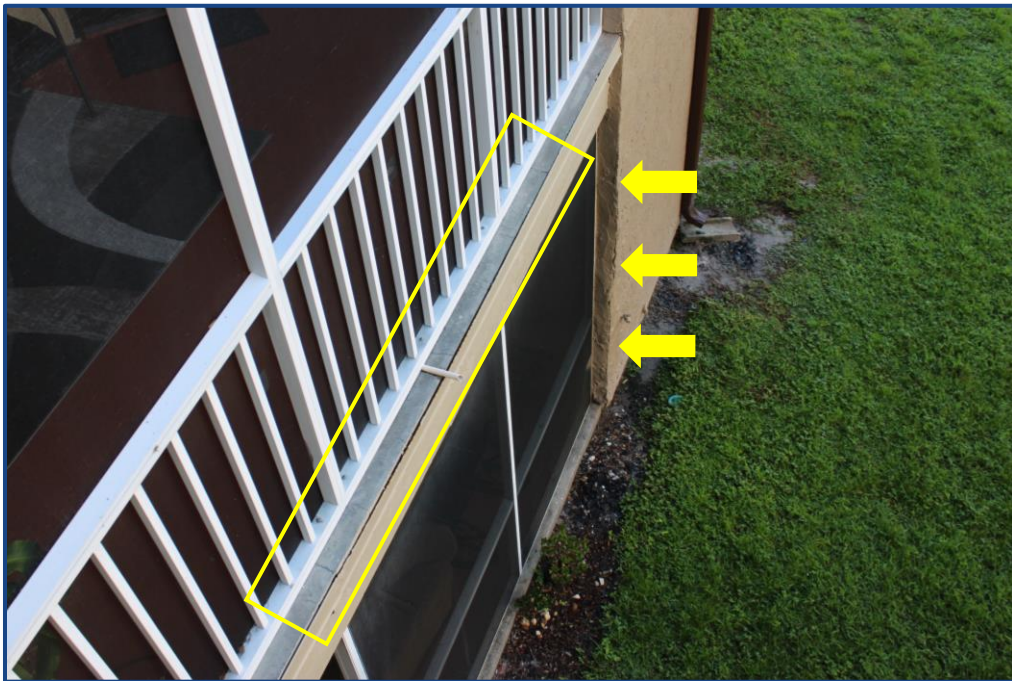
Photograph No. 16: Cracks in the exterior balcony slab on Unit 201 and cracks in the stucco finish at the 1st floor level.

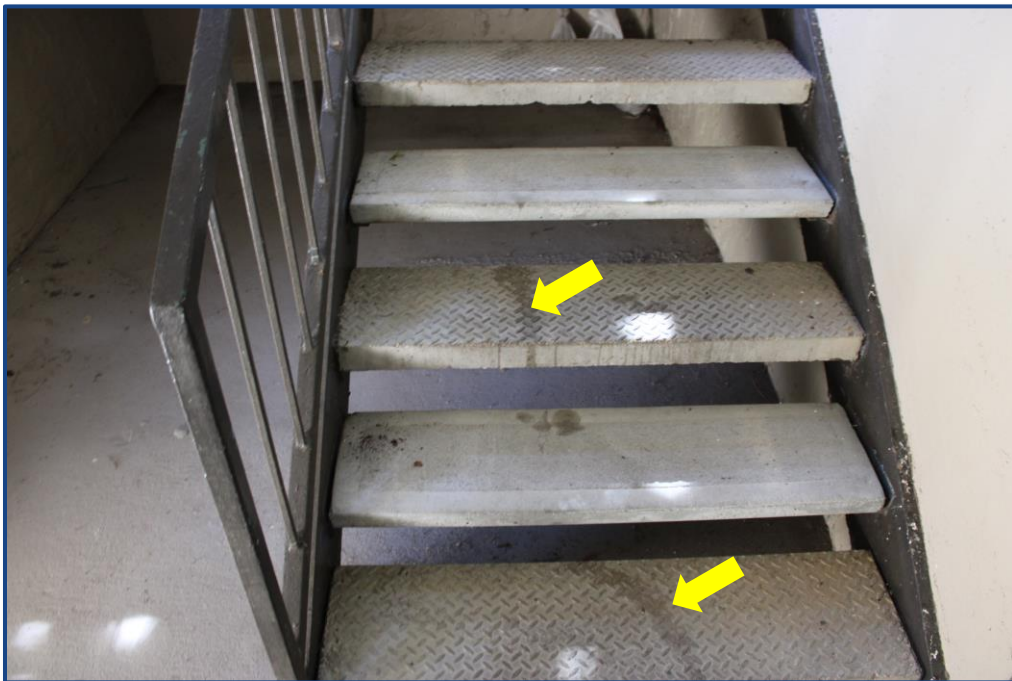
Photograph No. 18: Previously sealed cracks located in the concrete steps in the stairway.
