August 25, 2023

Janette Barcena
The Landing Condominium Association, Inc.
953 Salt Pond Place
Altamonte Springs, Florida 32714

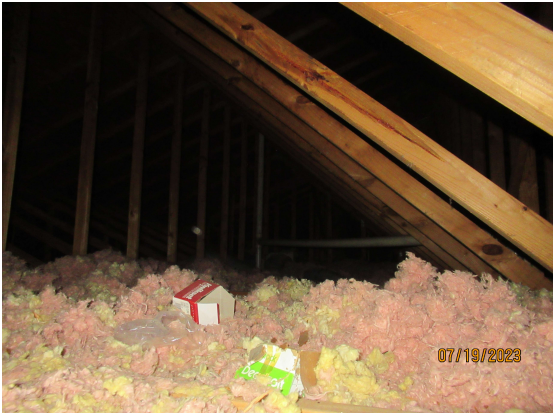
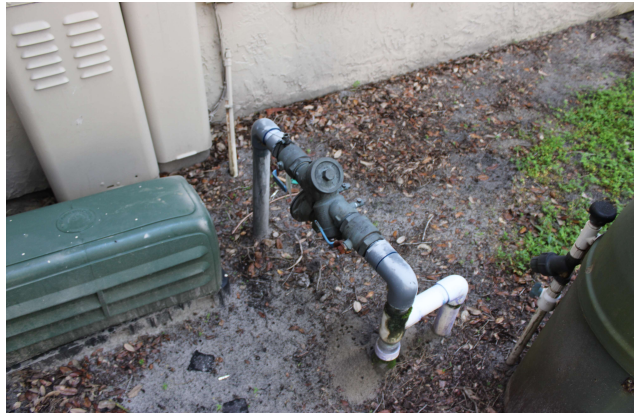
Plumbing - Total Current Cost	\$2,500
Assigned Reserves	\$2,500
Fully Funded Reserves	\$2,500

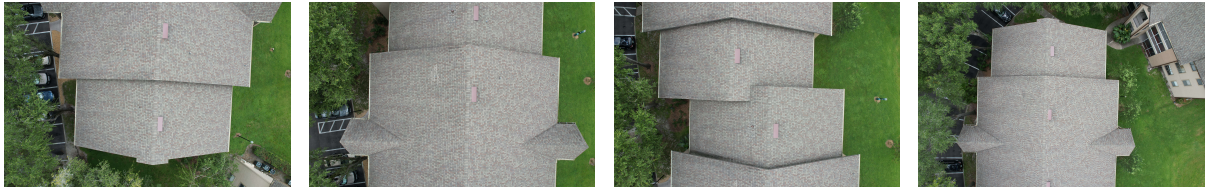
Roofing - Total Current Cost	\$50,300
Assigned Reserves	\$50,300
Fully Funded Reserves	\$12,575

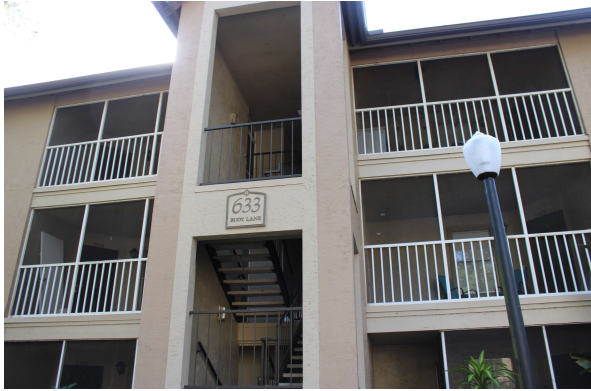
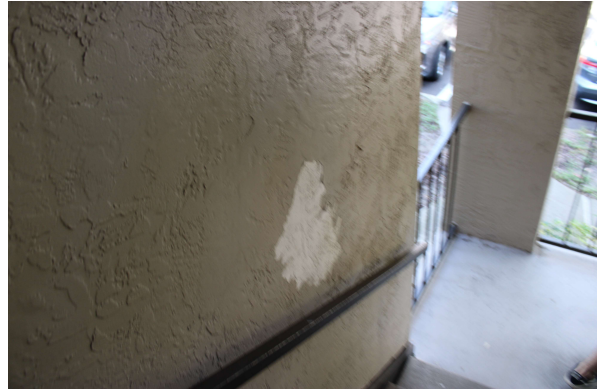
Stucco Repairs - 2030

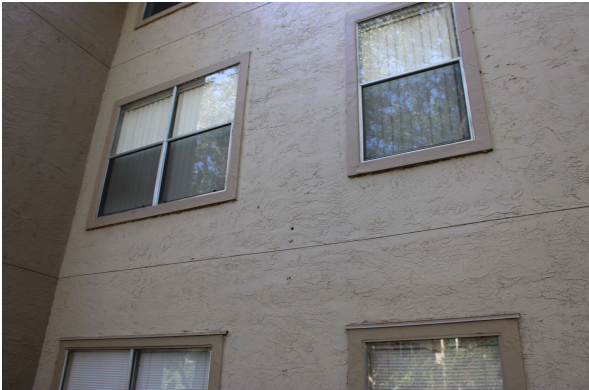
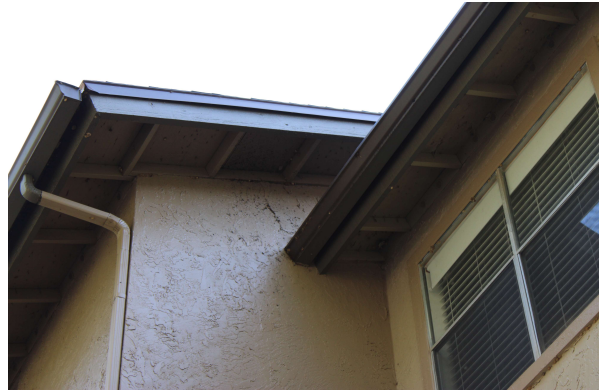
Painting - Total Current Cost	\$29,000
Assigned Reserves	\$29,000
Fully Funded Reserves	\$15,029

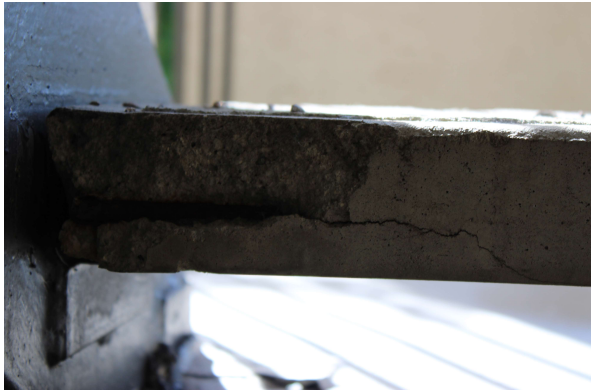
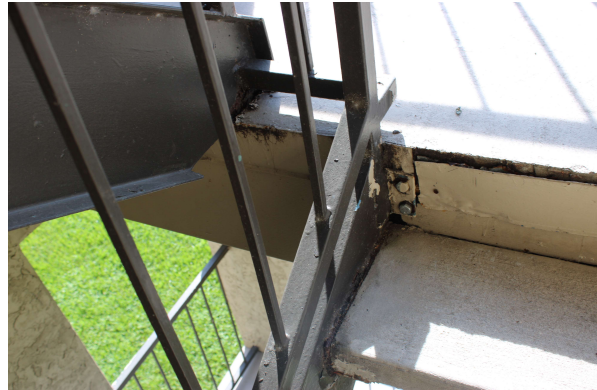
Concrete and Stairway Repair for year 2024 shall include repairs to cracked and spalled concrete and corrosion to the steel framing referenced within this report.

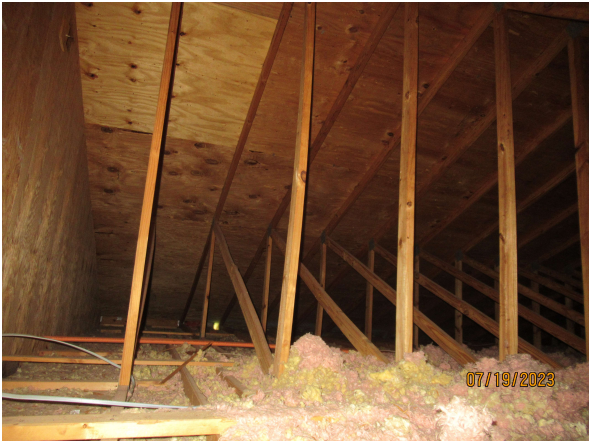
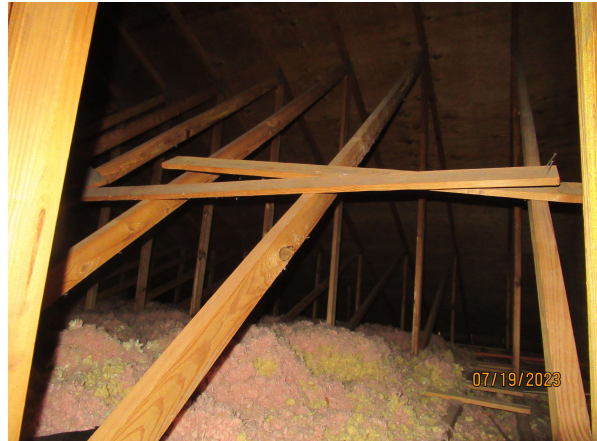
Structural Components - Total Current Cost	\$10,000
Assigned Reserves	\$10,000
Fully Funded Reserves	\$5,500

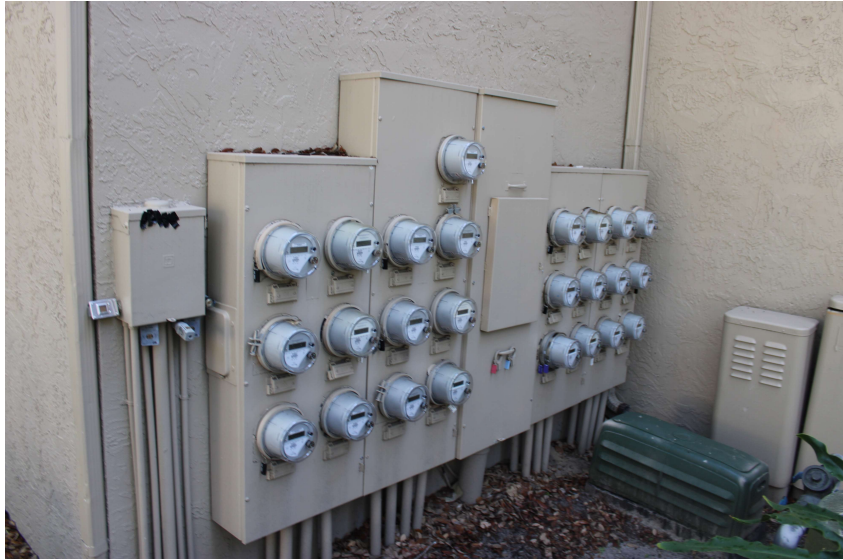
Electrical Systems - Total Current Cost	\$2,500
Assigned Reserves	\$6,691
Fully Funded Reserves	\$2,500

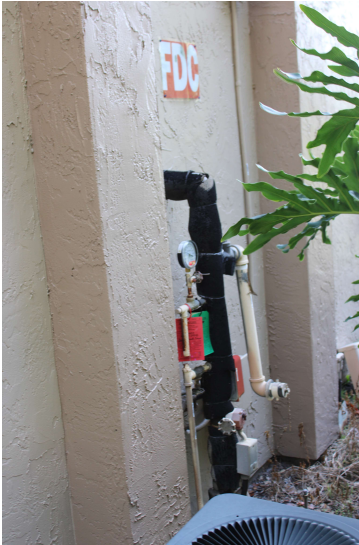
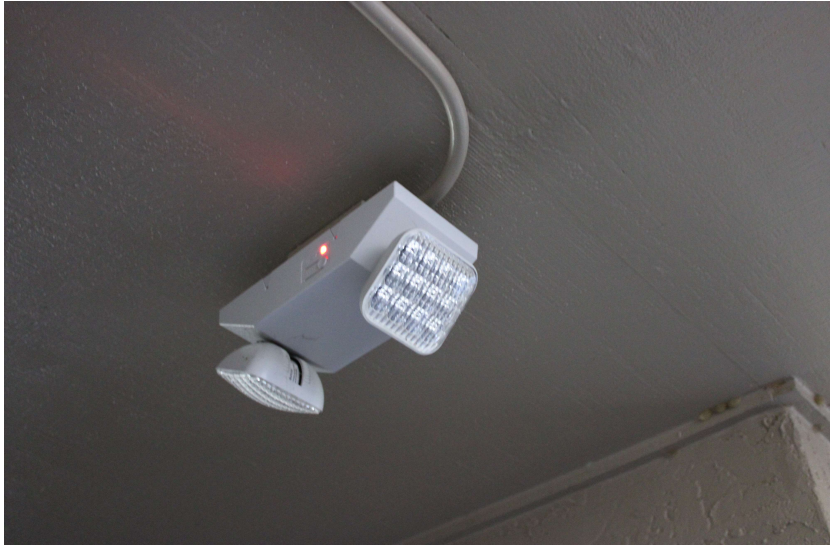
Fire Protective Systems - Total Current Cost	\$2,500
Assigned Reserves	\$2,500
Fully Funded Reserves	\$2,500

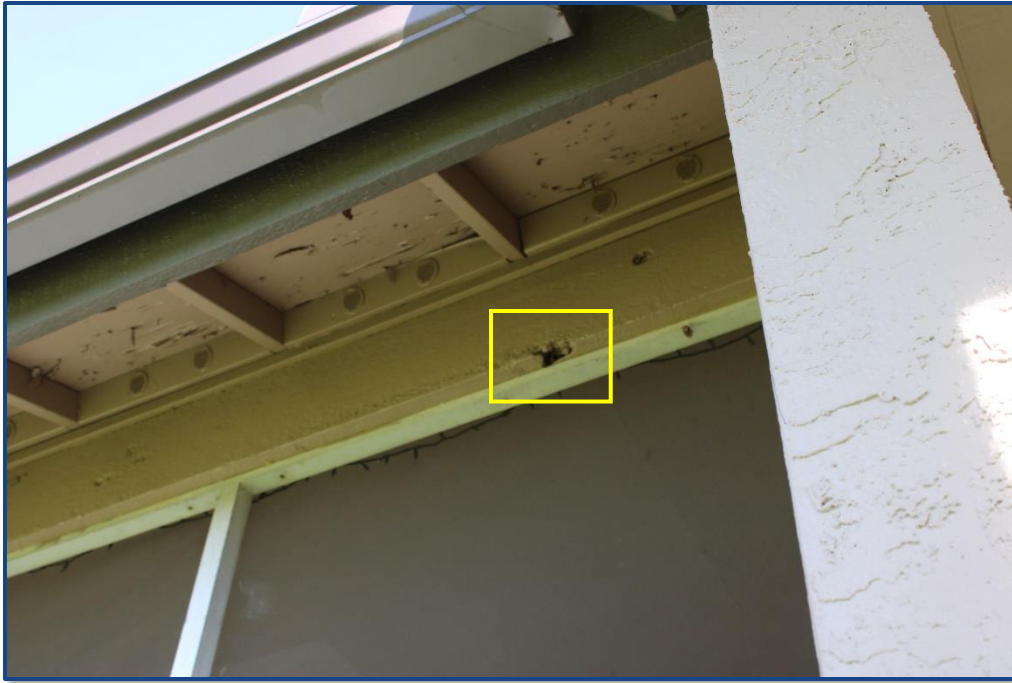
Photograph No. 11: Damage to the wood balcony framing located at the balcony on Unit 308.

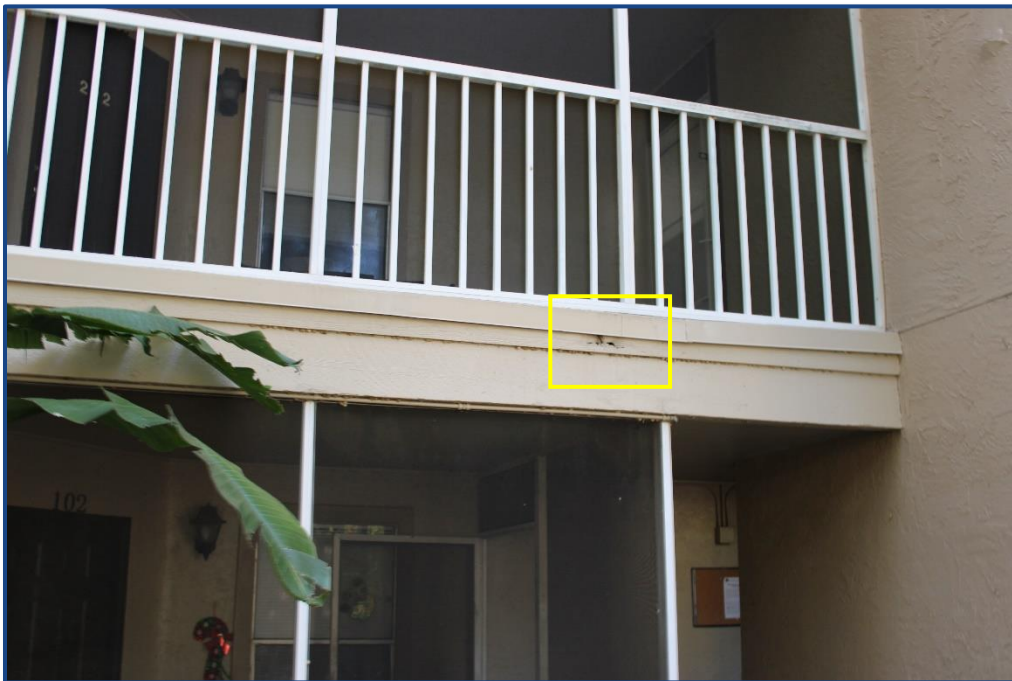
Photograph No. 12: Damage to the wood beam located at the balcony edge on Unit 202.

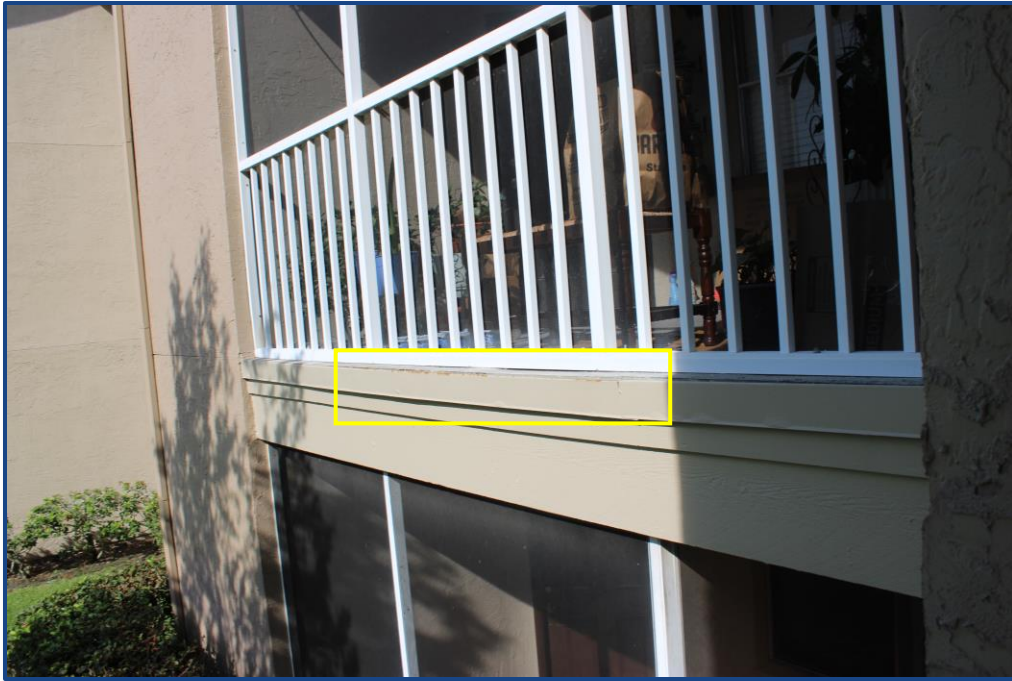
Photograph No. 13: Corrosion and separation of the metal flashing at the edge of the balcony slab on Unit 206.

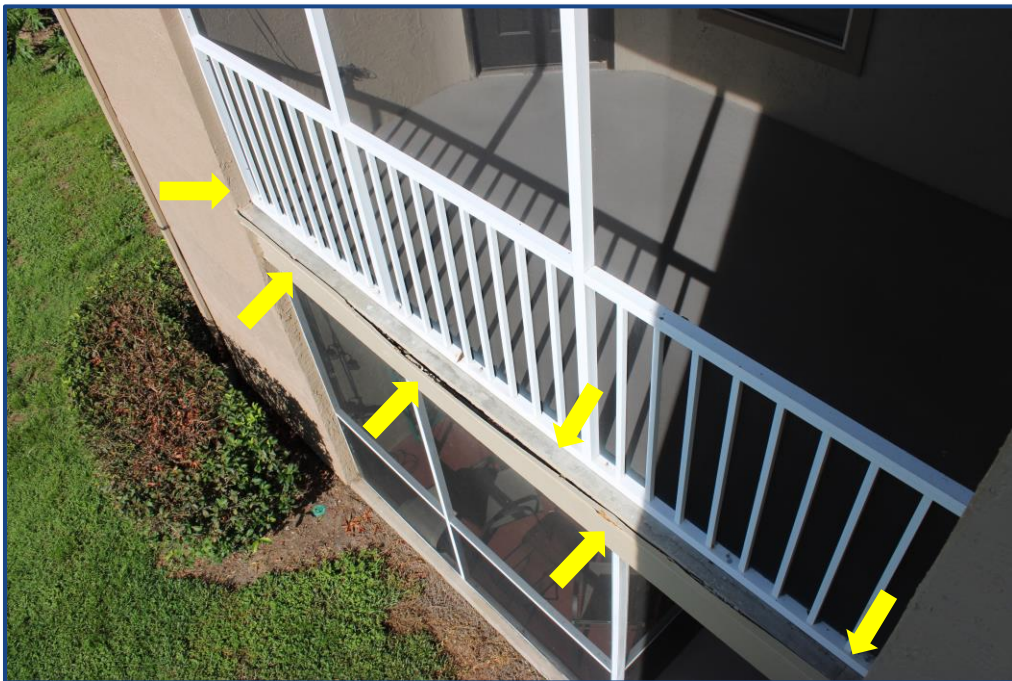
Photograph No. 14: Cracks in the stucco wall finish, cracks in the balcony slab, and damage to the metal flashing at the edge of the balcony slab on Unit 208.

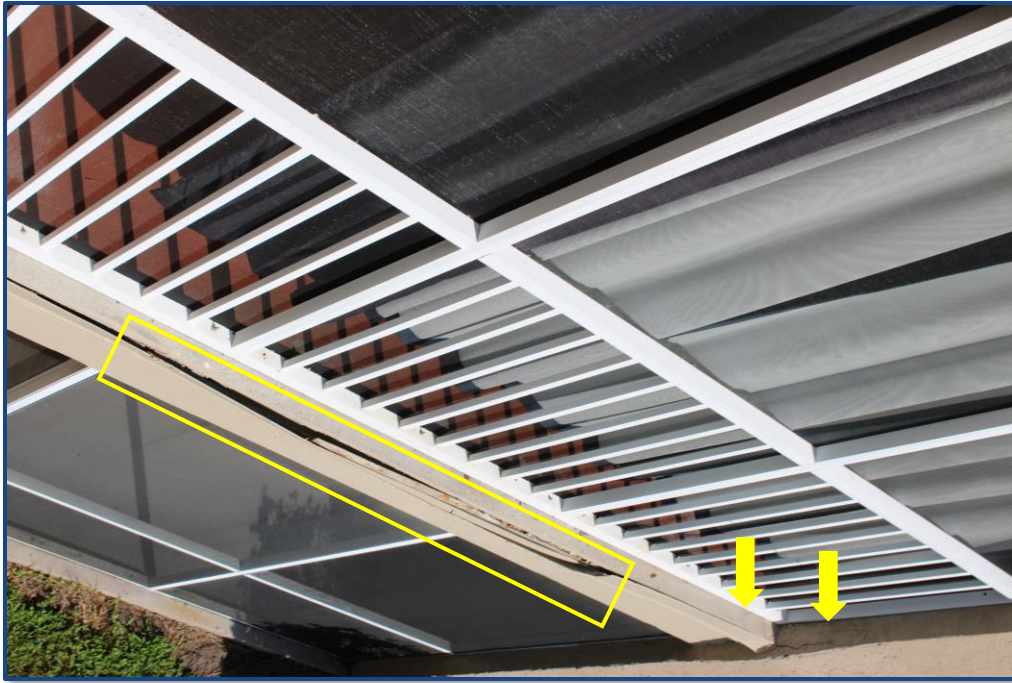
Photograph No. 15: Cracks in the stucco wall finish, crack in the balcony slab, and damage to the metal flashing at the edge of the balcony slab on Unit 207.

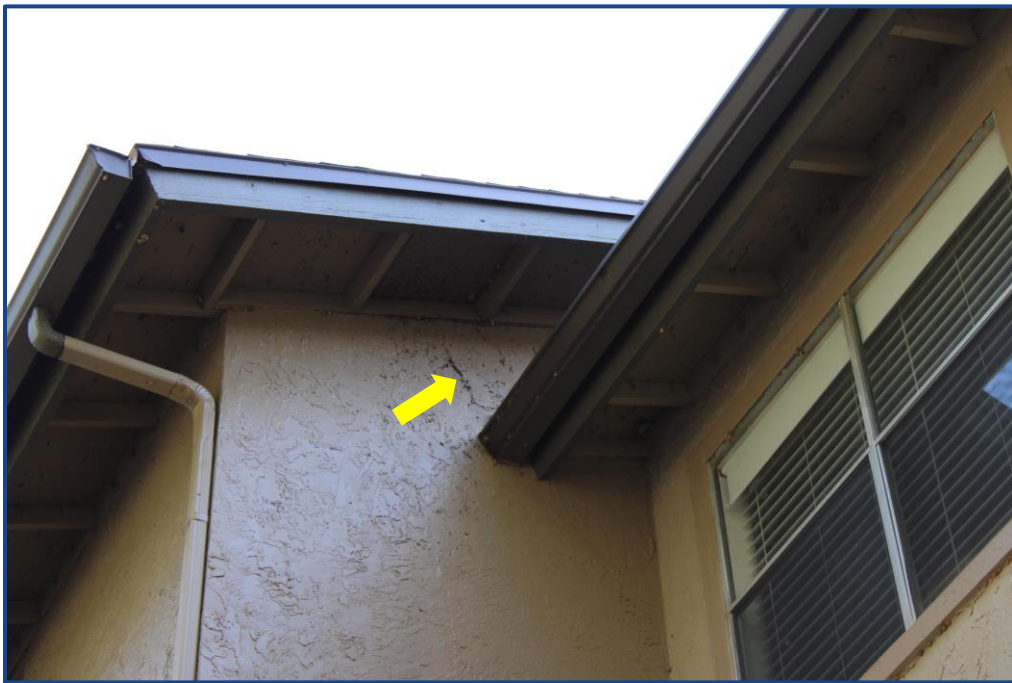
Photograph No. 16: Crack in the exterior wall stucco finish.

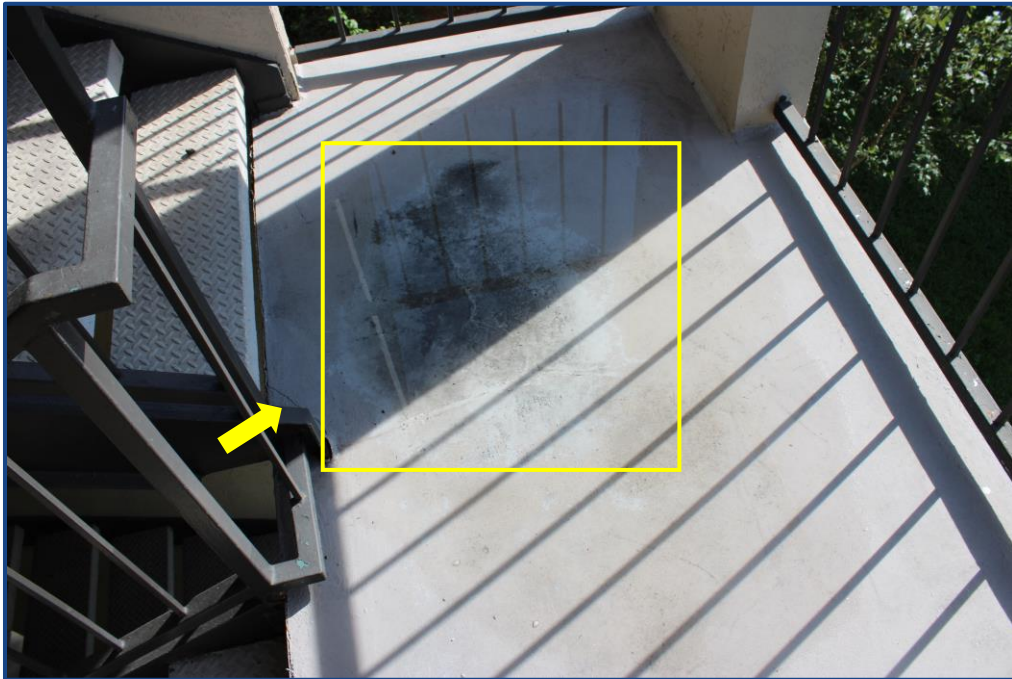
Photograph No. 18: Crack and ponding on the stairway landing in the northeast stairway.

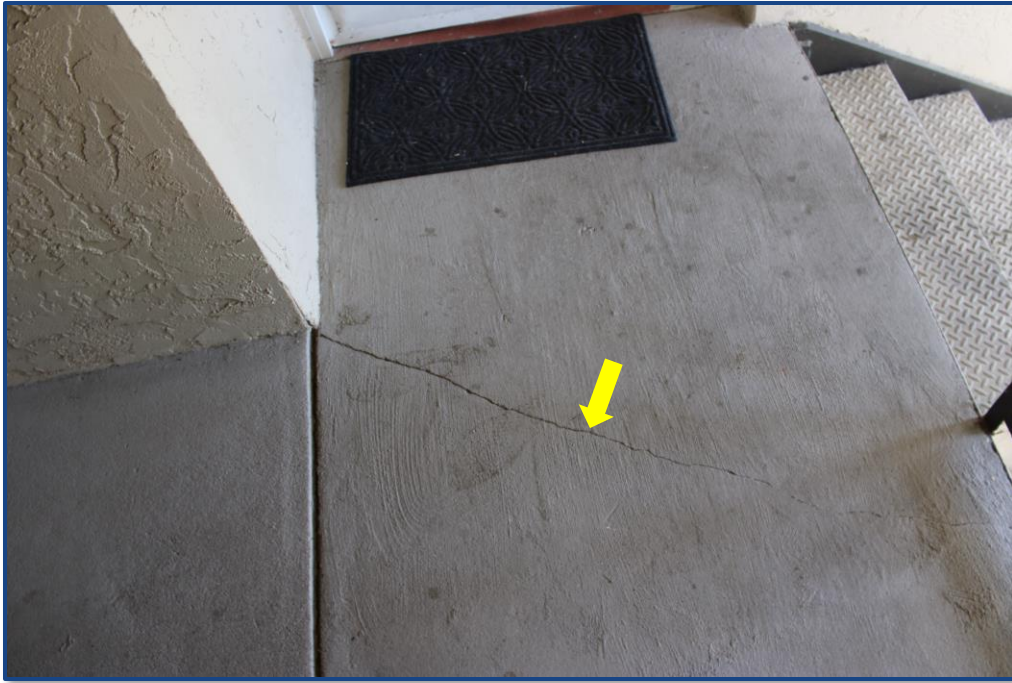
Photograph No. 19: Crack in the concrete slab located on the 3rd floor.

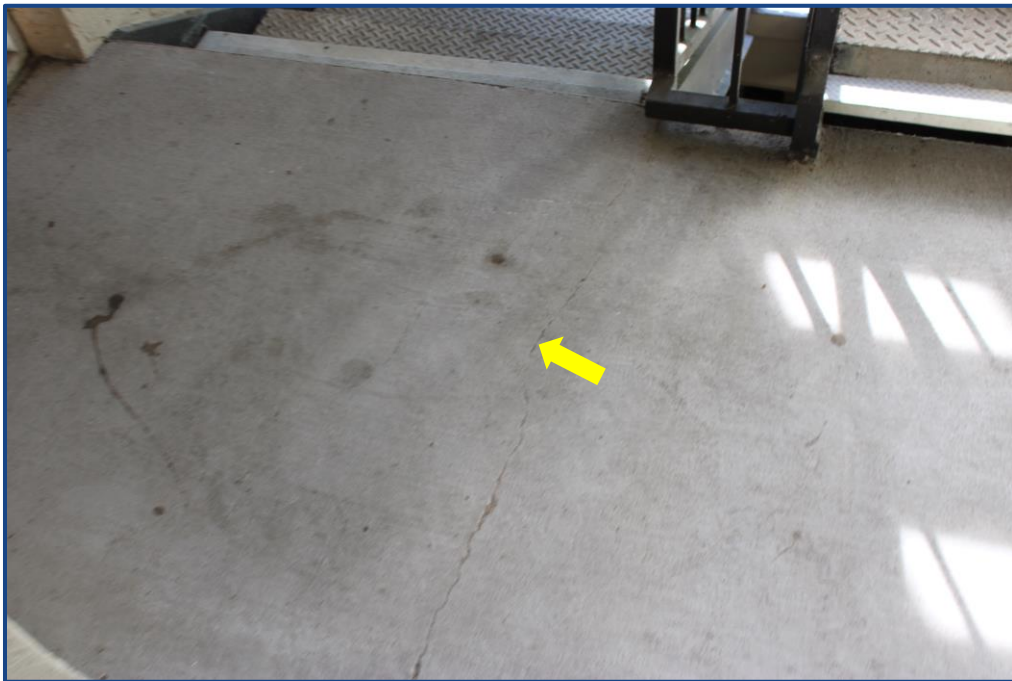
Photograph No. 20: Crack in the concrete slab located on the 2nd floor.

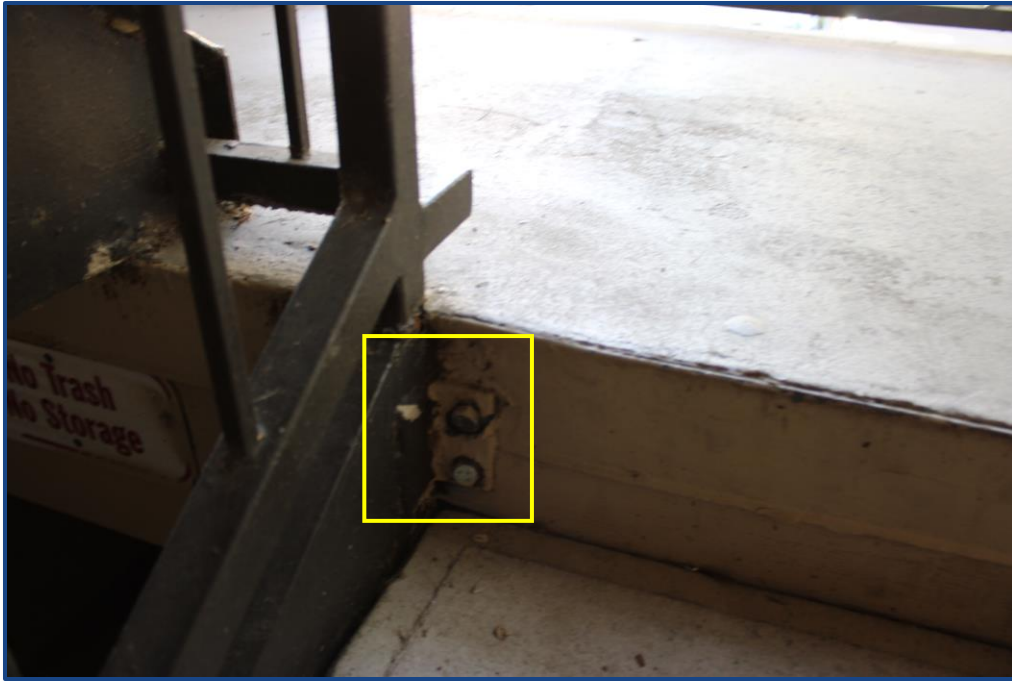
Photograph No. 21: Misaligned bolt and corrosion to the steel framing located in the stairway.

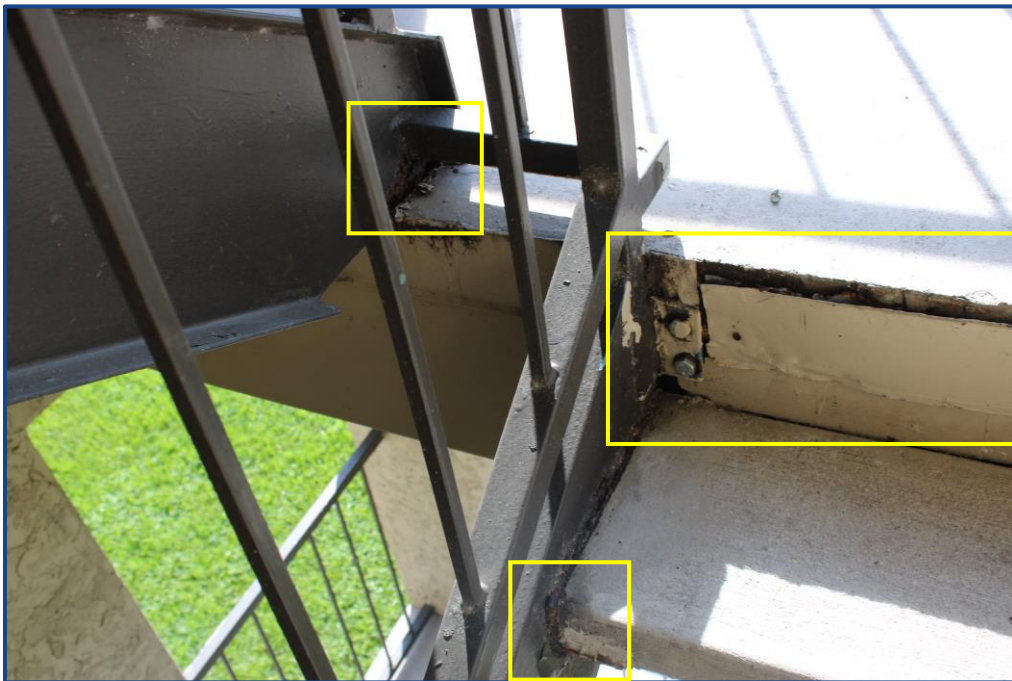
Photograph No. 22: Corrosion to the steel framing and metal flashing located in the southwest stairway.

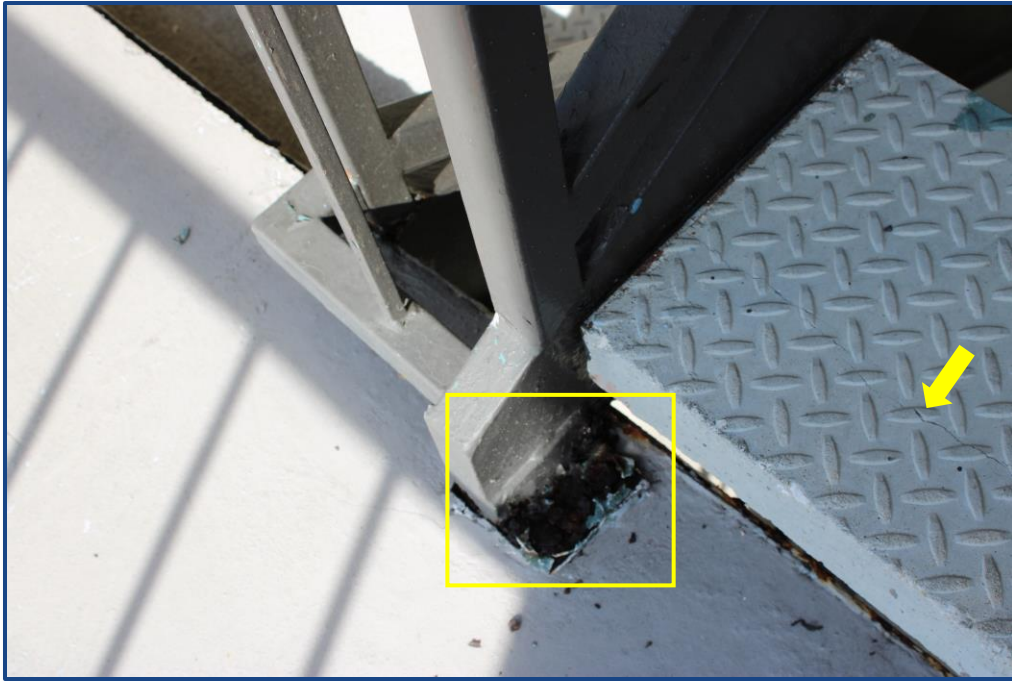
Photograph No. 23: Corrosion to the steel framing and crack in the concrete step located in the southeast stairway.

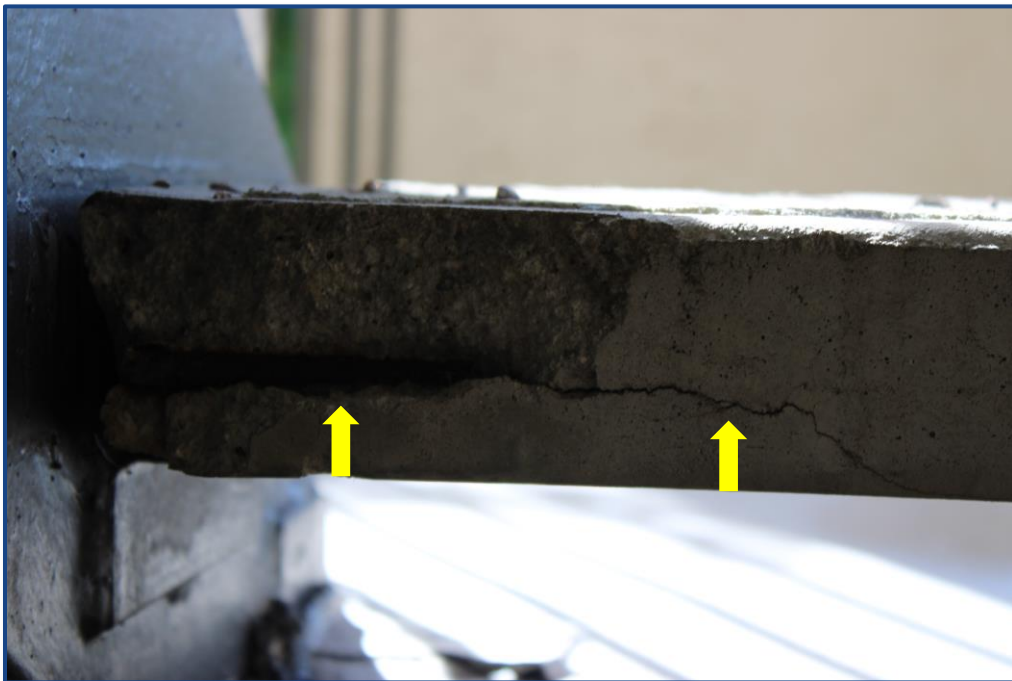
Photograph No. 24: Crack and spalling with exposed steel reinforcement in a concrete step located in the northeast stairway.
