August 25, 2023

Janette Barcena  
The Landing Condominium Association, Inc.  
953 Salt Pond Place  
Altamonte Springs, Florida 32714

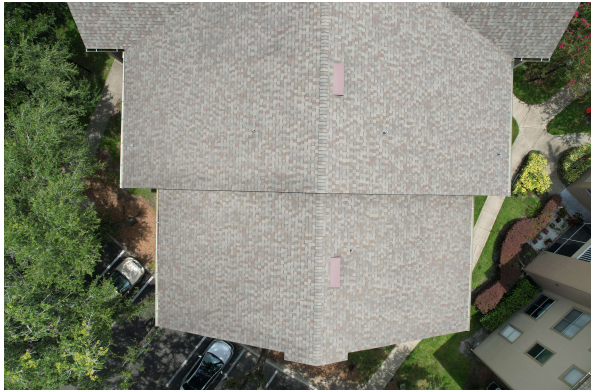
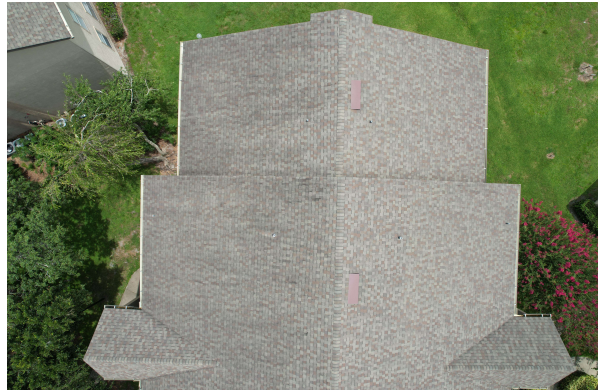
<b>Roofing - Total Current Cost</b>	<b>\$25,150</b>
<b>Assigned Reserves</b>	<b>\$25,150</b>
<b>Fully Funded Reserves</b>	<b>\$6,287</b>

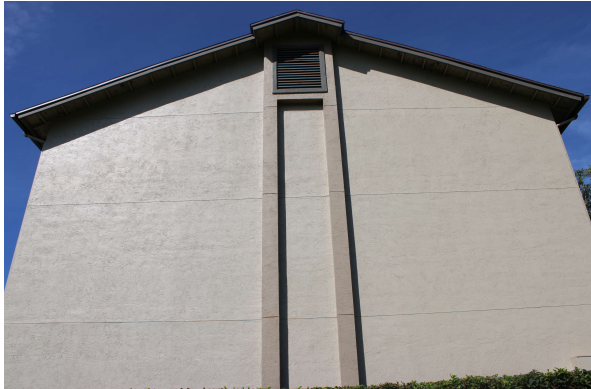
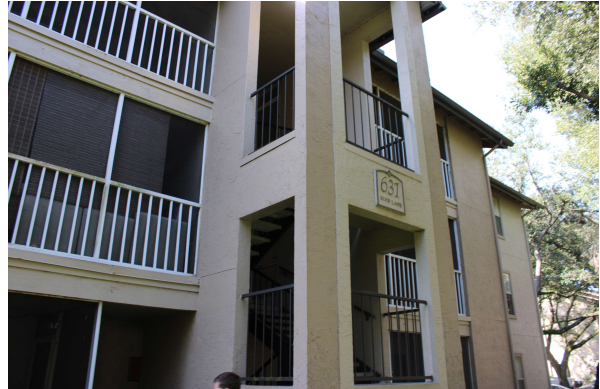
**Stucco Repairs - 2030**

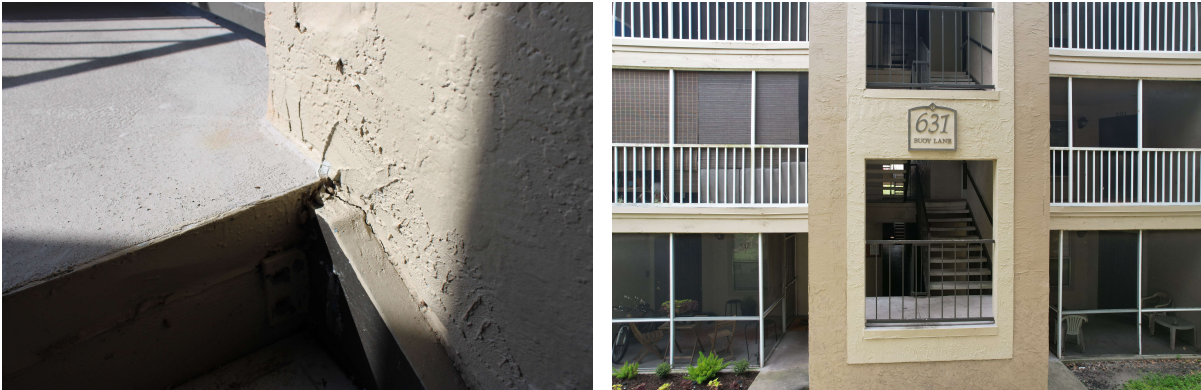
<b>Painting - Total Current Cost</b>	<b>\$17,000</b>
<b>Assigned Reserves</b>	<b>\$17,000</b>
<b>Fully Funded Reserves</b>	<b>\$8,514</b>

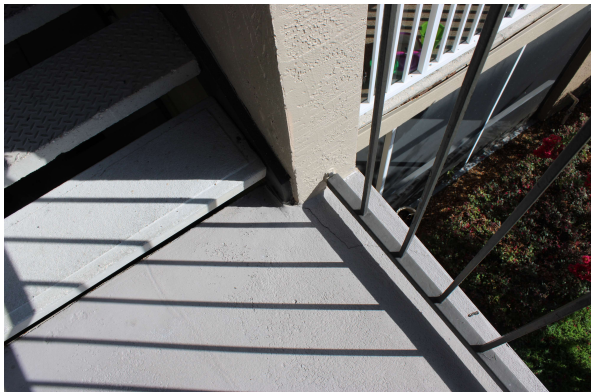
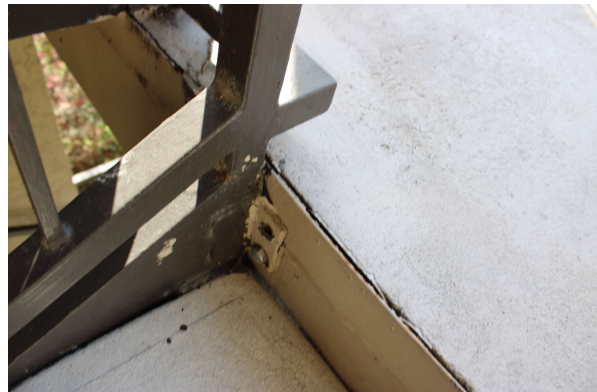
Concrete and Stairway Repair for year 2024 shall include repairs to cracked and spalled concrete, corrosion to the steel framing, and missing bolts referenced within this report.

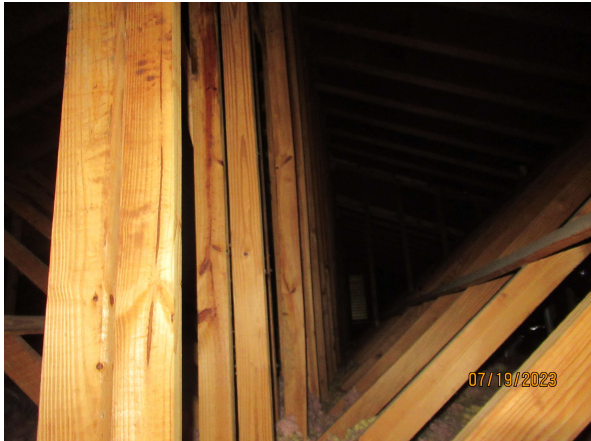
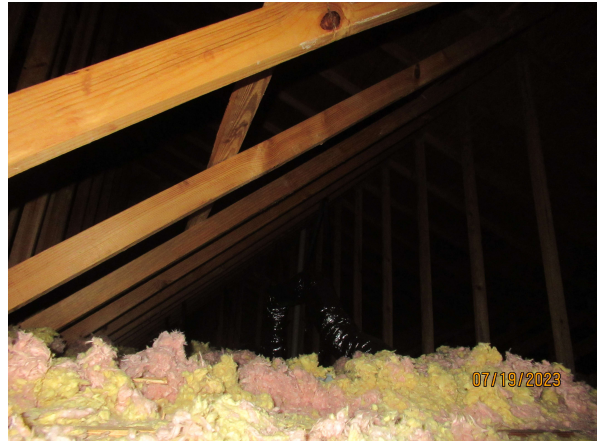
<b>Structural Components - Total Current Cost</b>	<b>\$6,000</b>
<b>Assigned Reserves</b>	<b>\$9,000</b>
<b>Fully Funded Reserves</b>	<b>\$3,300</b>

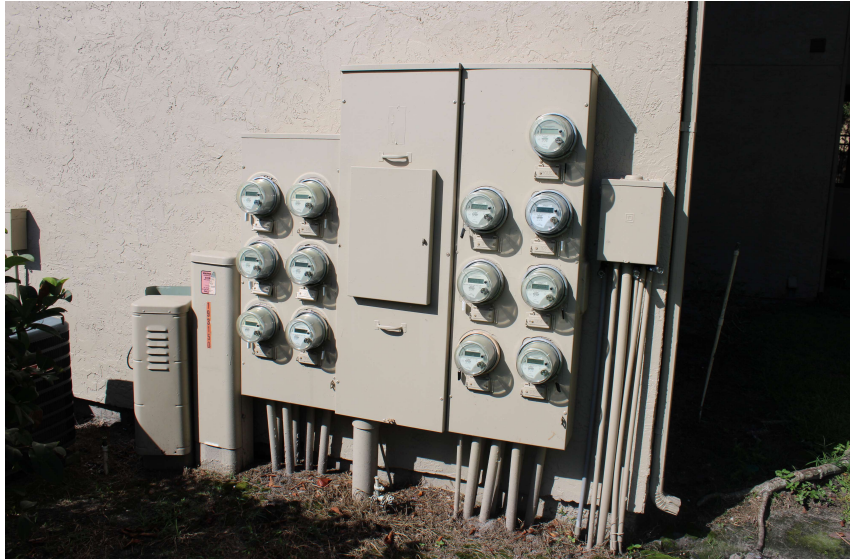
<b>Electrical Systems - Total Current Cost</b>	<b>\$2,500</b>
<b>Assigned Reserves</b>	<b>\$5,000</b>
<b>Fully Funded Reserves</b>	<b>\$2,500</b>

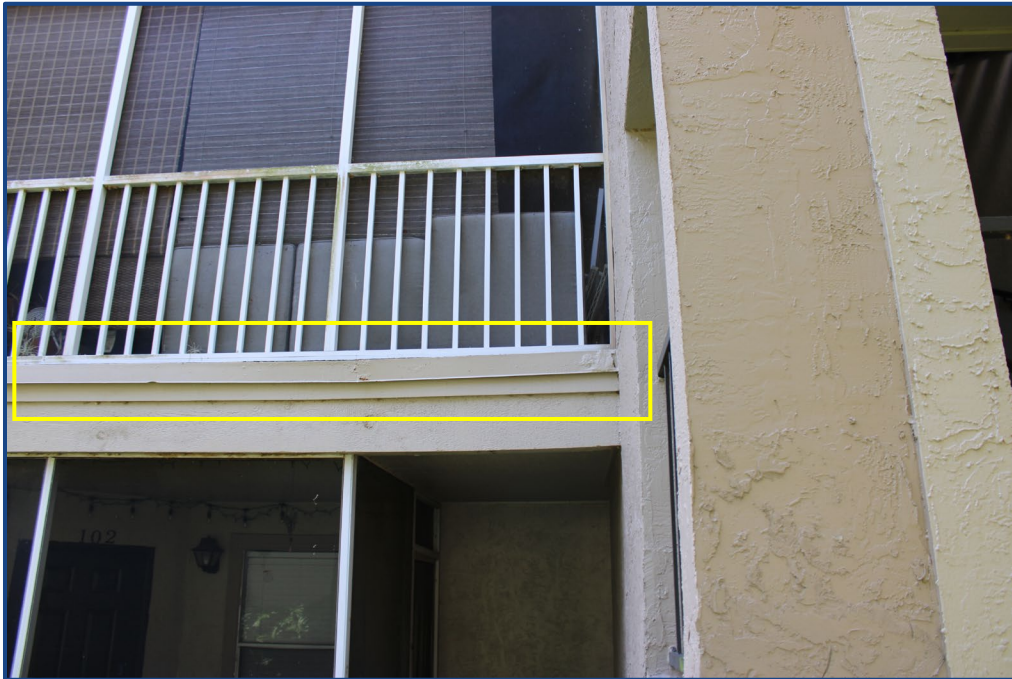
Photograph No. 8: Corrosion and separation of the metal flashing at the edge of the balcony slab on Unit 201.

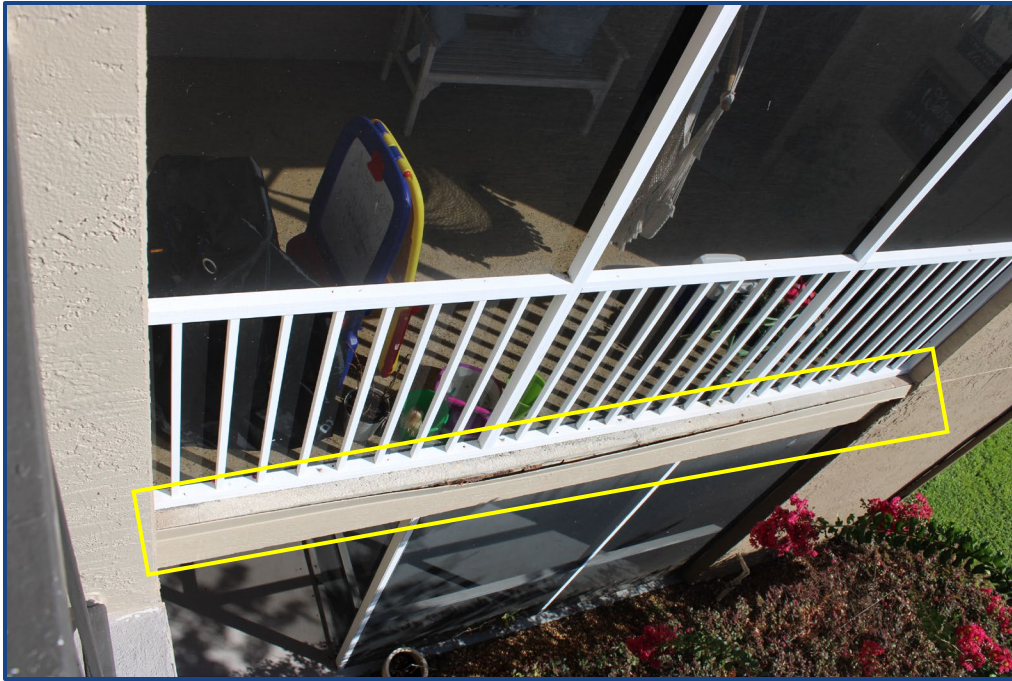
Photograph No. 9: Cracks in the balcony slab and corrosion and separation of the metal flashing at the edge of the balcony slab on Unit 203.

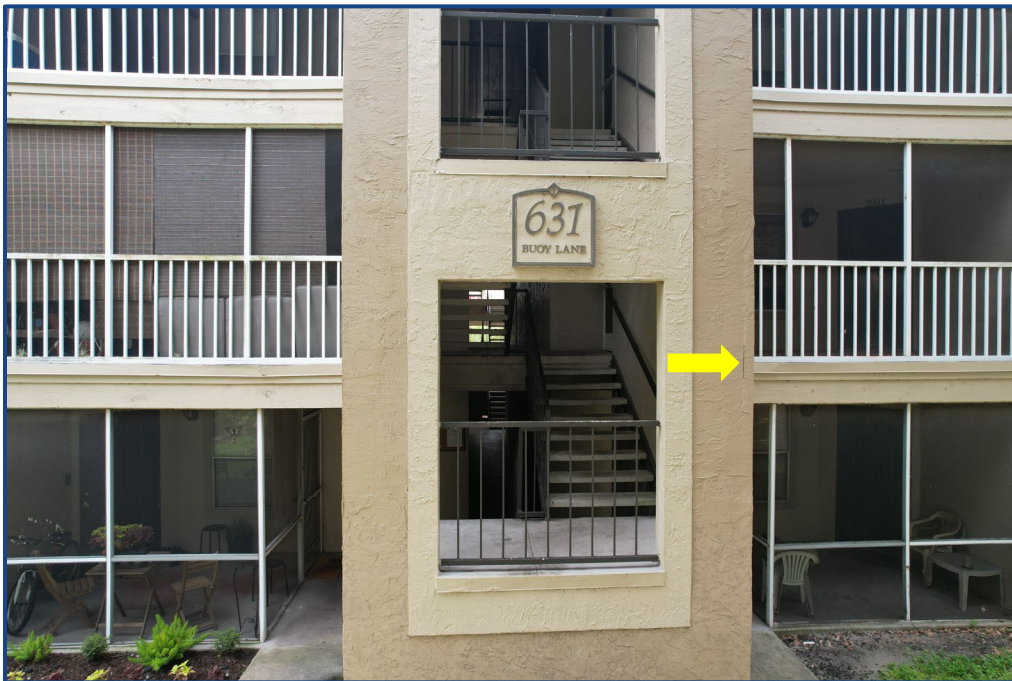
Photograph No. 10: Crack in the exterior wall stucco finish.

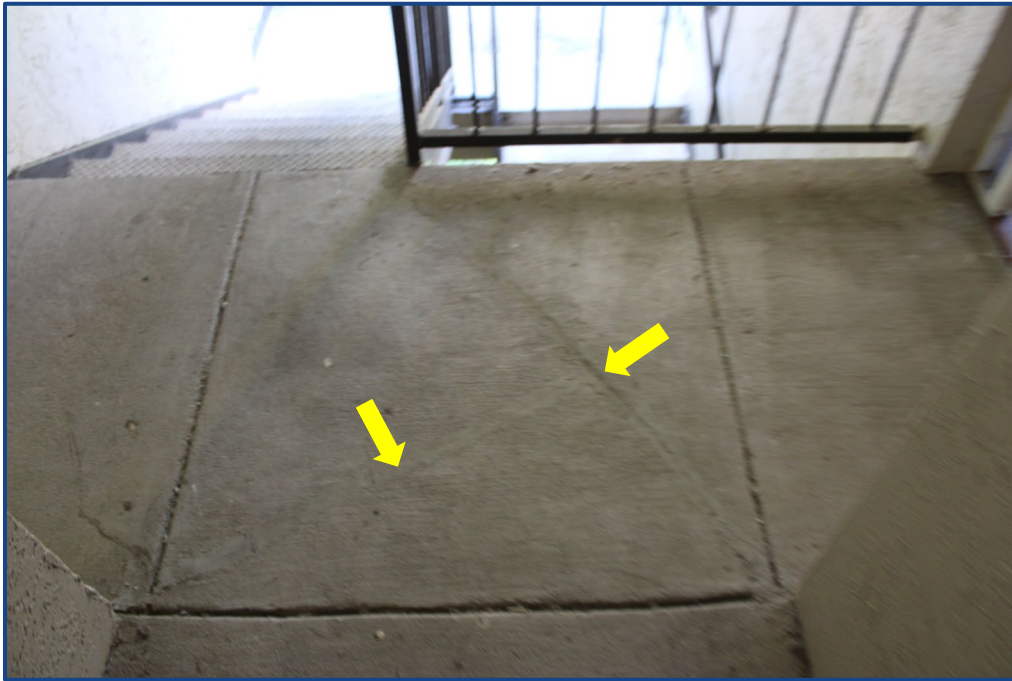
Photograph No. 12: Previously sealed cracks in the concrete slab located on the 3rd floor.

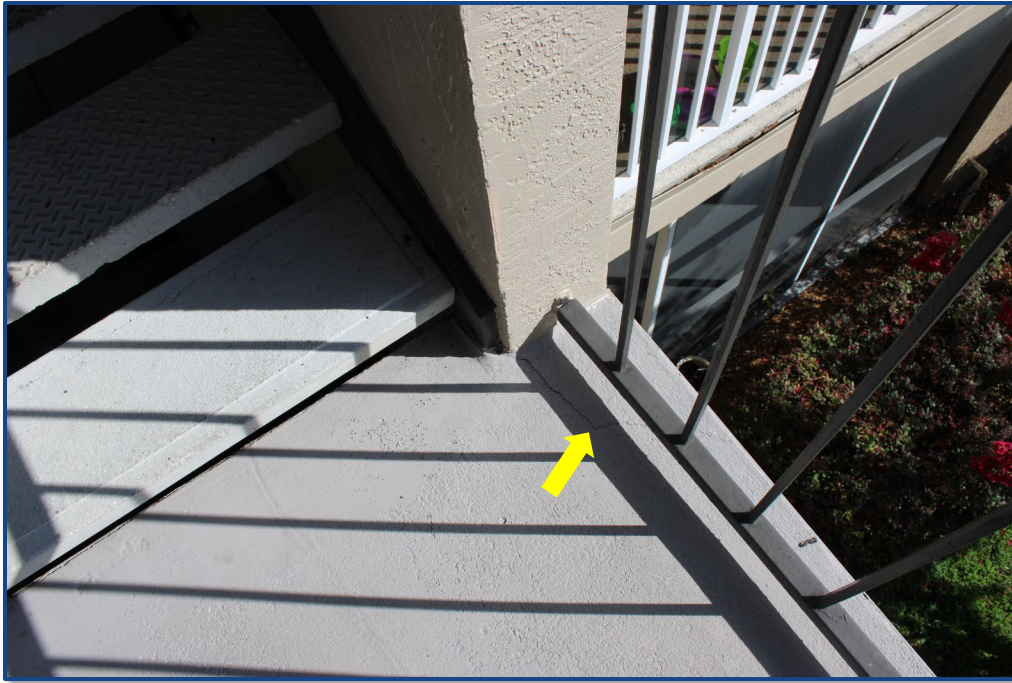
Photograph No. 13: Crack in the stairway landing in the southeast stairway.

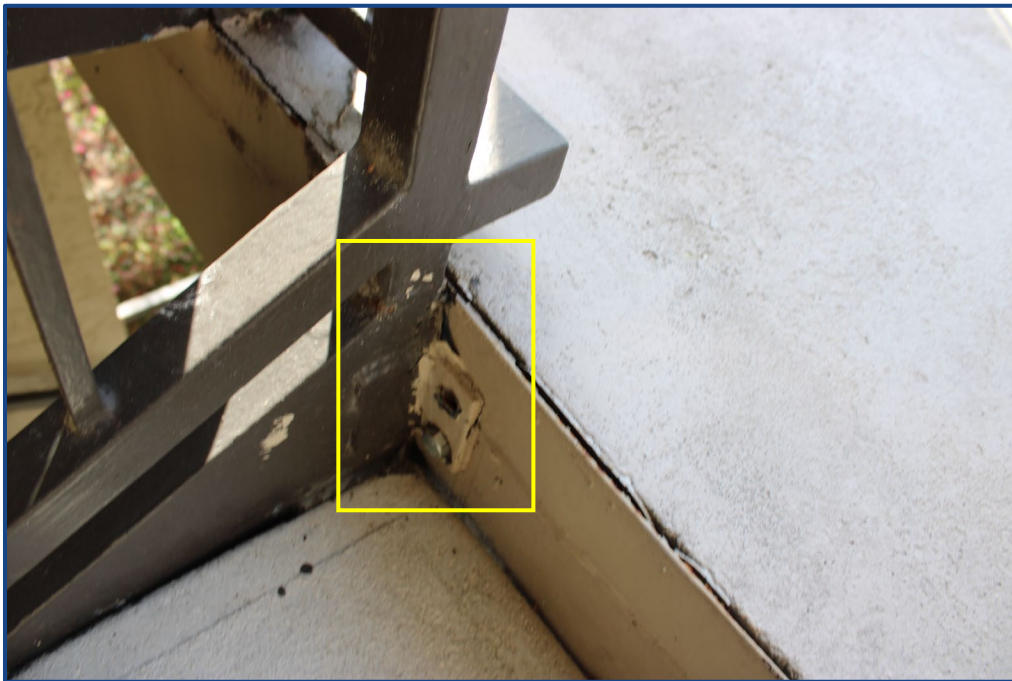
Photograph No. 14: Missing bolt and corrosion to the steel framing located in the southeast stairway.

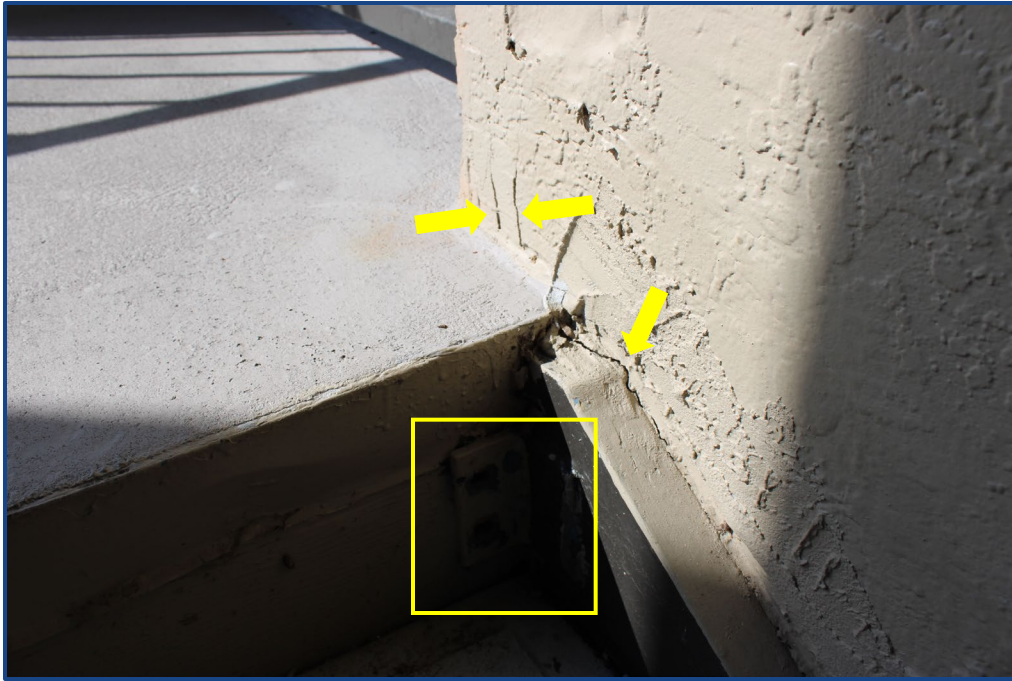
Photograph No. 15: Missing fastener, cracks in the stucco and corrosion to the steel framing located in the southeast stairway.

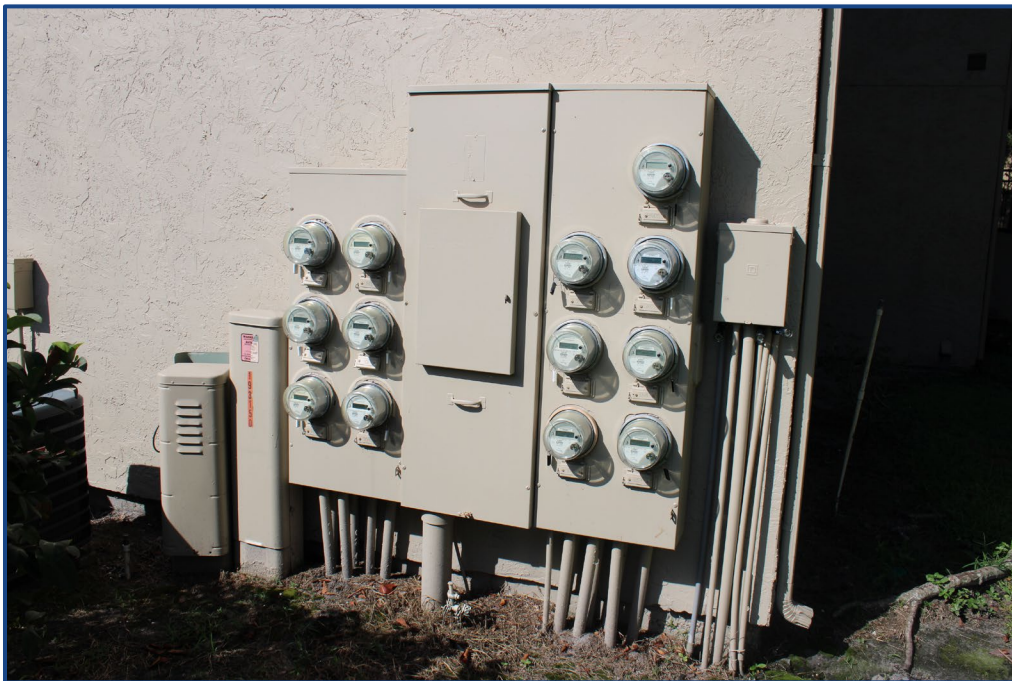
Photograph No. 16: Electrical meters.
