August 25, 2023

Janette Barcena
The Landing Condominium Association, Inc.
953 Salt Pond Place
Altamonte Springs, Florida 32714

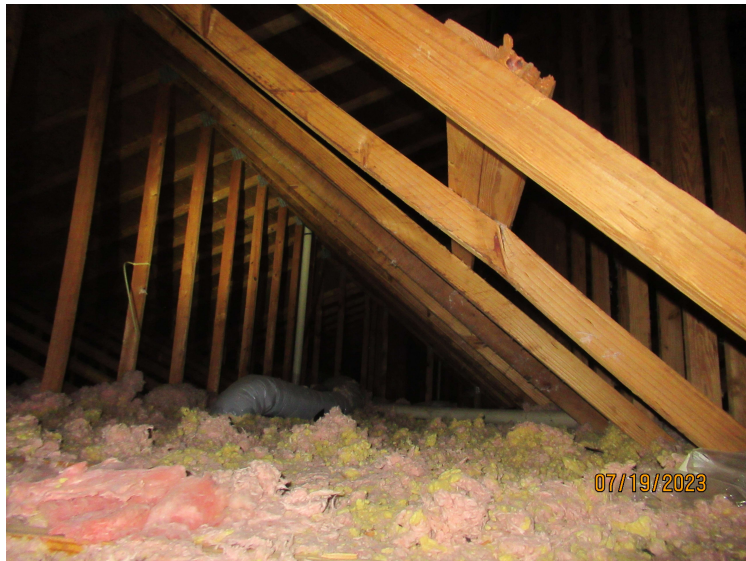
Plumbing - Total Current Cost	\$2,500
Assigned Reserves	\$5,000
Fully Funded Reserves	\$2,500

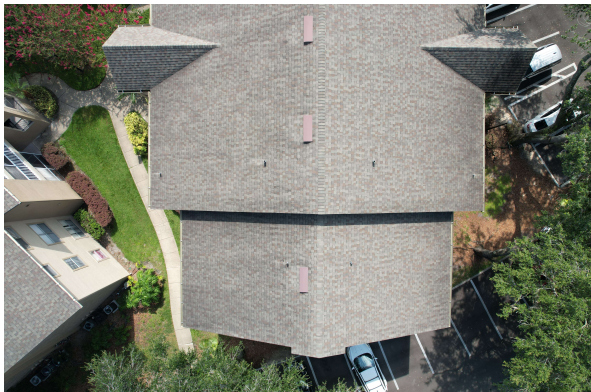
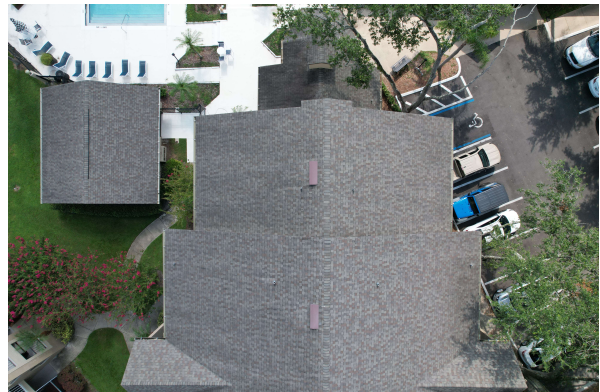
Roofing - Total Current Cost	\$25,150
Assigned Reserves	\$25,150
Fully Funded Reserves	\$6,287

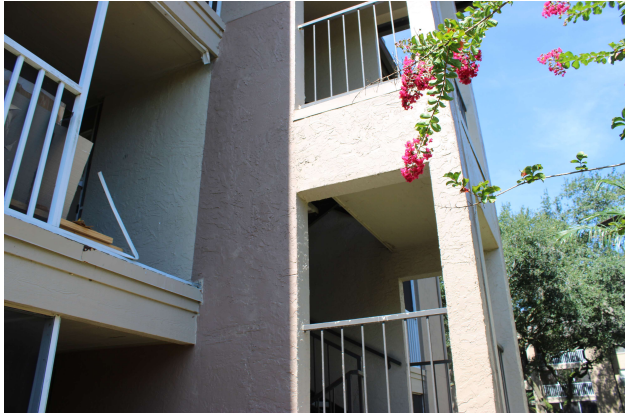
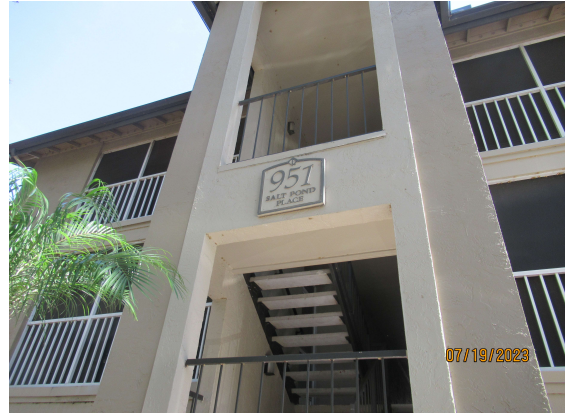
Stucco Repairs - 2030

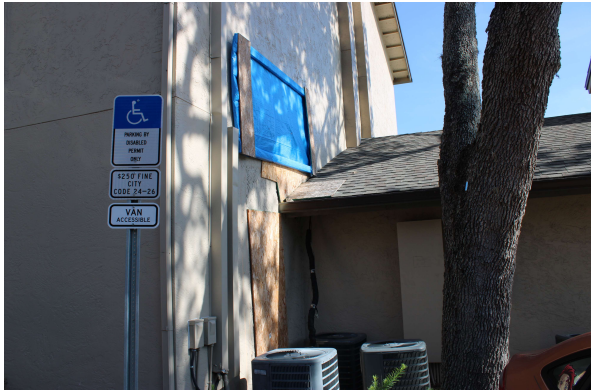
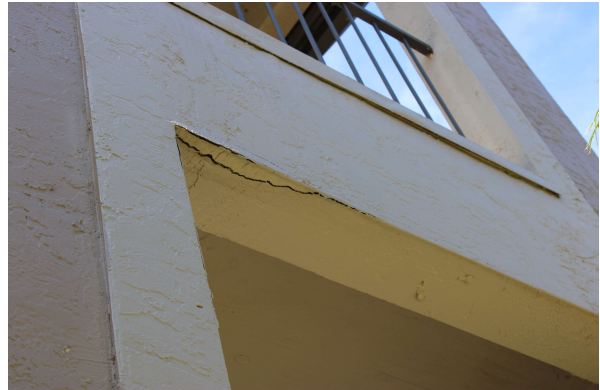
Painting - Total Current Cost	\$17,000
Assigned Reserves	\$17,000
Fully Funded Reserves	\$8,514

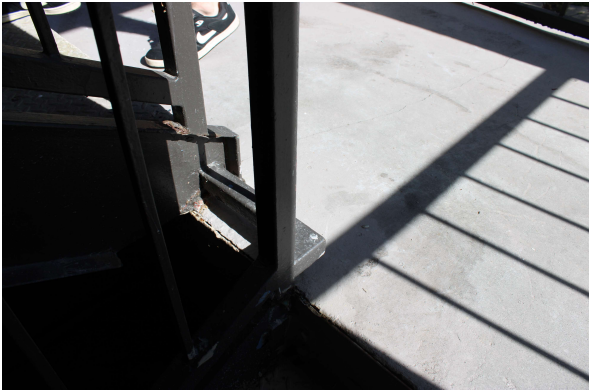
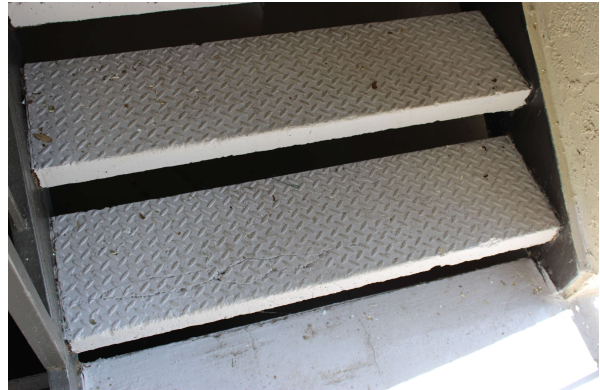
Concrete and Stairway Repair for year 2024 shall include repairs to cracked and spalled concrete and corrosion to the steel framing referenced within this report.

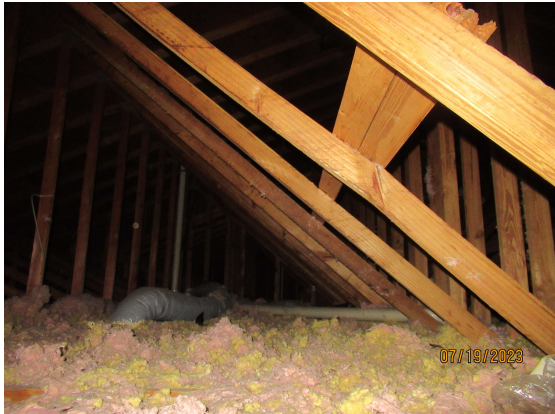
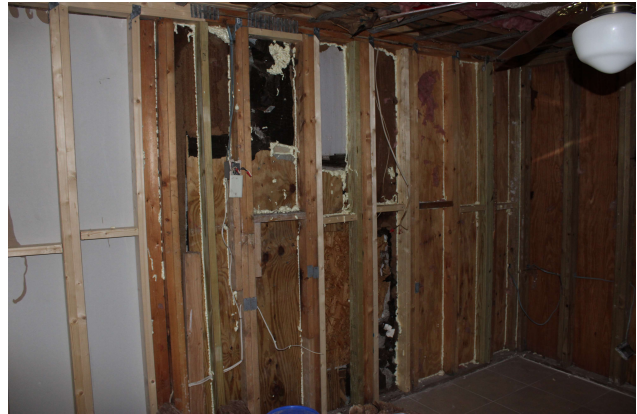
Wood Framing Repair for year 2024 shall include repairs to the broken roof truss referenced within this report but does not include the ongoing fire damage repairs.

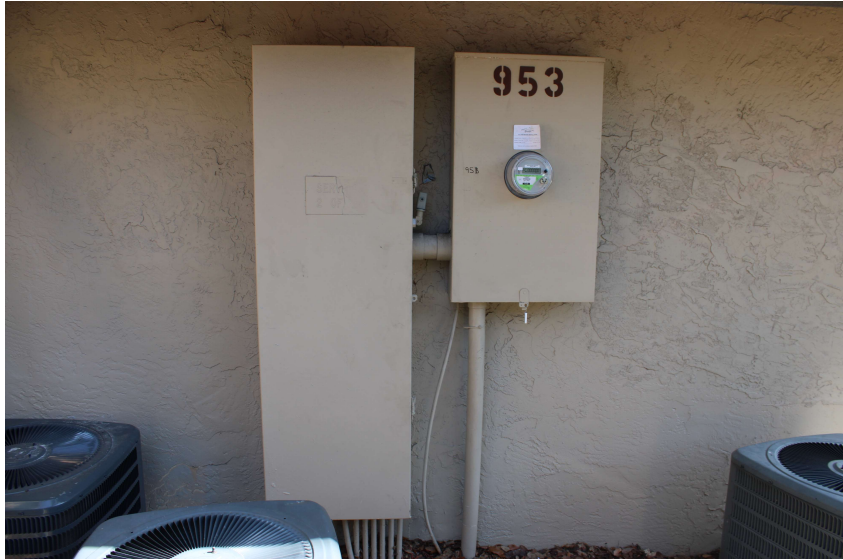
Electrical Systems - Total Current Cost	\$2,500
Assigned Reserves	\$5,000
Fully Funded Reserves	\$2,500

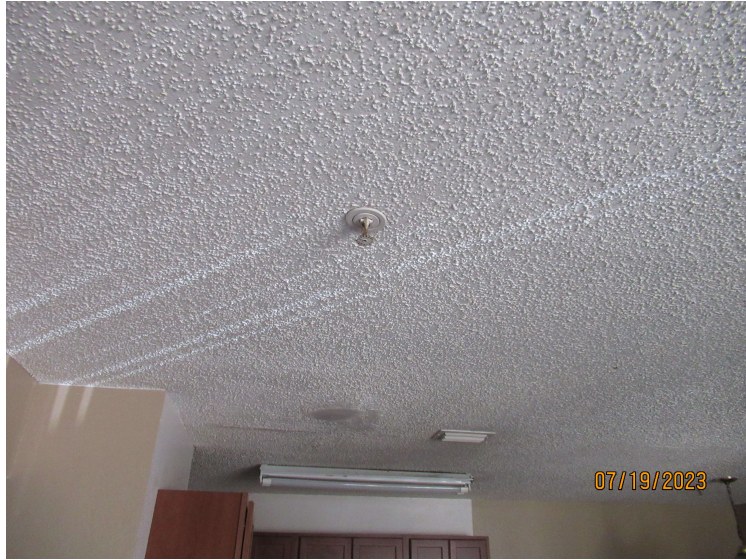
Fire Protective Systems - Total Current Cost	\$2,500
Assigned Reserves	\$5,000
Fully Funded Reserves	\$2,500

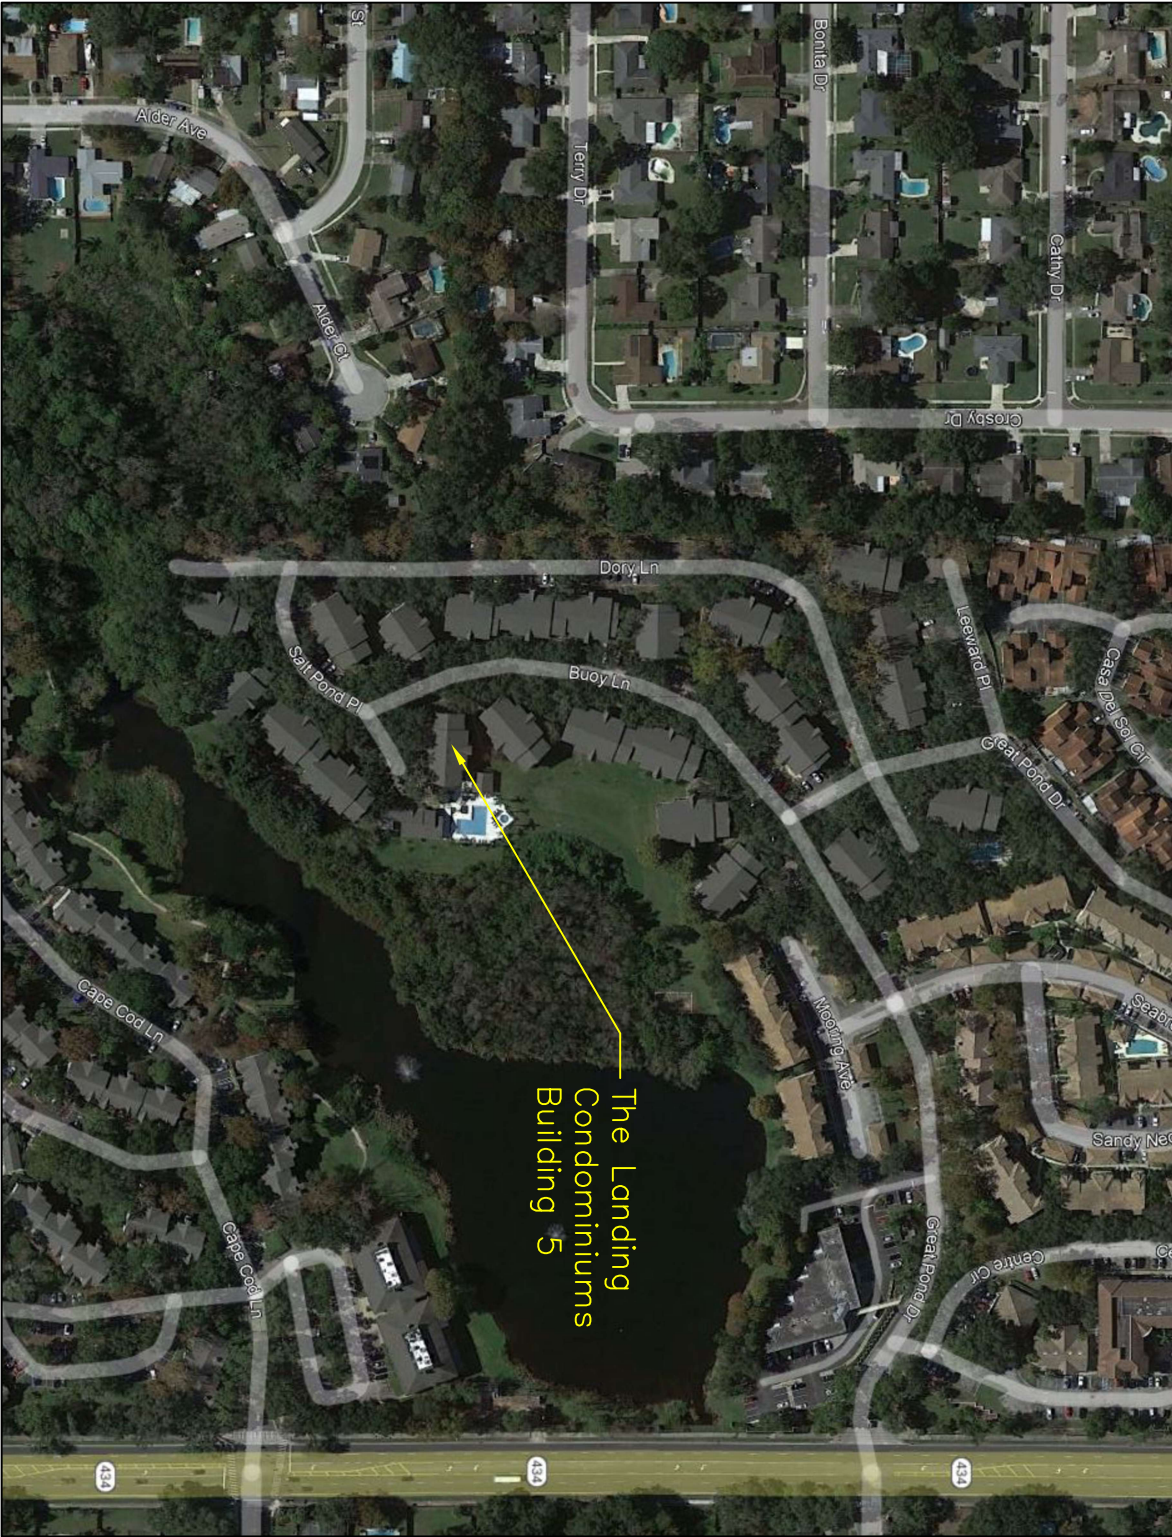
The Landing
Condominiums
Building 5

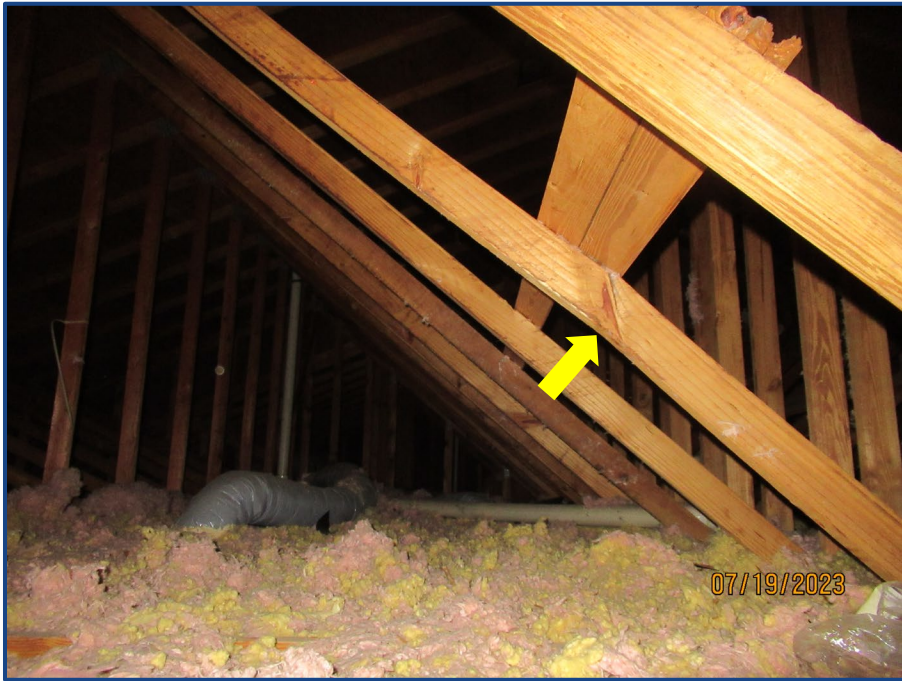
Photograph No. 8: View of a broken prefabricated wooden roof truss member.

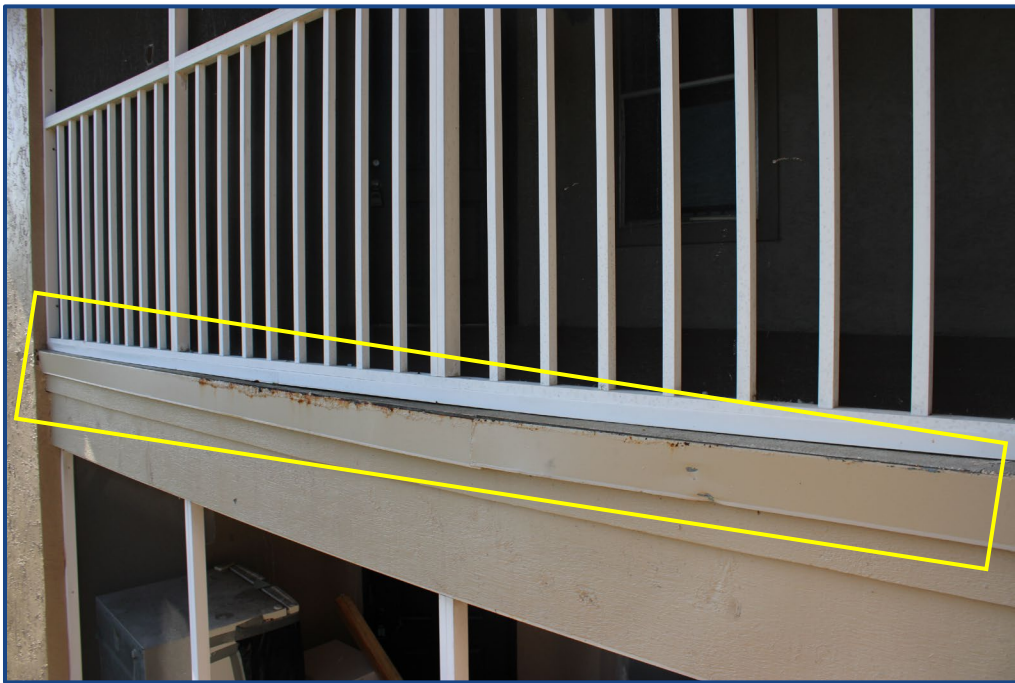
Photograph No. 10: Corrosion and separation of the metal flashing at the edge of the balcony slab on Unit 304.

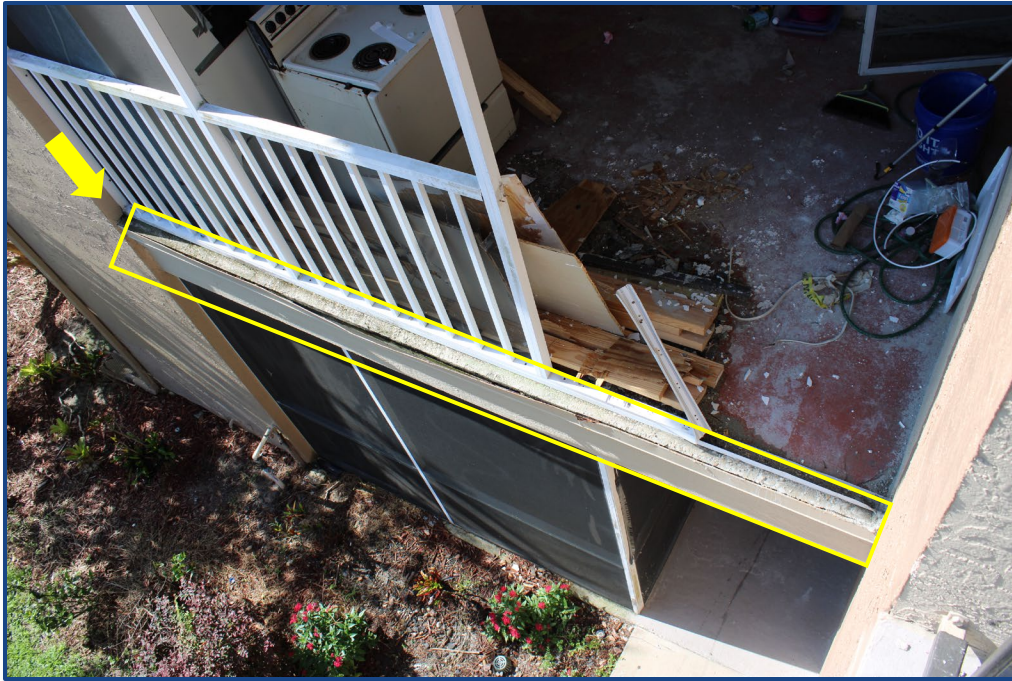
Photograph No. 11: Crack in the stucco wall finish, damage to the metal flashing at the edge of the balcony slab, and damaged balcony railing on Unit 204.

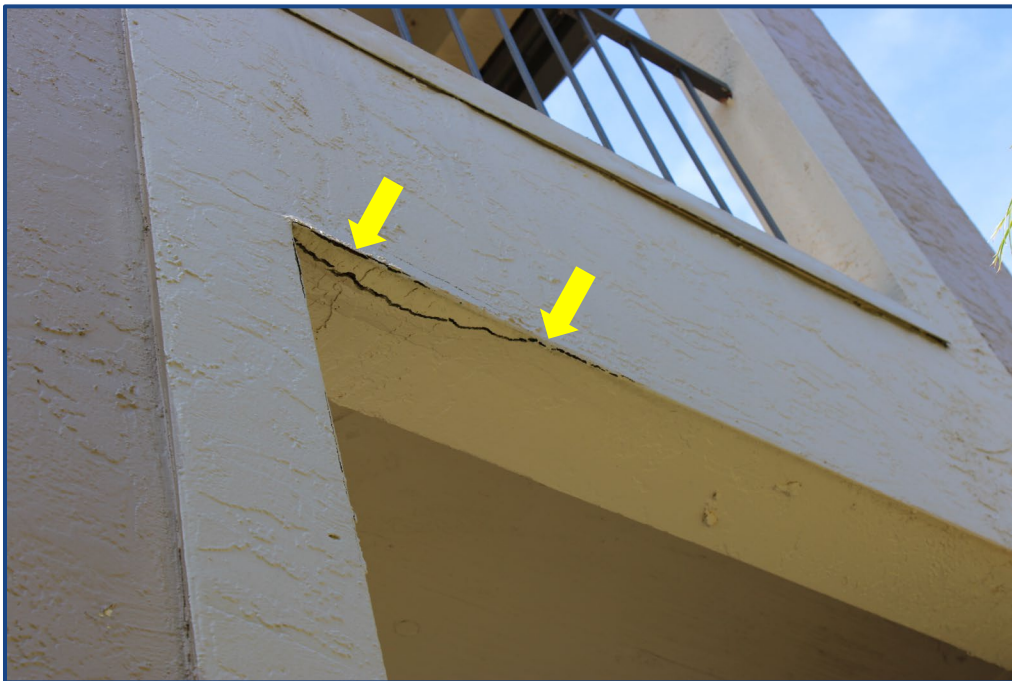
Photograph No. 12: Cracks in the exterior wall stucco finish located on the north stairway.

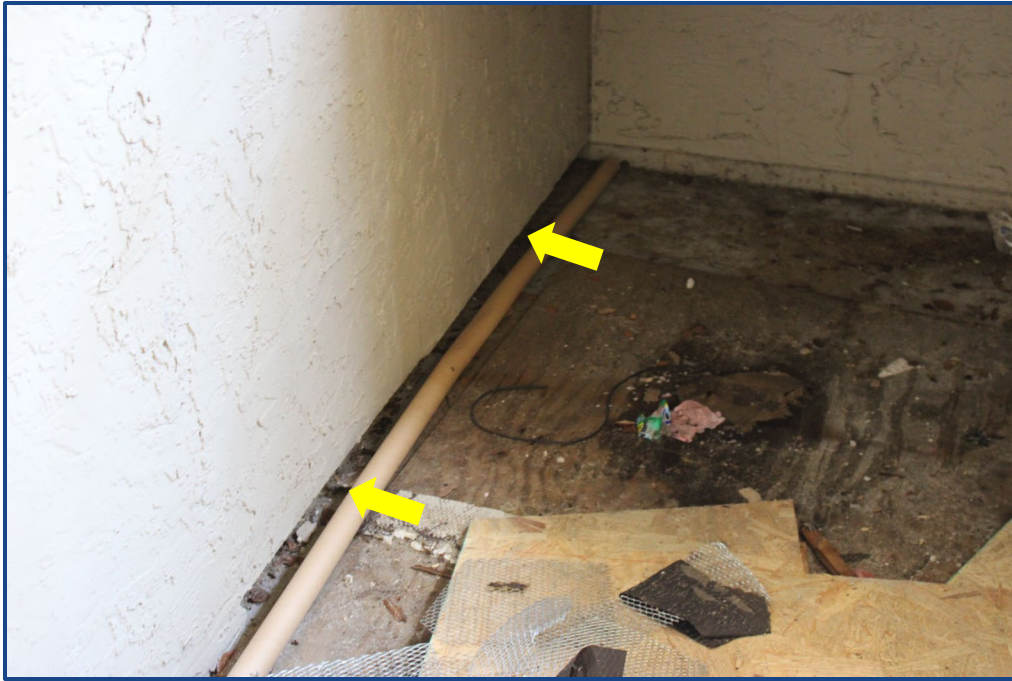
Photograph No. 13: Damage to the exterior wall stucco finish located in the north stairway.

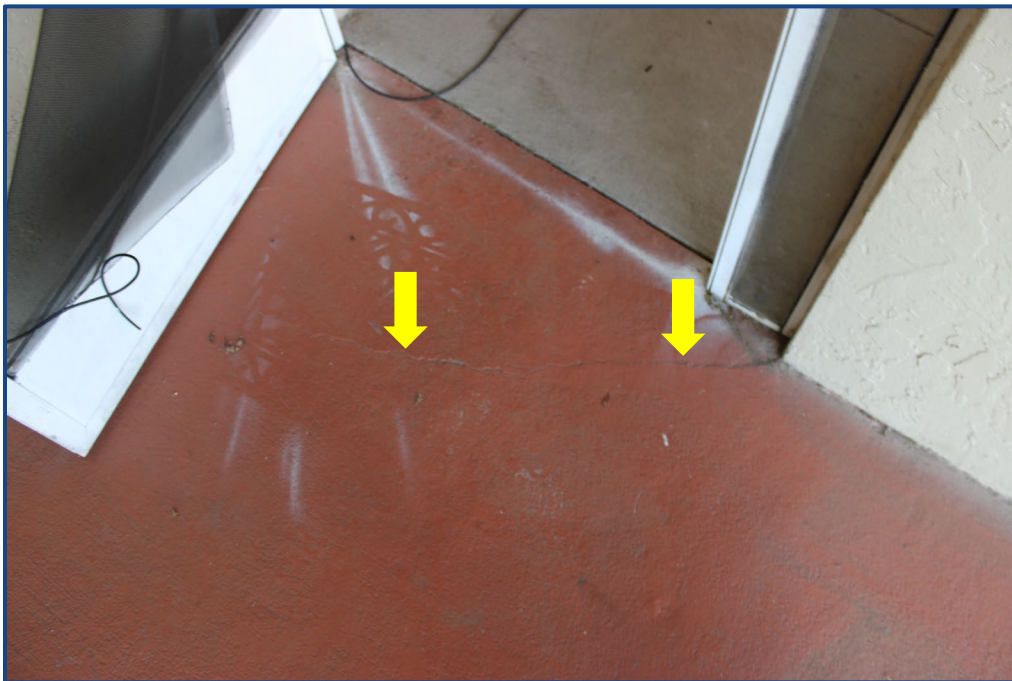
Photograph No. 14: Crack in the balcony slab on Unit 304.

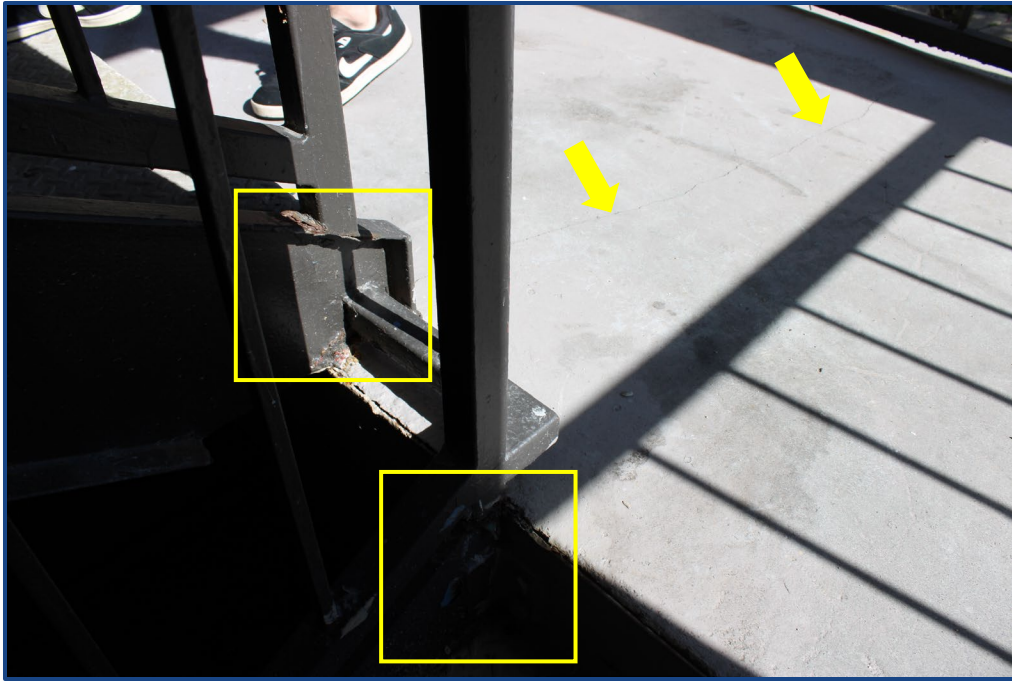
Photograph No. 15: Crack in the stairway landing and corrosion to the steel framing located in the north stairway.

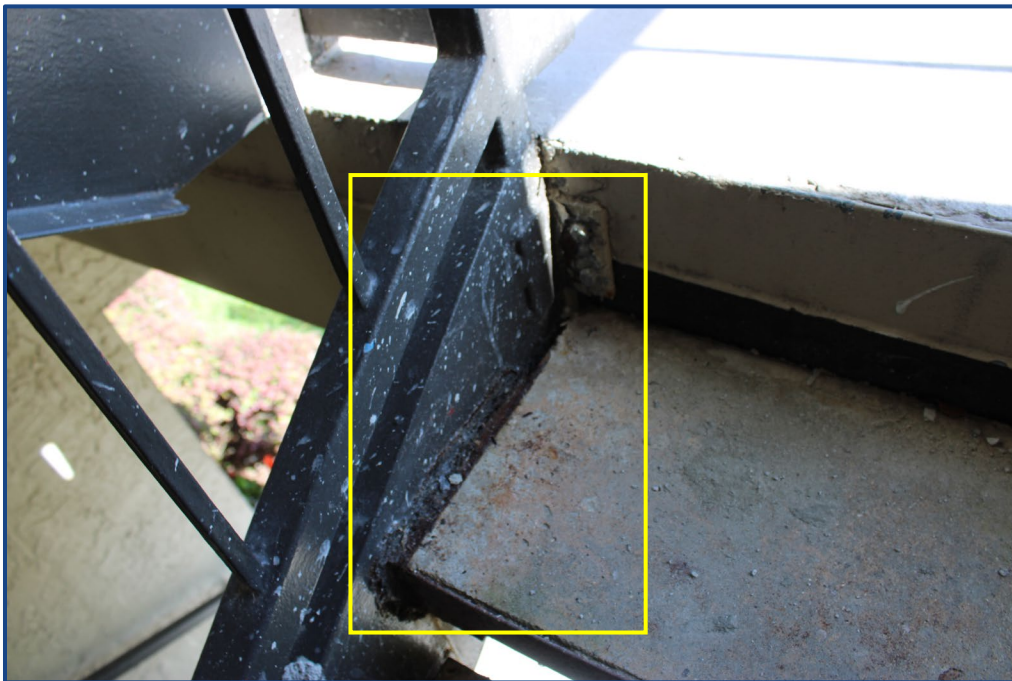
Photograph No. 16: Corrosion to the steel framing located in the north stairway.

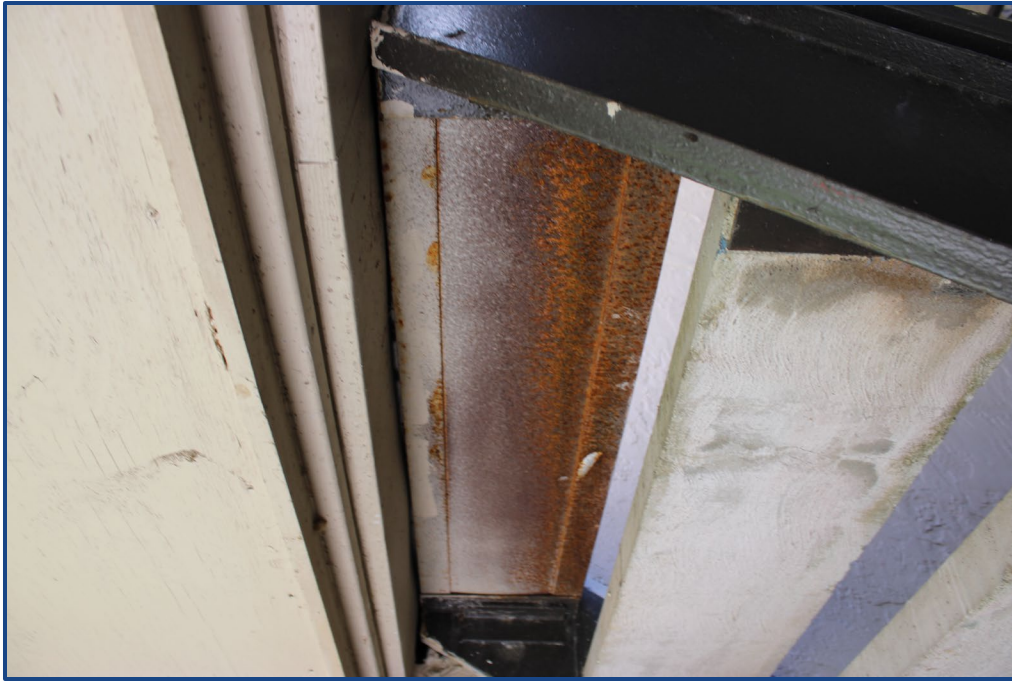
Photograph No. 17: Corrosion to the steel framing located in the north stairway.

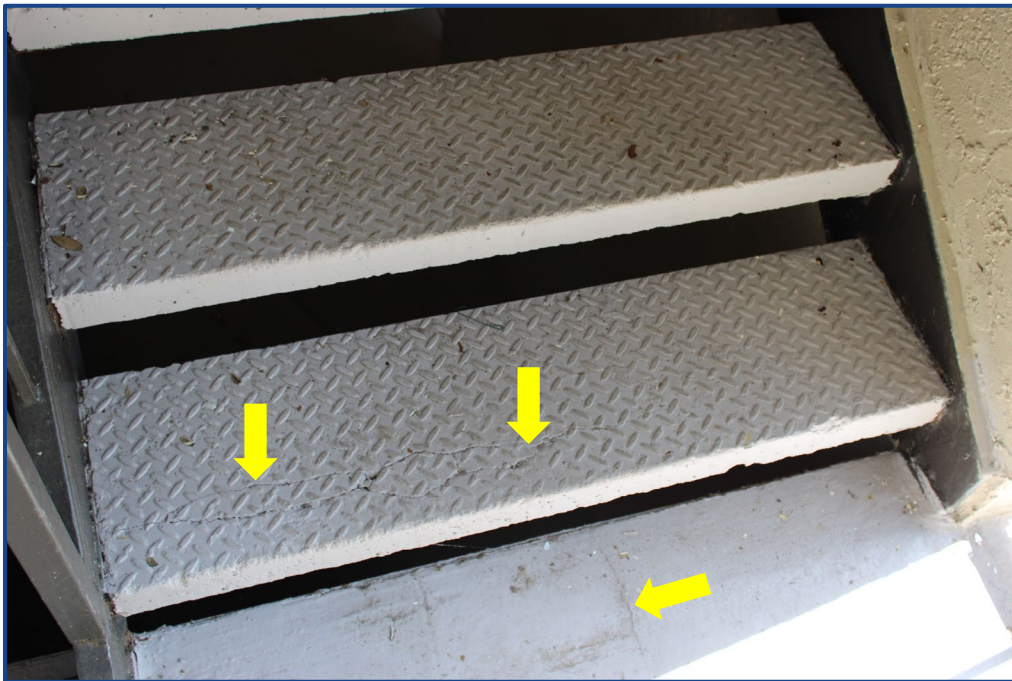
Photograph No. 18: Cracks in the stairway landing slab and the concrete step located in the south stairway.

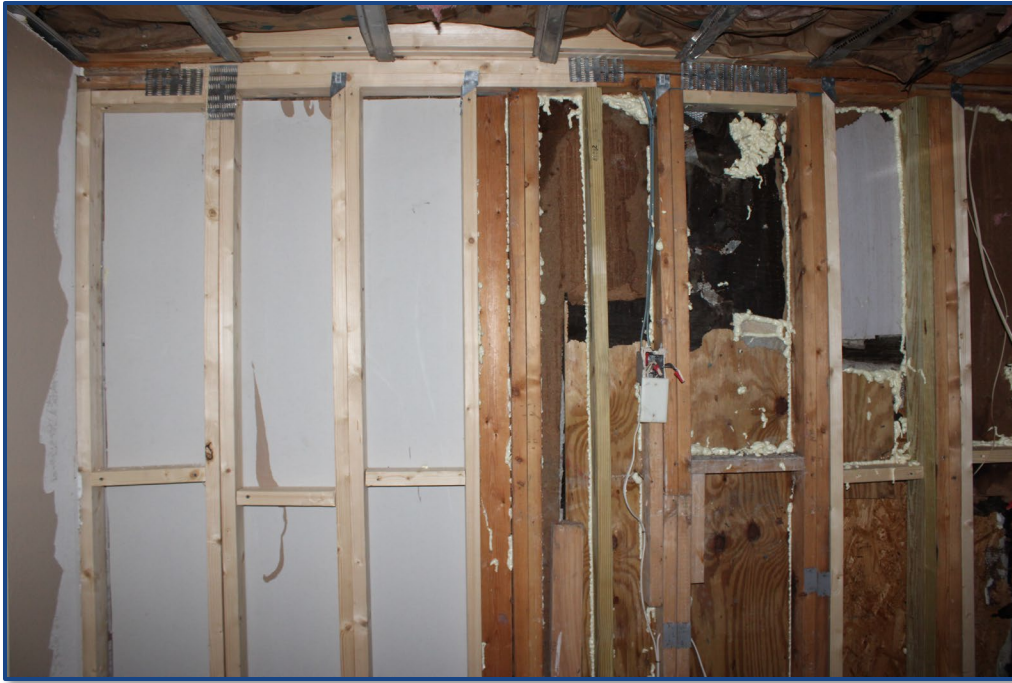
Photograph No. 19: View of the wood framing fire damage repairs located in Unit 101.

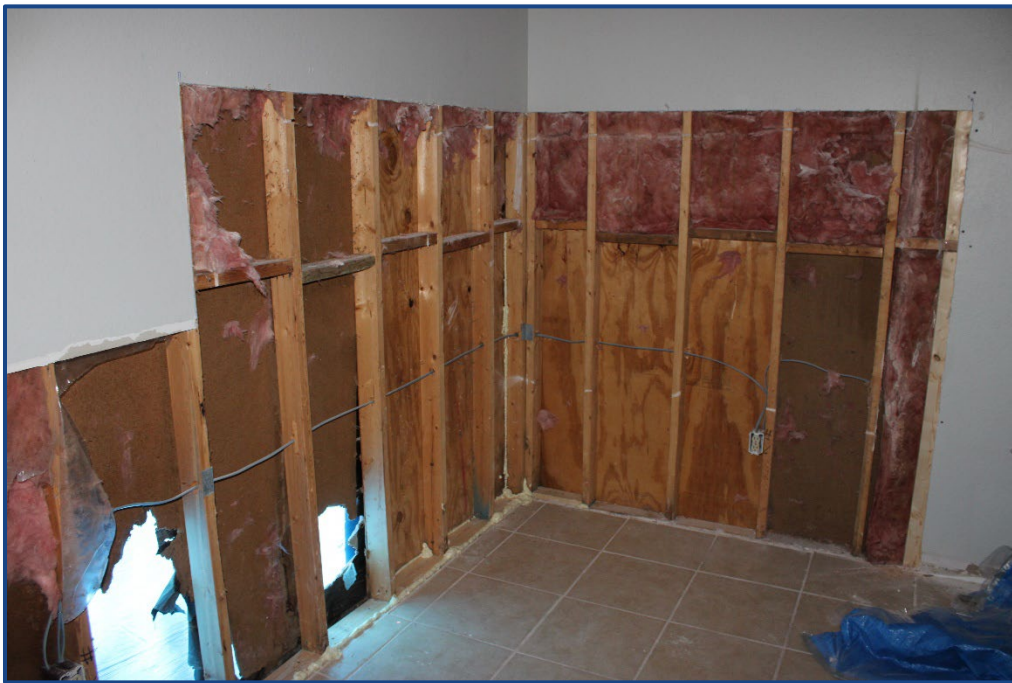
Photograph No. 20: View of the wood framing fire damage repairs located in Unit 201.

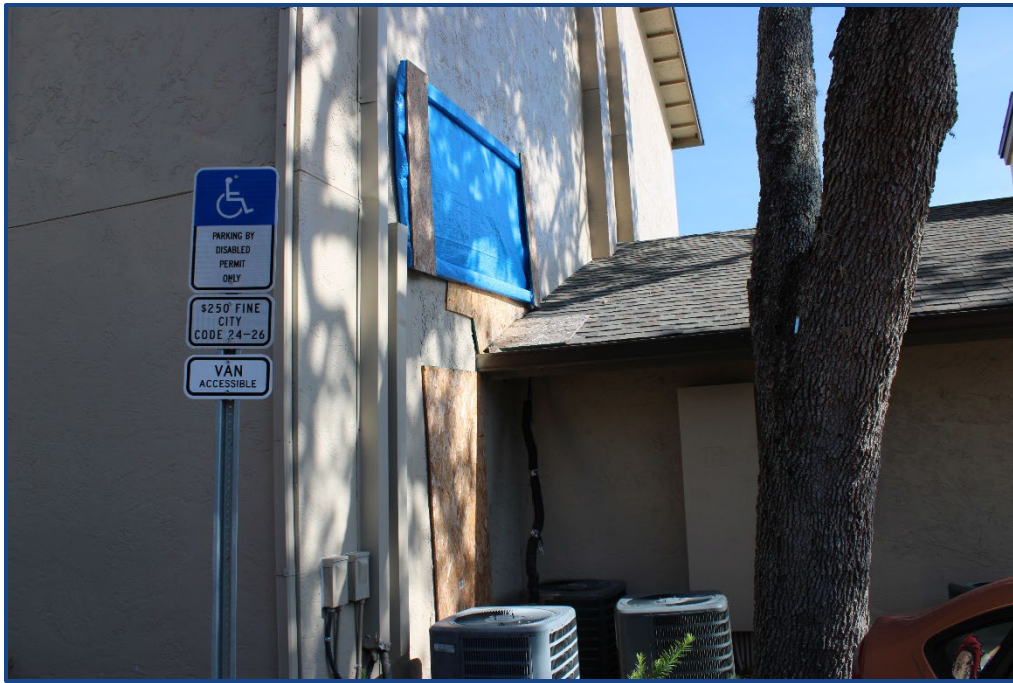
Photograph No. 21: View of the fire damaged areas on Unit 101 and 201 from the exterior.

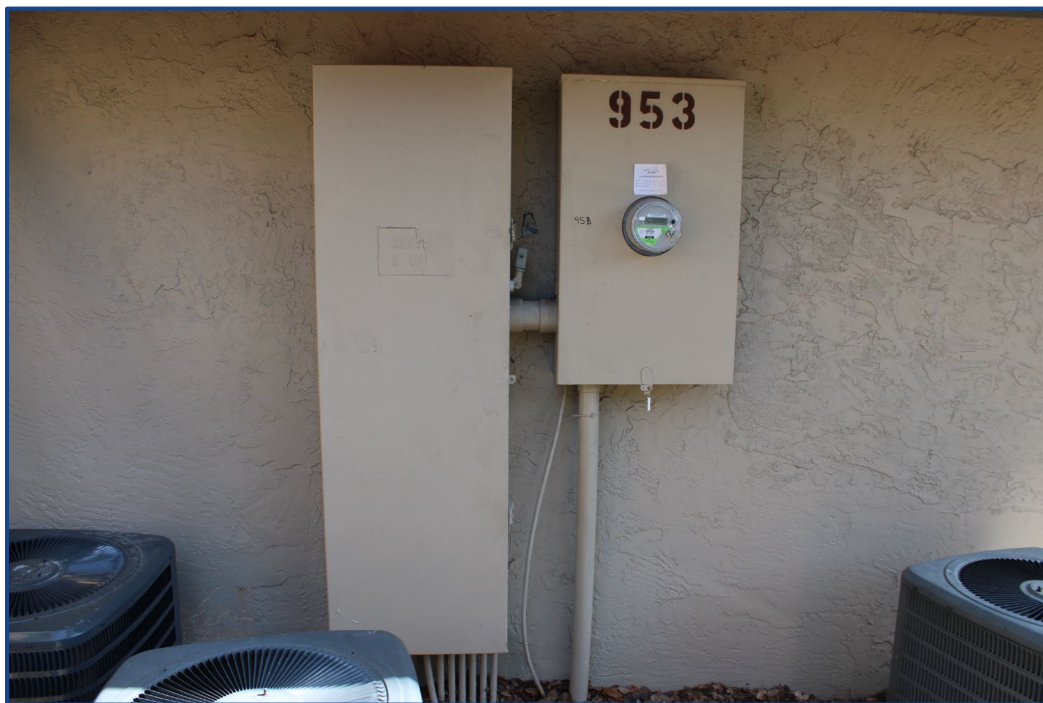
Photograph No. 22: Electrical meter and electrical panel.
