August 25, 2023

Re: The Landing Condominiums – Building 6
Structural Integrity Reserve Study (SIRS)
956 Salt Pond Place, Altamonte Springs, FL 32714
UES Project No: 0811.2300006.0000

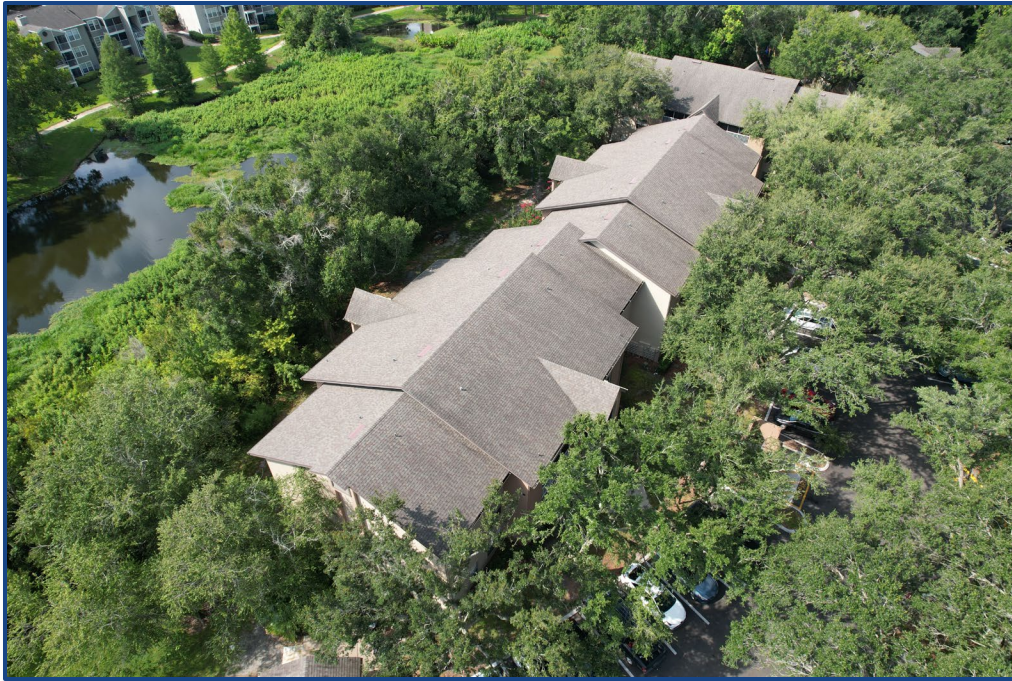
Photograph No. 1: North elevation.

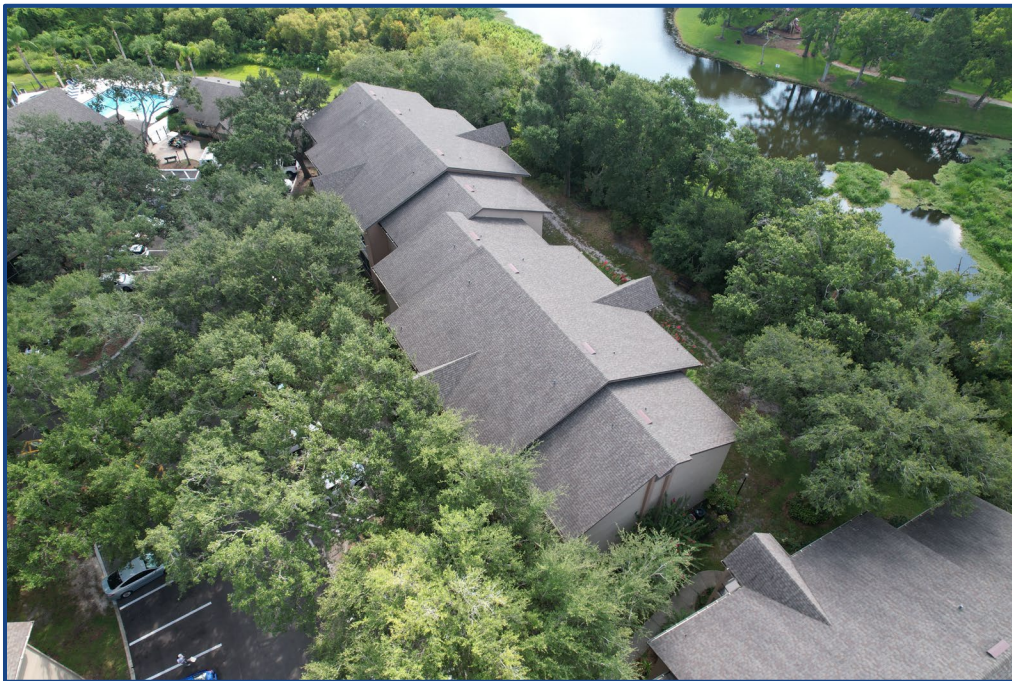
Photograph No. 2: West elevation.

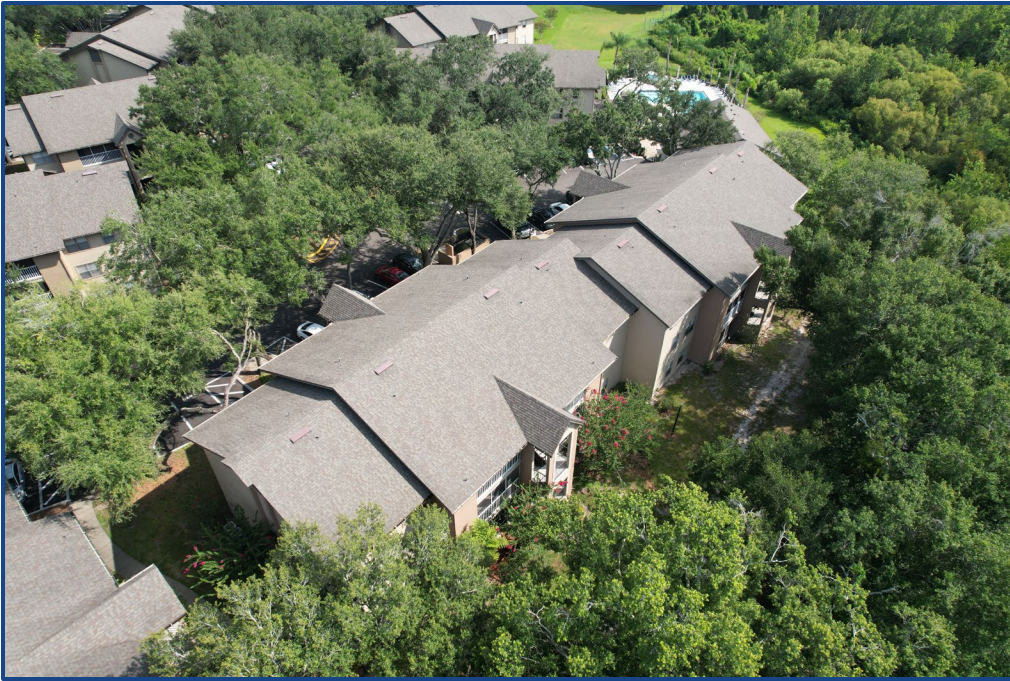
Photograph No. 3: South elevation.

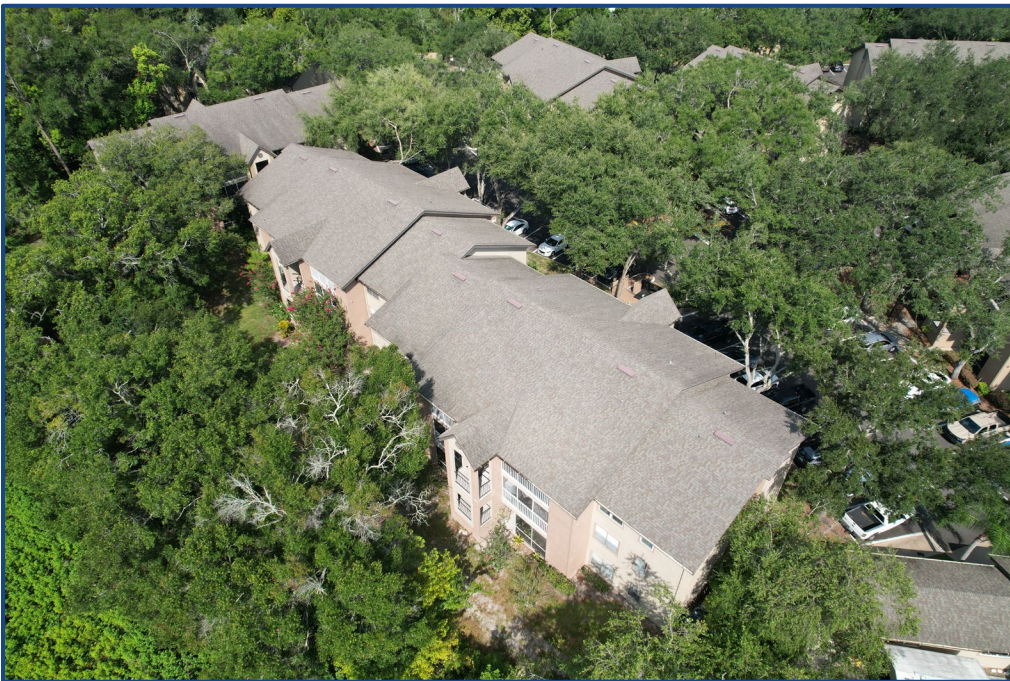
Photograph No. 4: East elevation.

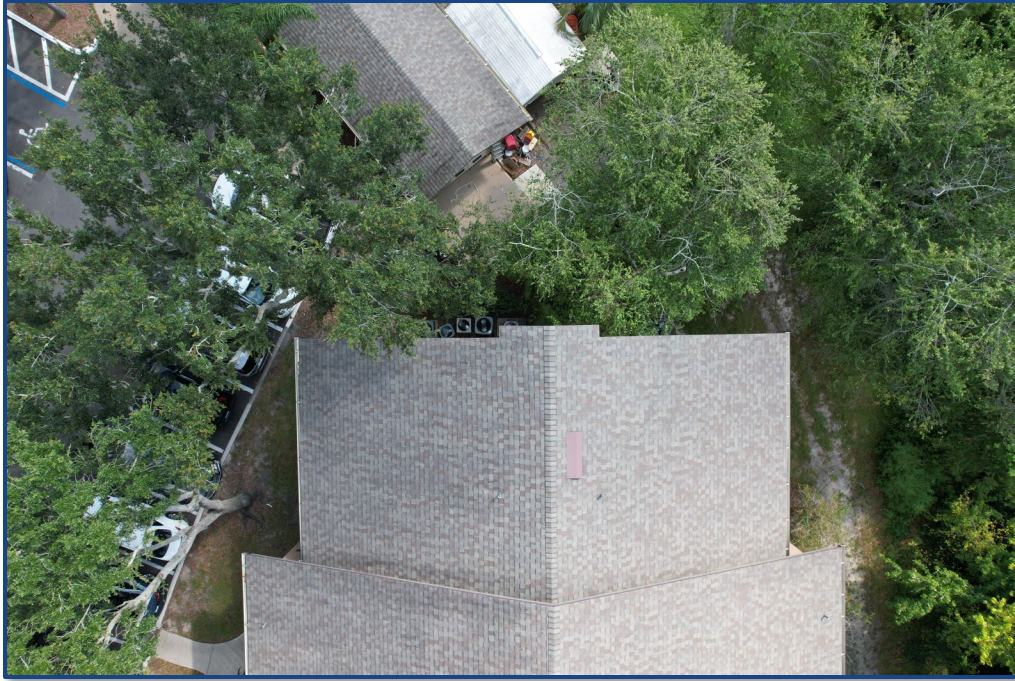
Photograph No. 5: View of the east roof section.

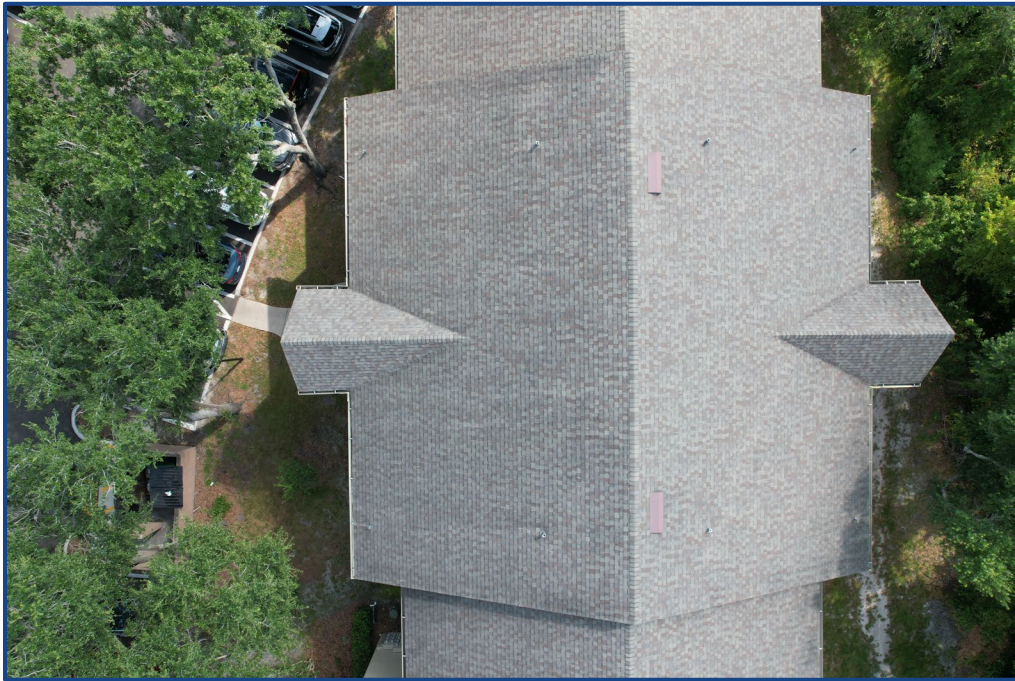
Photograph No. 6: View of the east roof section.

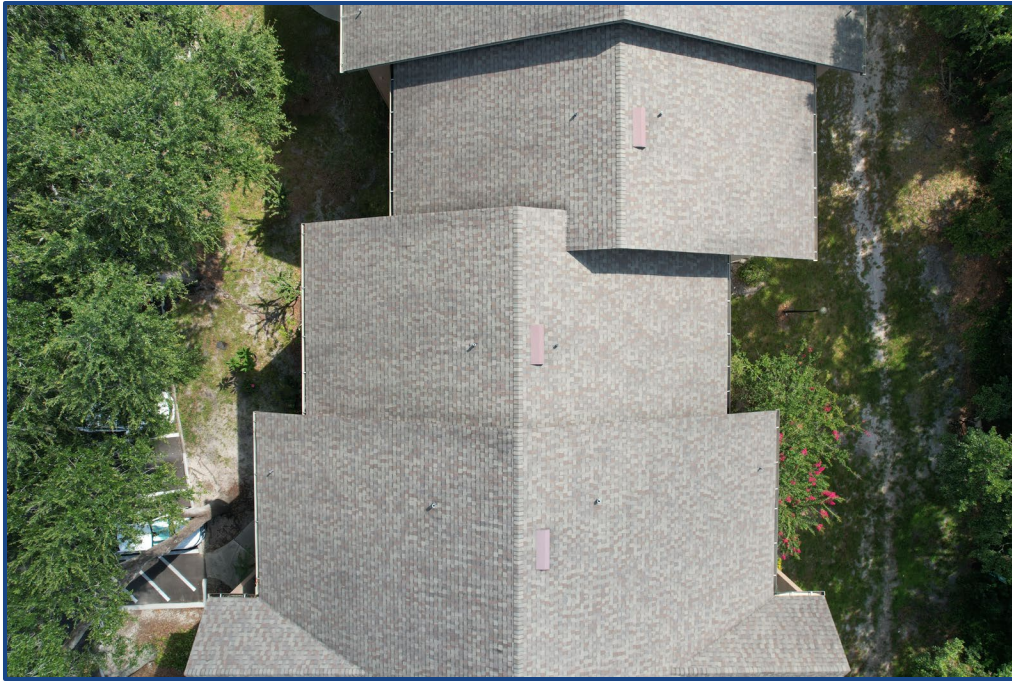
Photograph No. 7: View of the west roof.

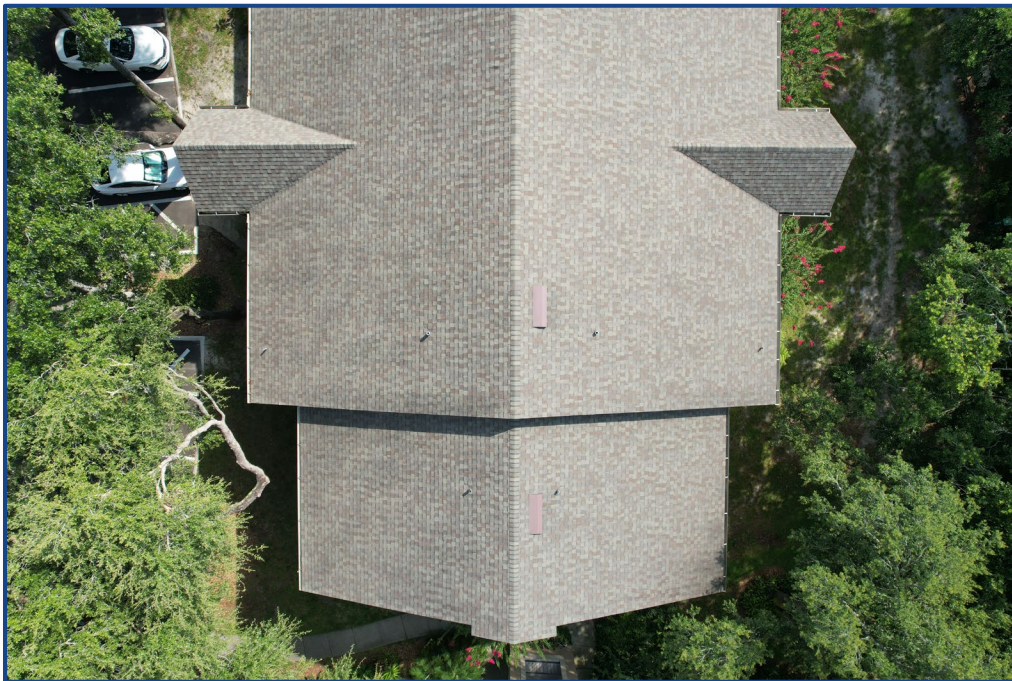
Photograph No. 8: View of the west roof section.

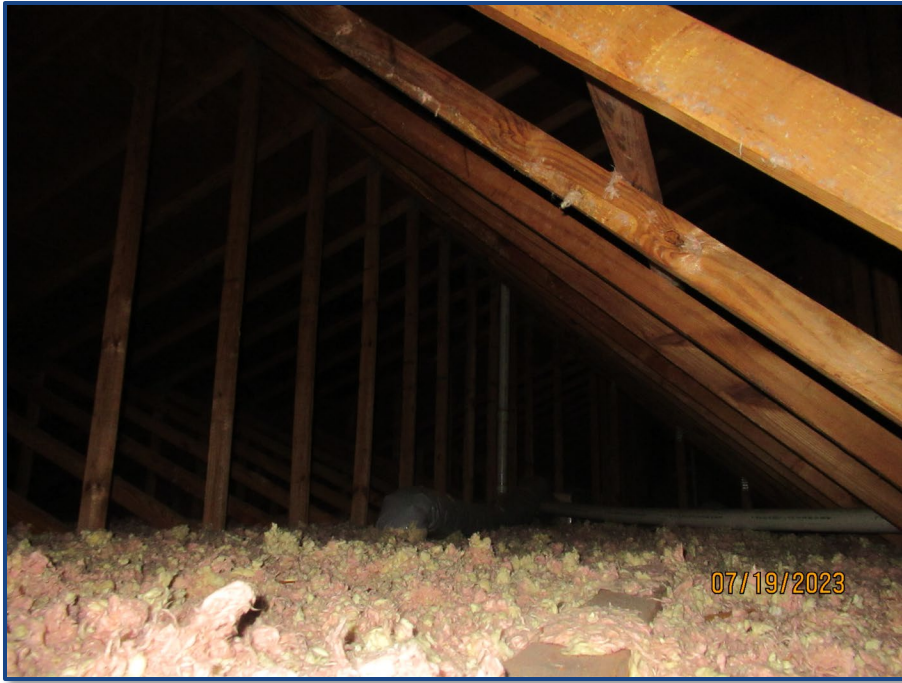
Photograph No. 9: General view of the prefabricated wooden roof trusses.

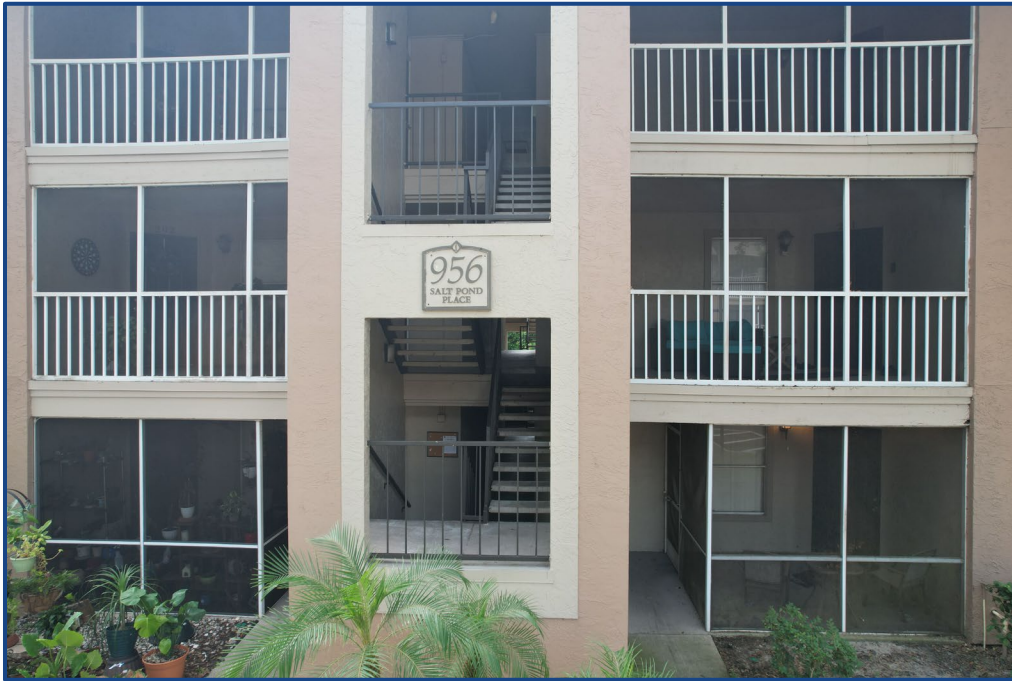
Photograph No. 10: View of the balconies and stairway on the northwest side of the building.

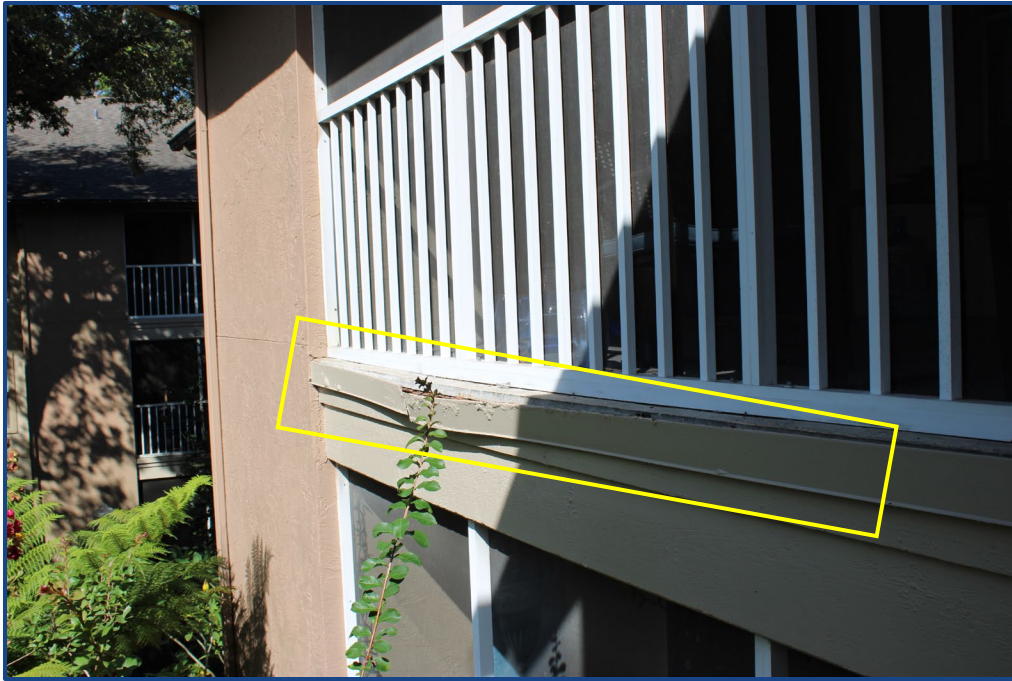
- Damage was observed to the metal balcony and stairway landing edge flashing in multiple locations. See **Appendix C** Photographs No. 11, 12, and 18.
- Damages in the exterior stucco finishes were observed in multiple locations. See **Appendix C** Photographs No. 13 and 14.
- Spalling and cracks in the elevated concrete slabs were observed in multiple locations. See **Appendix C** Photographs No. 15 through 17.
- Corrosion to the steel framing was observed in multiple locations in the stairways. See **Appendix C** Photographs No. 17 and 18.
- Corrosion to the metal handrails was observed in multiple locations in the stairways. See **Appendix C** Photograph No. 20.
- Cracks were observed in the precast concrete steps in multiple locations. See **Appendix C** Photographs No. 19.

Photograph No. 11: Corrosion and separation of the metal flashing at the edge of the balcony slab on Unit 308.

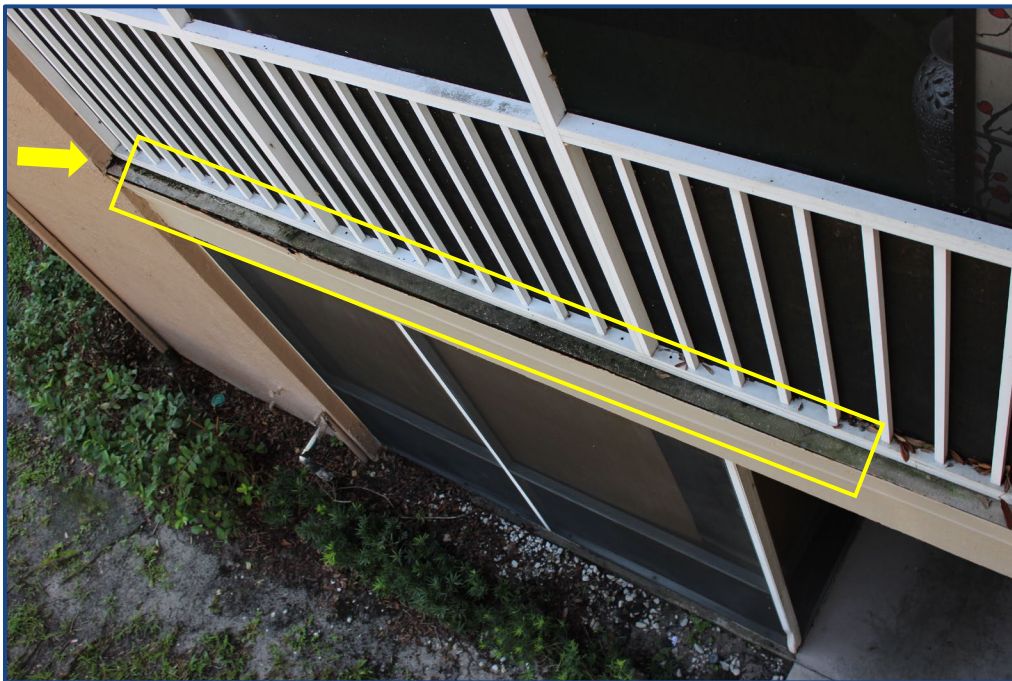
Photograph No. 12: Cracks in the stucco wall finish and corrosion and separation of the metal flashing at the edge of the balcony slab on Unit 204.

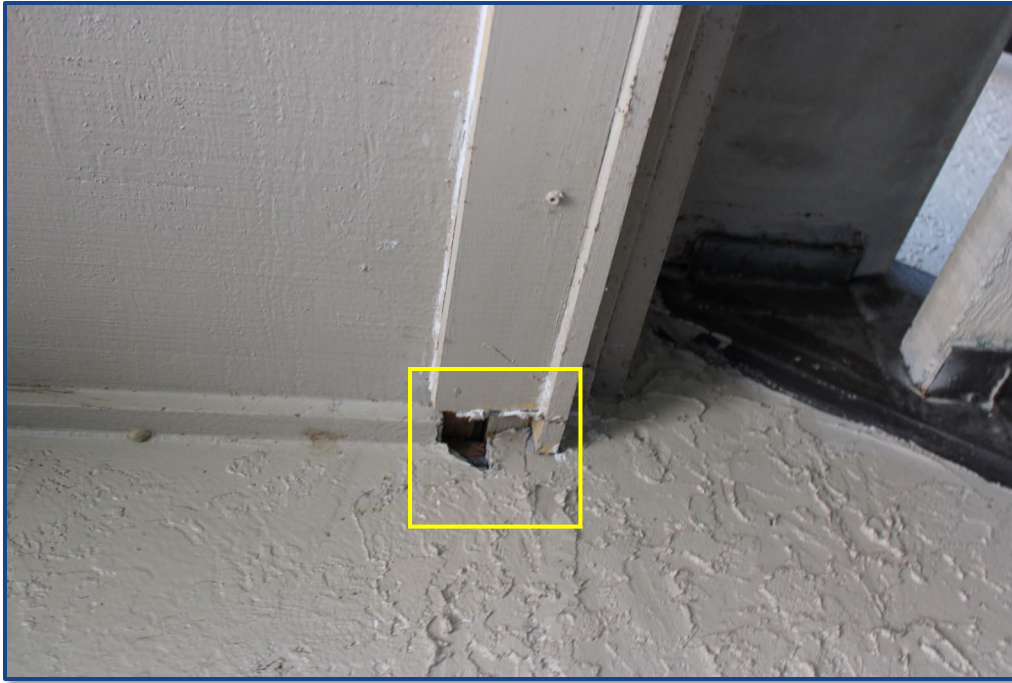
The exterior finishes of the building consists of painted stucco finishes. At the time of inspection, damage was observed in the stucco finish in multiple locations (Photographs No. 13 and 14). Overall, the general condition of the exterior finishes is in good condition. See **Appendix C** for reference site photographs.

Photograph No. 13: Damage to the stucco wall finish located in the southwest stairway.

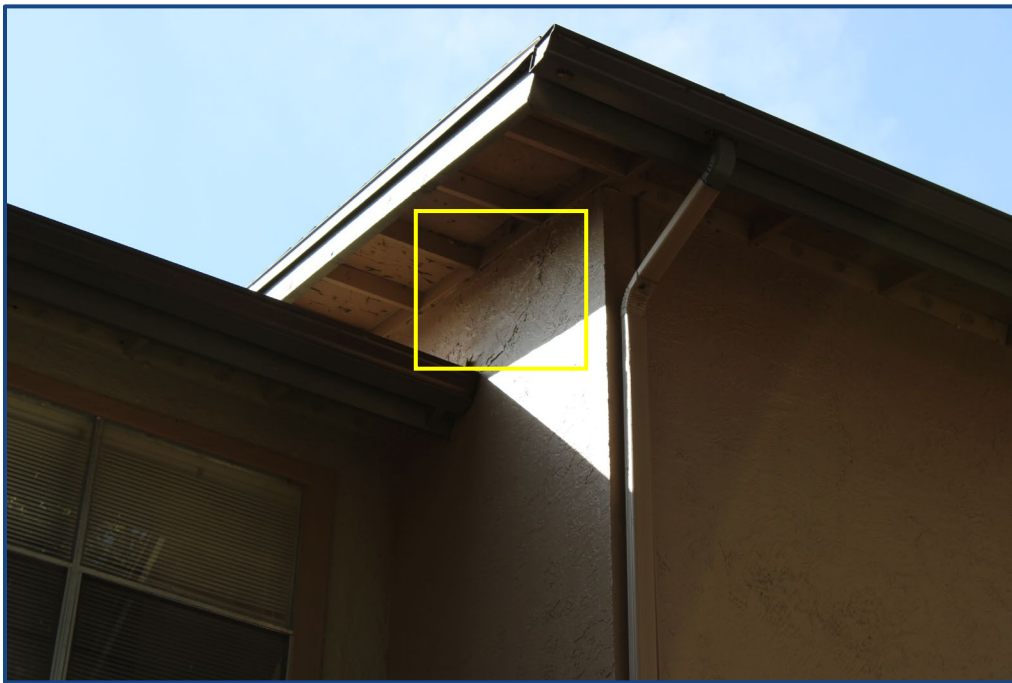
Photograph No. 14: Previous stucco repair.

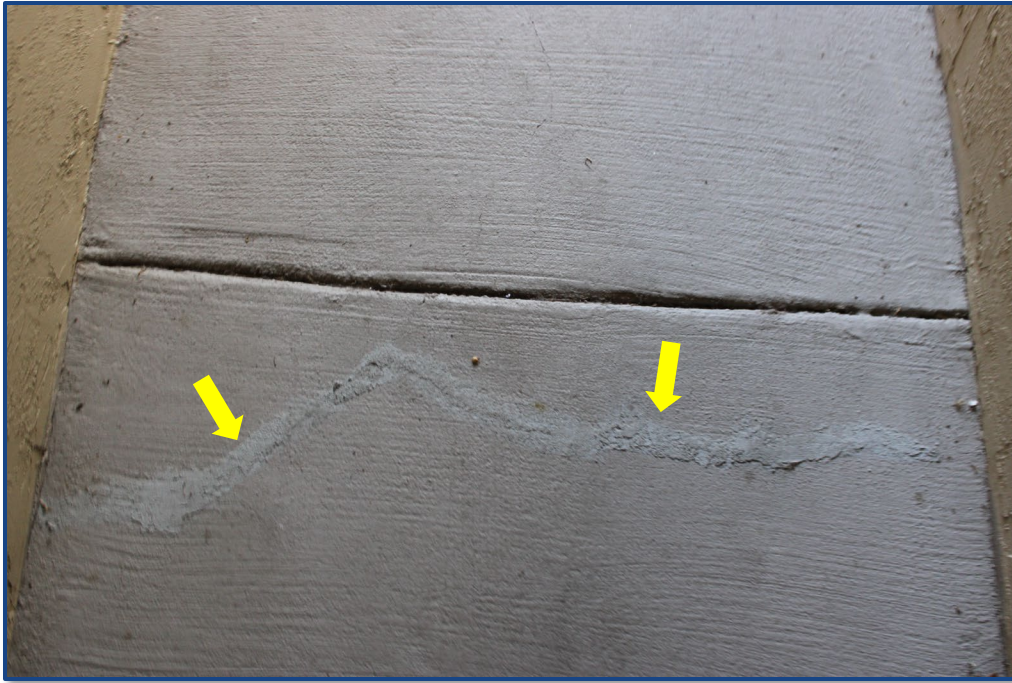
Photograph No. 15: Previously sealed crack in the concrete slab located in the 2nd floor breezeway.

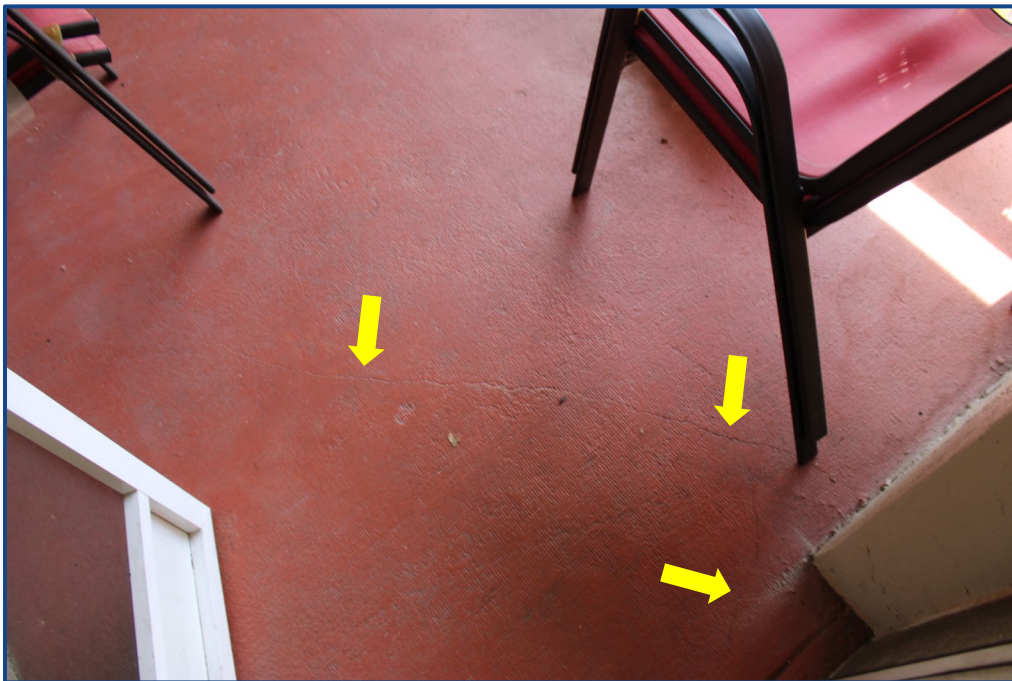
Photograph No. 16: Cracks in the concrete balcony slab on Unit 307.

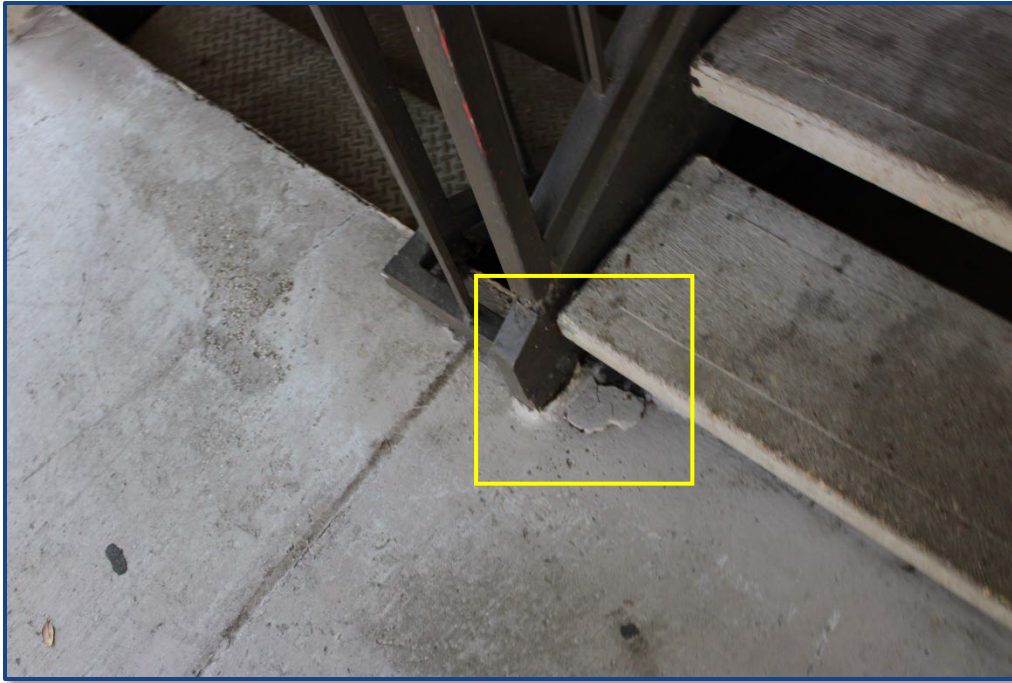
The building consists of exterior and interior wood framing walls and wood beams. The exterior walls are sheathed in plywood and stucco finished. The floor systems consist of prefabricated wooden floor trusses at the elevated units and reinforced concrete slabs at the elevated exterior stairway landings, walkways, and balconies. The roof framing system consists of prefabricated wooden roof trusses. The stairways consist of steel stringers with precast reinforced concrete steps. At the time of inspection, spalling and cracks in the elevated concrete slabs were observed in multiple locations (Photographs No. 15 through 17). Corrosion to the steel framing was observed in multiple locations in the stairways (Photographs No. 17 and 18). See **Appendix C** for reference site photographs.

Photograph No. 17: Cracks and spalling in the concrete stairway landing and corrosion to the steel framing in the northwest stairway.

Concrete and Stairway Repair for year 2024 shall include repairs to cracked concrete and corrosion to the steel framing referenced within this report.

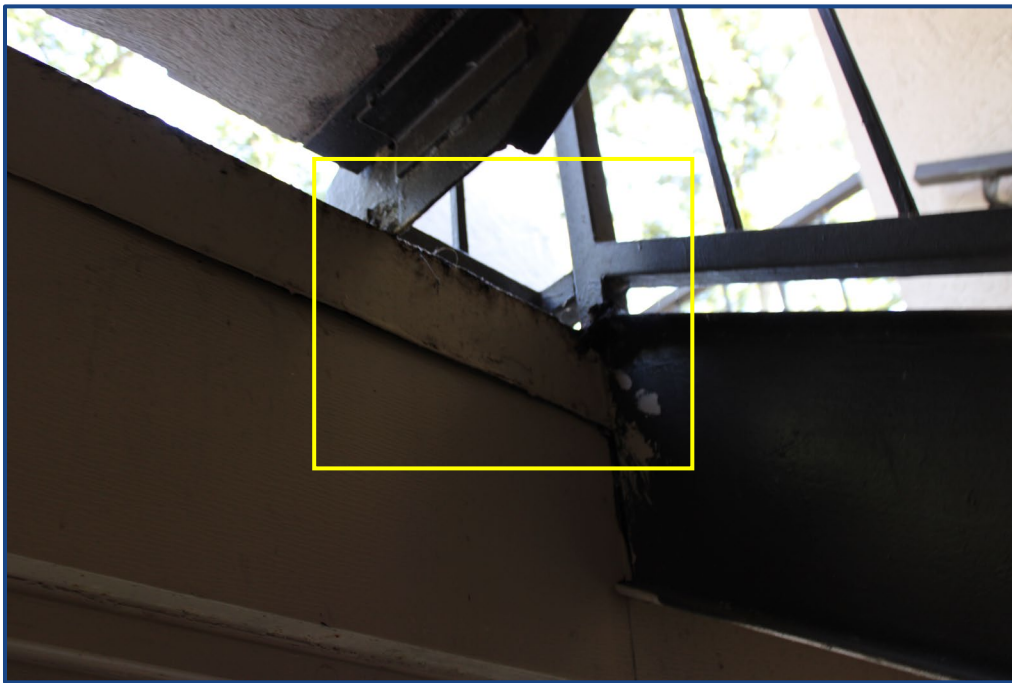
Photograph No. 18: Corrosion to the steel framing and metal flashing located in the northeast stairway.

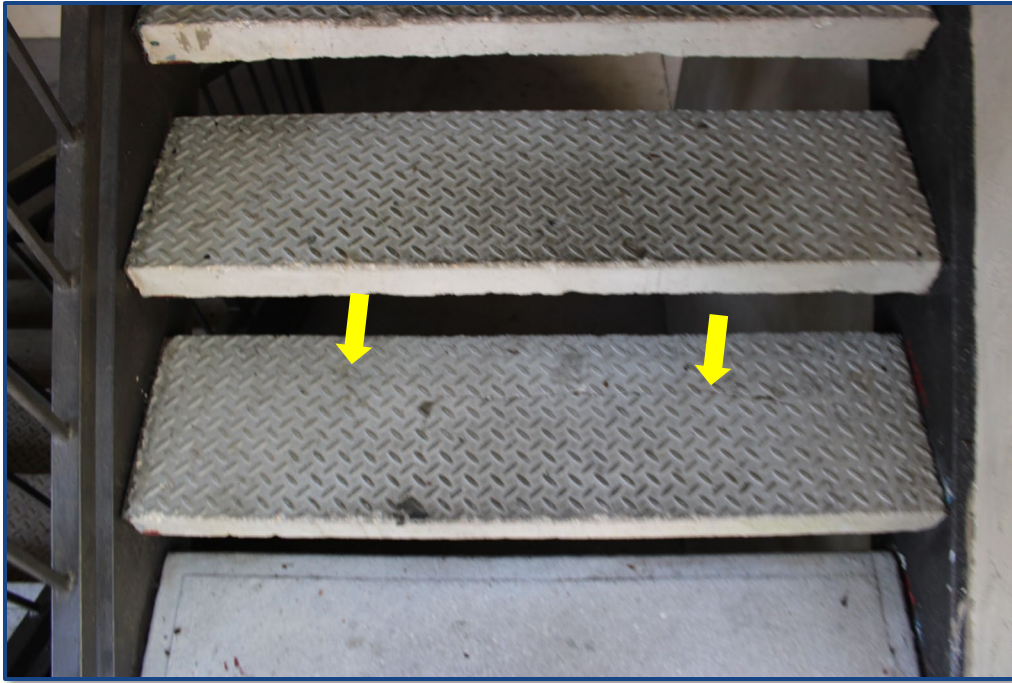
Photograph No. 19: Cracks in the concrete step located in the southeast stairway.

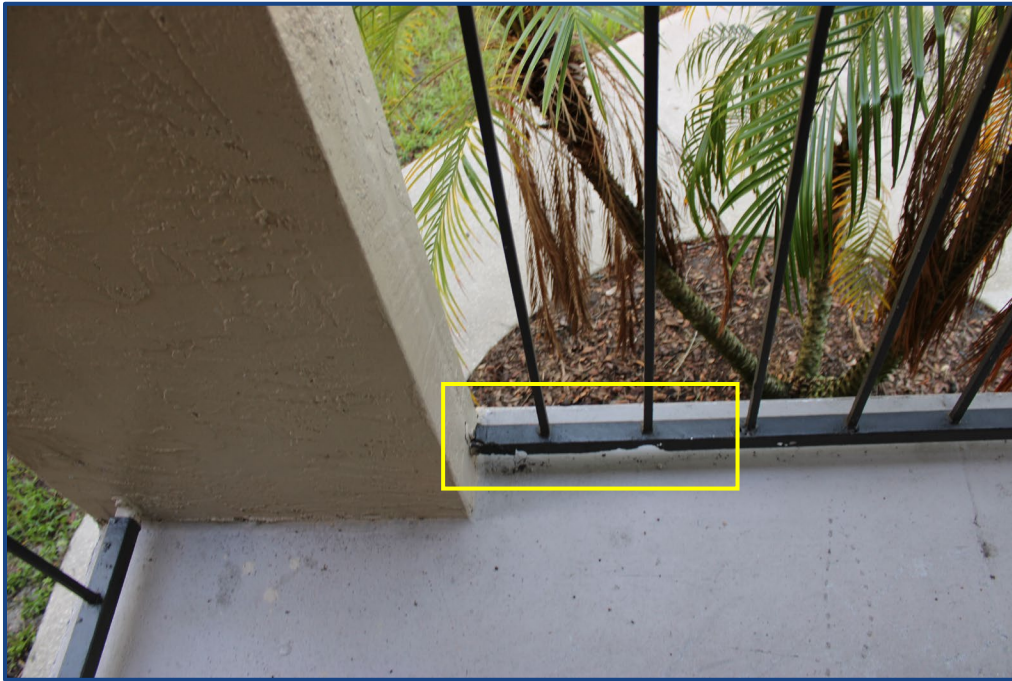
Photograph No. 20: Corrosion to the metal handrail located in the northeast stairway.

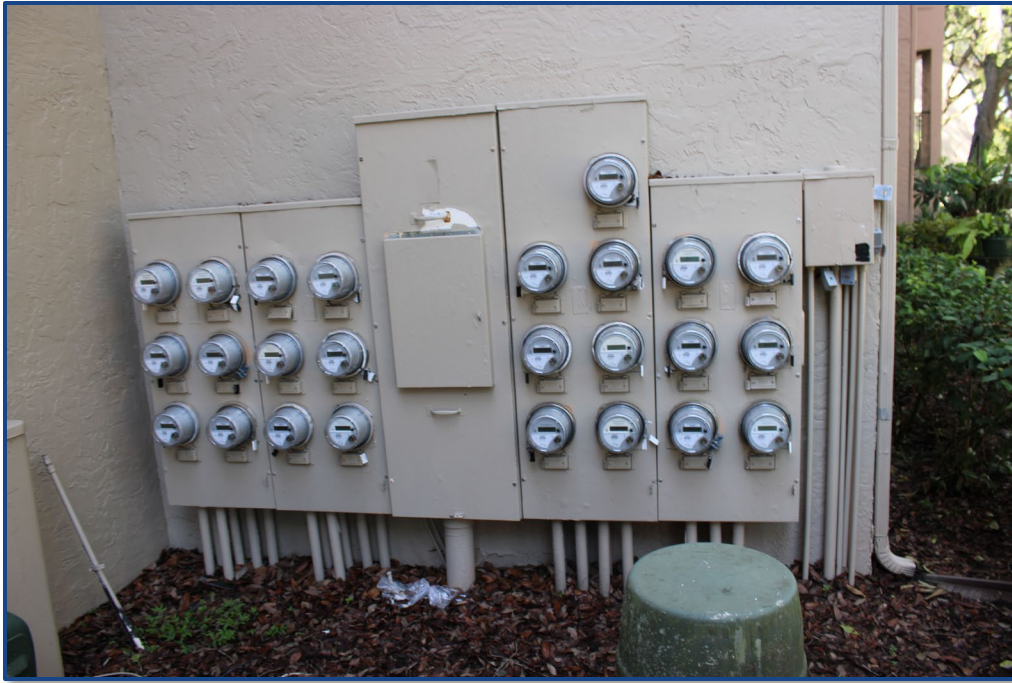
Photograph No. 21: Electrical meters.

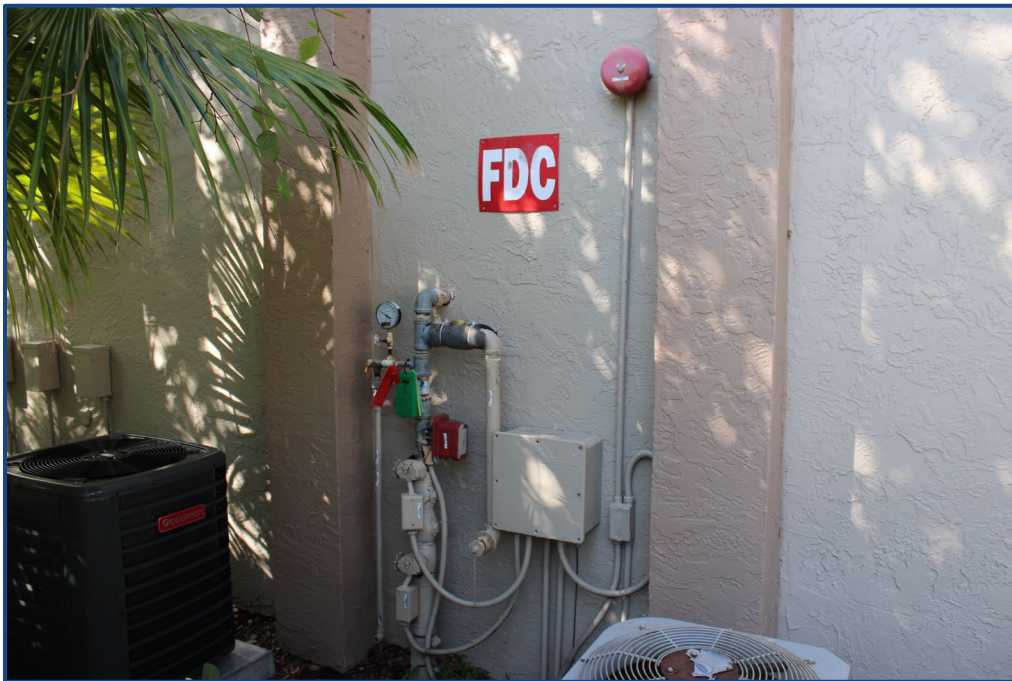
Photograph No. 22: Fire riser system and fire alarm.

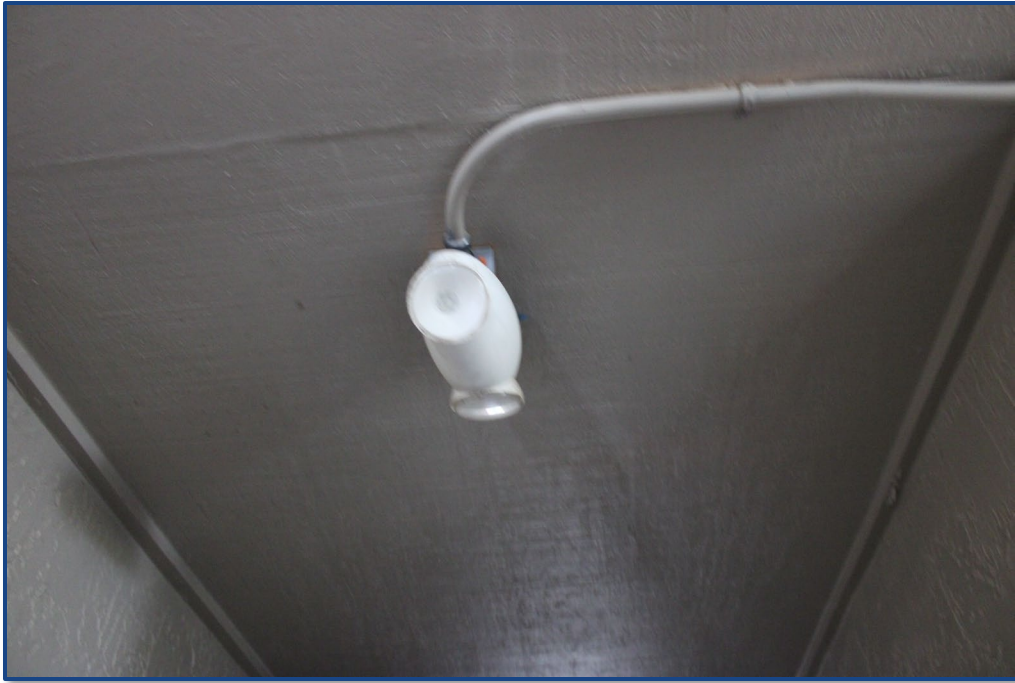
Photograph No. 23: Emergency lighting.
