August 25, 2023

Janette Barcena
The Landing Condominium Association, Inc.
953 Salt Pond Place
Altamonte Springs, Florida 32714

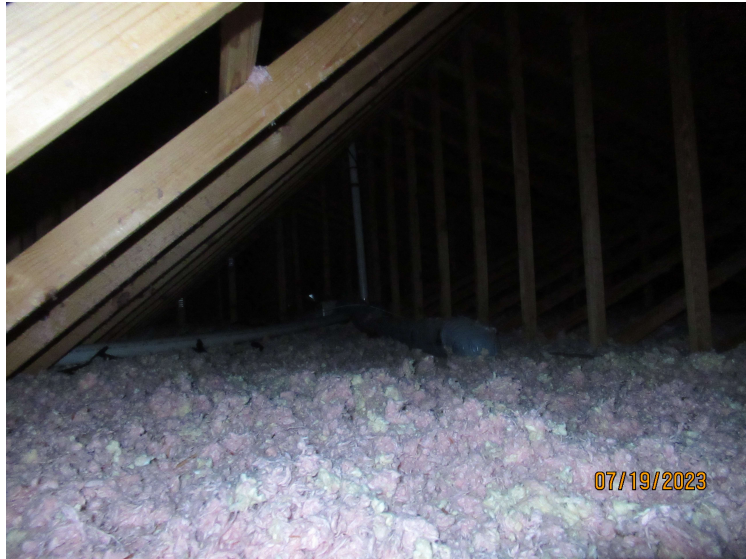
Plumbing - Total Current Cost	\$2,500
Assigned Reserves	\$5,000
Fully Funded Reserves	\$2,500

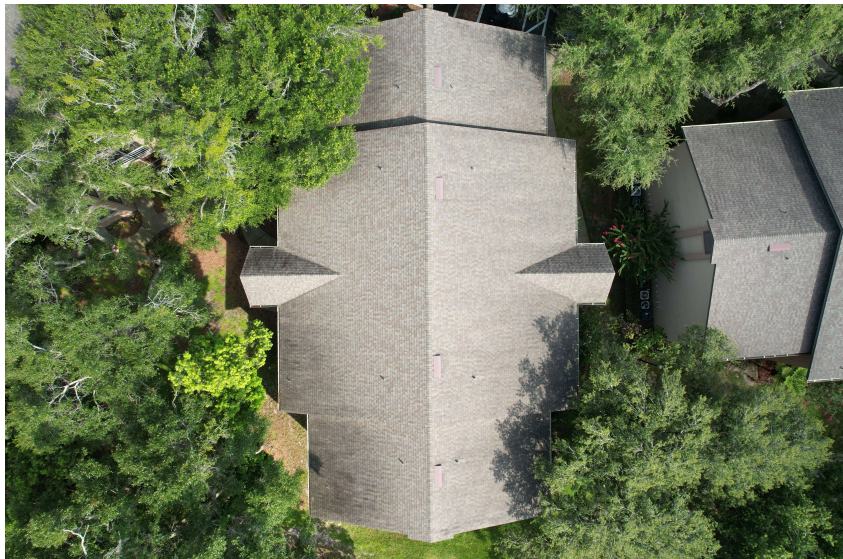
Roofing - Total Current Cost	\$25,150
Assigned Reserves	\$25,150
Fully Funded Reserves	\$6,287

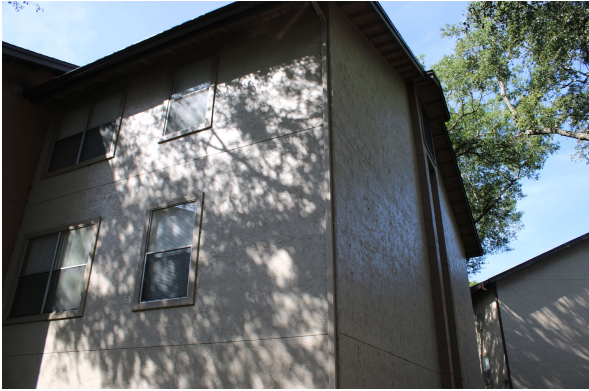
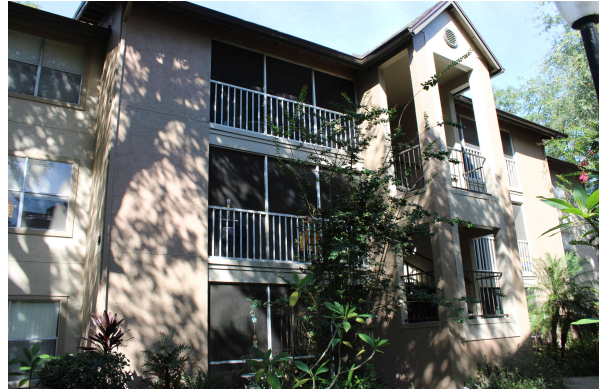
Stucco Repairs - 2030

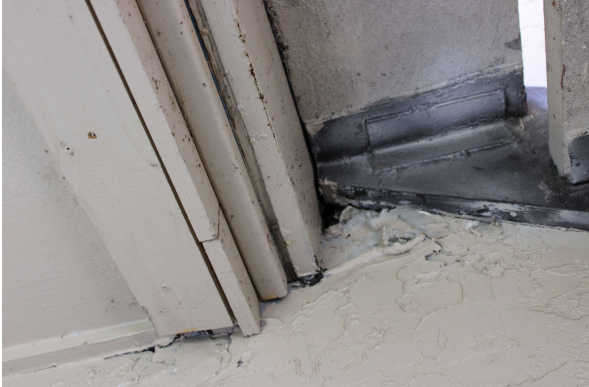
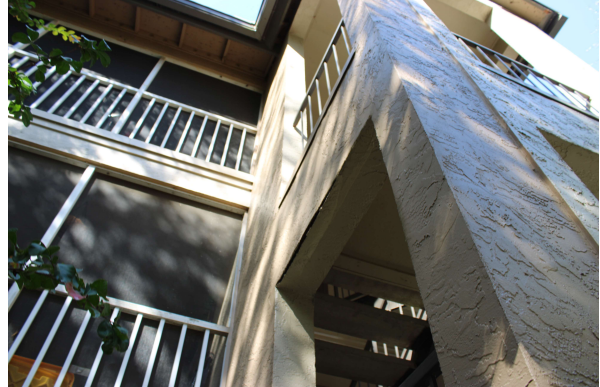
Painting - Total Current Cost	\$17,000
Assigned Reserves	\$17,000
Fully Funded Reserves	\$8,514

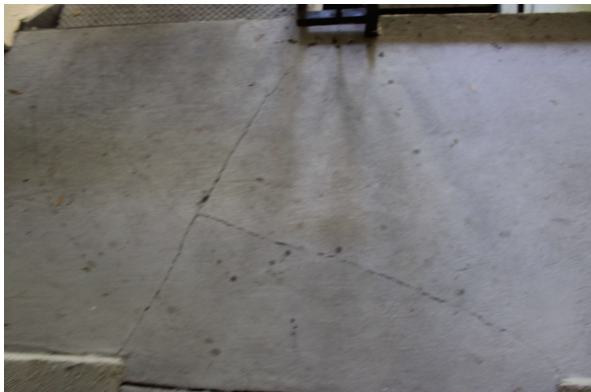
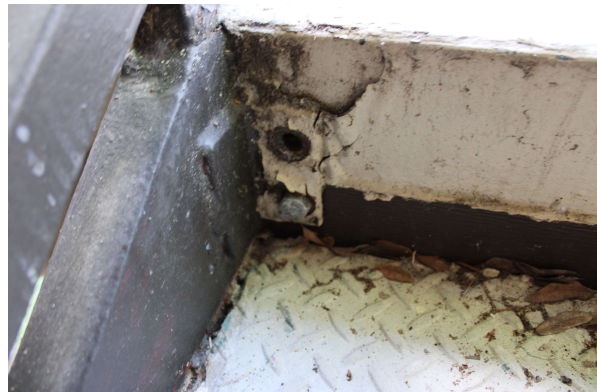
Concrete and Stairway Repair for year 2024 shall include repairs to cracked concrete and corrosion to the steel framing referenced within this report.

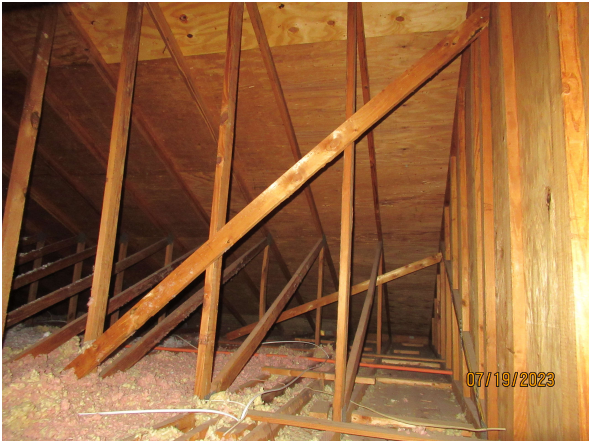
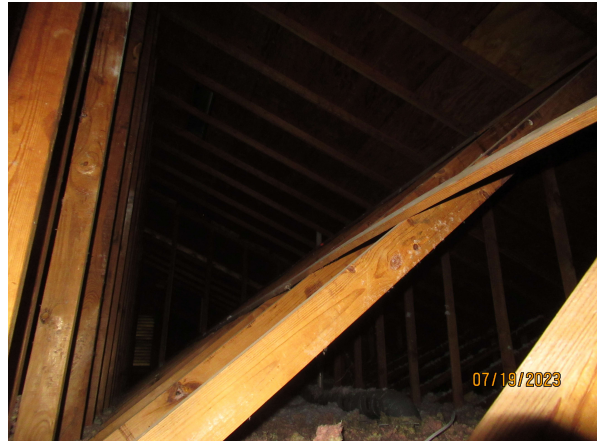
Structural Components - Total Current Cost	\$6,000
Assigned Reserves	\$9,000
Fully Funded Reserves	\$3,300

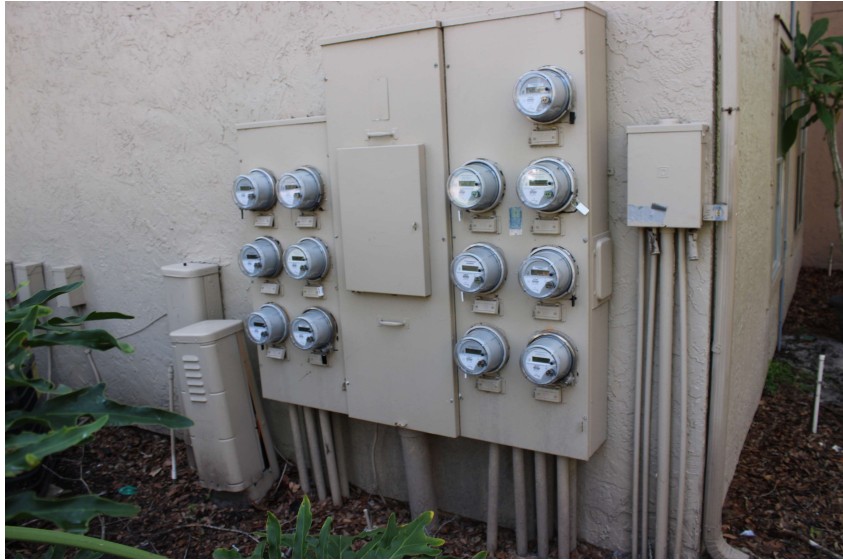
Electrical Systems - Total Current Cost	\$2,500
Assigned Reserves	\$5,000
Fully Funded Reserves	\$2,500

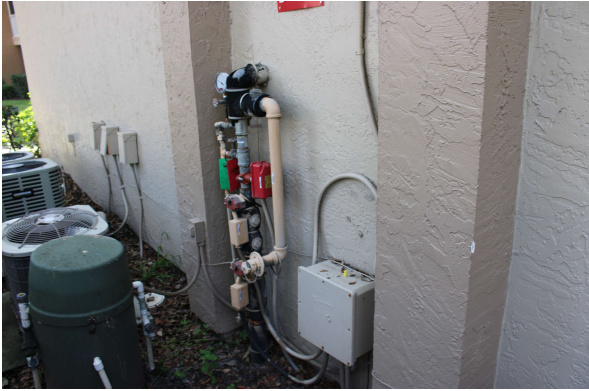
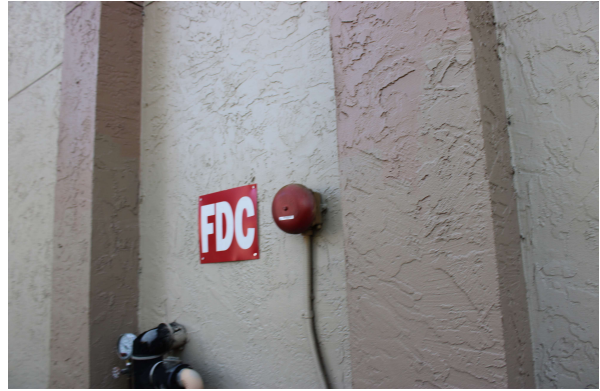
Fire Protective Systems - Total Current Cost	\$2,500
Assigned Reserves	\$5,000
Fully Funded Reserves	\$2,500

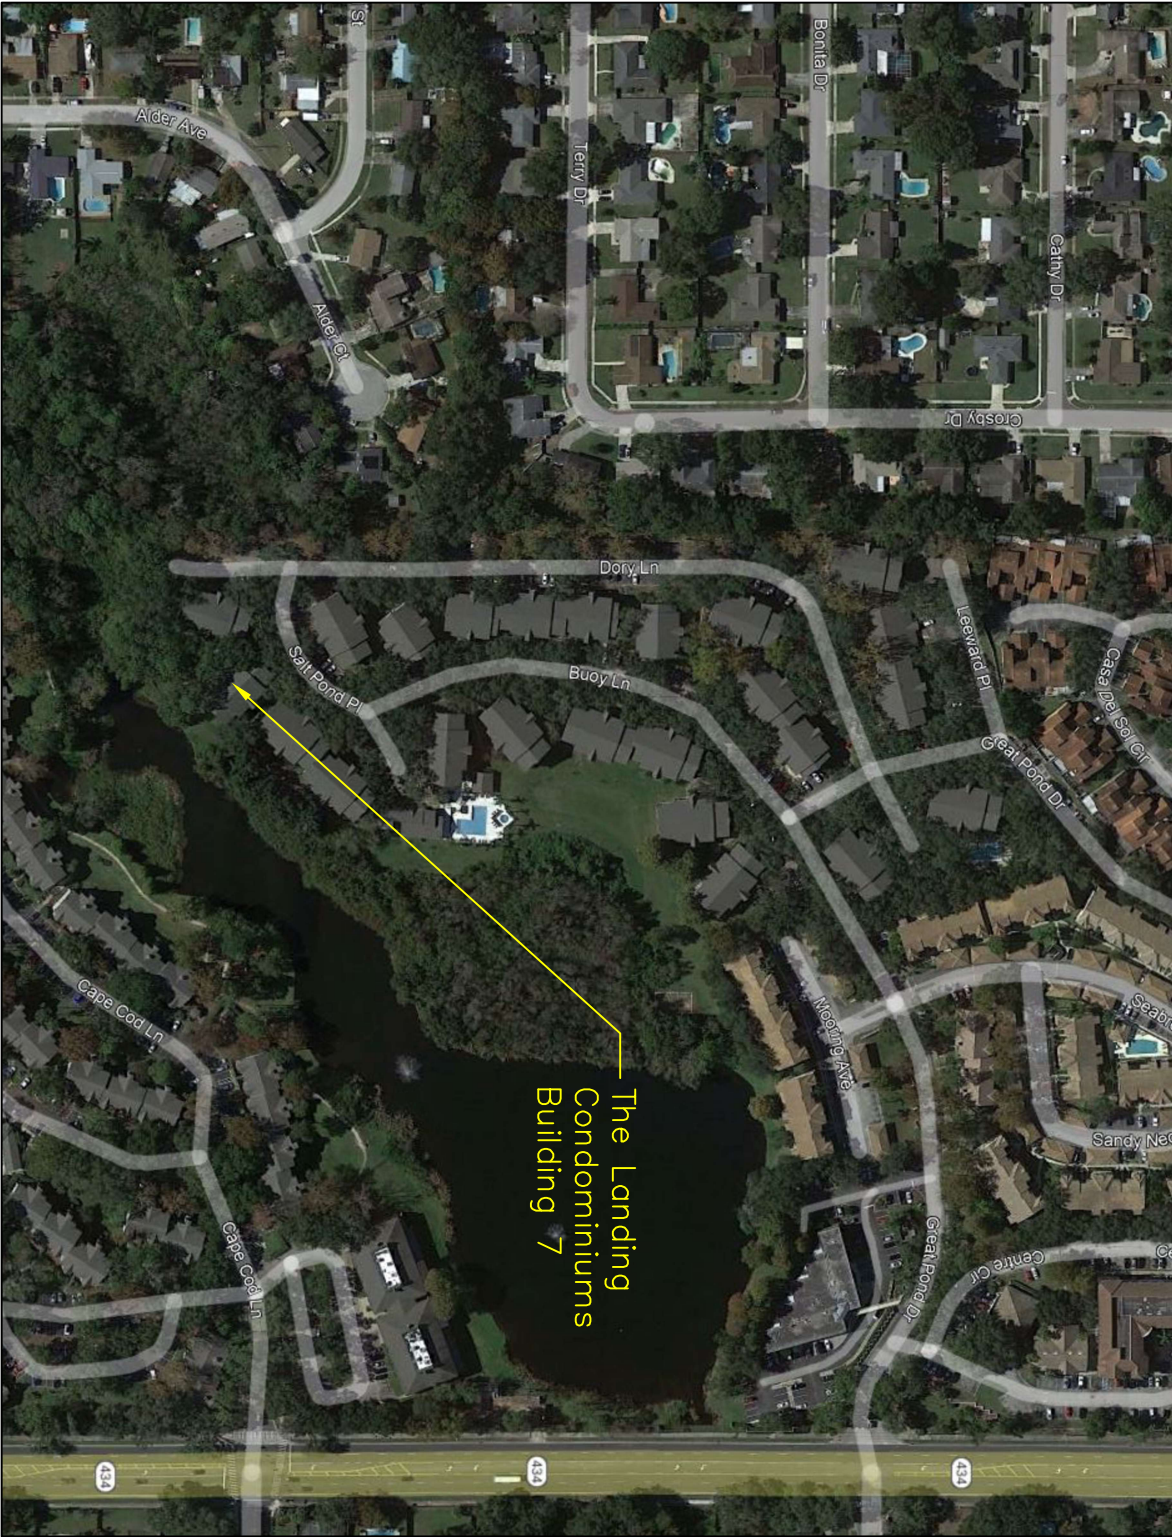
APPENDIX B
SITE LOCATION MAP

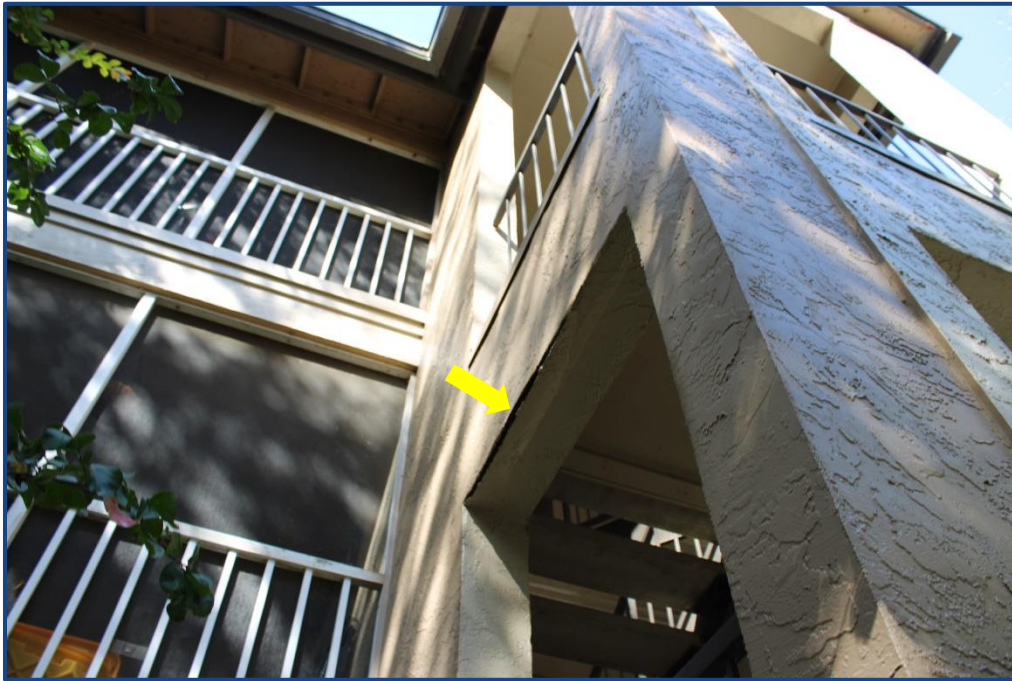
Photograph No. 8: Crack in the exterior wall stucco finish located on the east stairway.

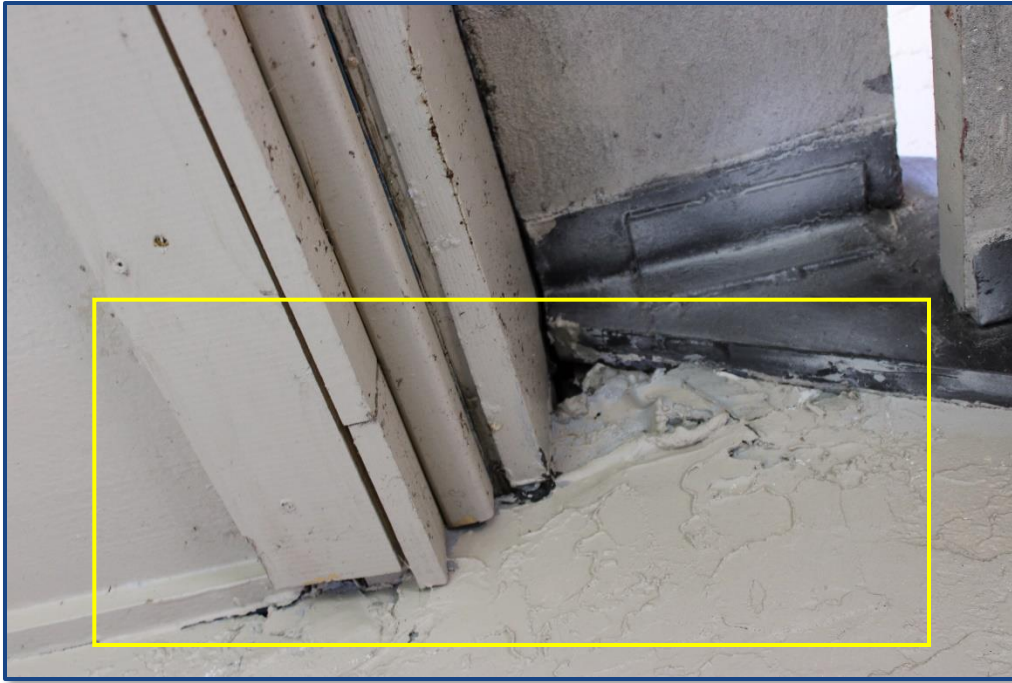
Photograph No. 9: Damage and previous patch to the exterior wall stucco finish located in the east stairway.

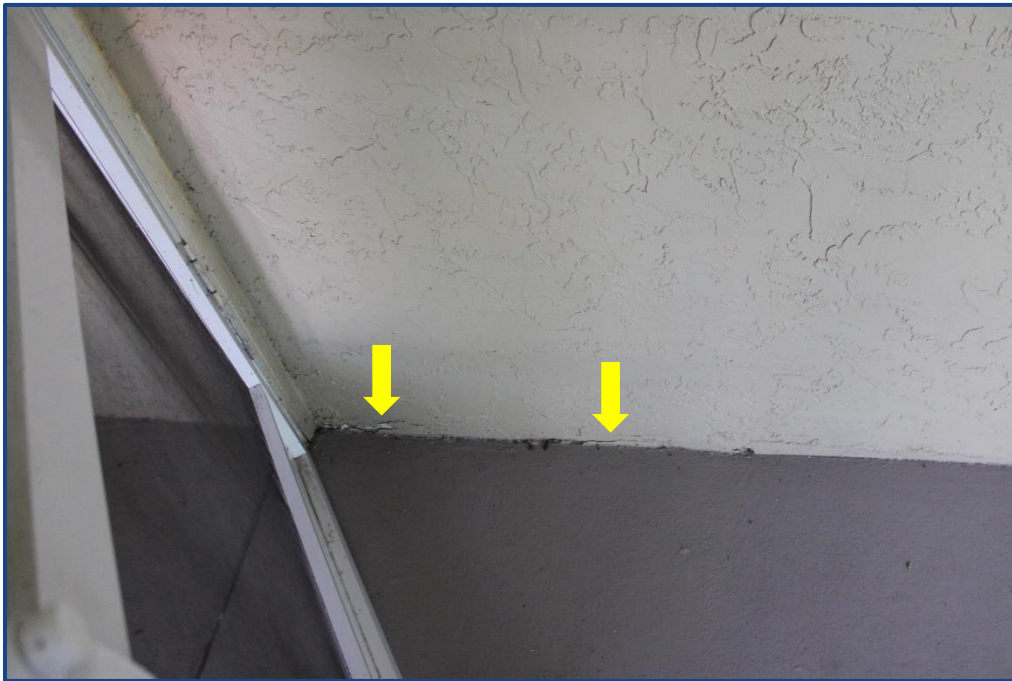
Photograph No. 10: Cracks in the exterior wall stucco finish located on Unit 203.

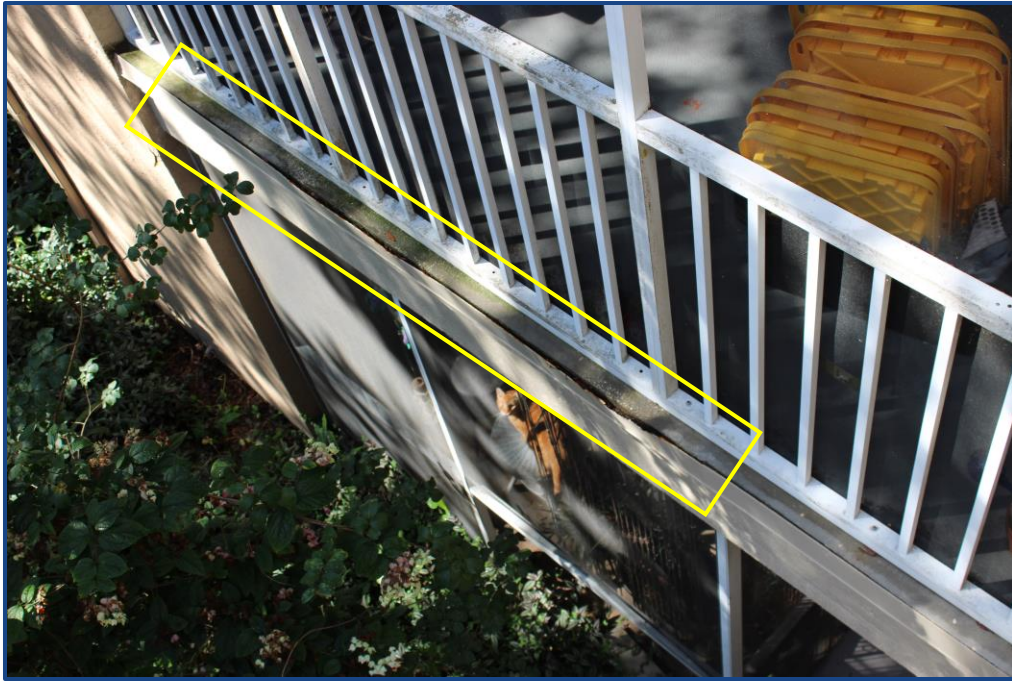
Photograph No. 11: Cracks in the balcony slab and corrosion and separation of the metal flashing at the edge of the balcony slab on Unit 202.

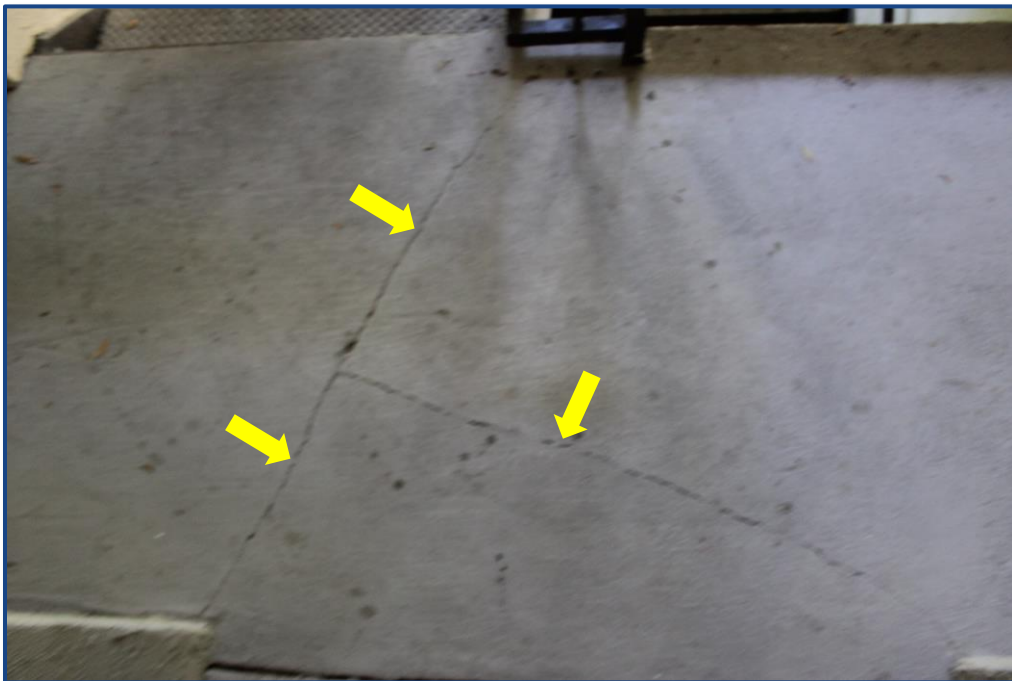
Photograph No. 12: Cracks in the concrete slab located on the 2nd floor.

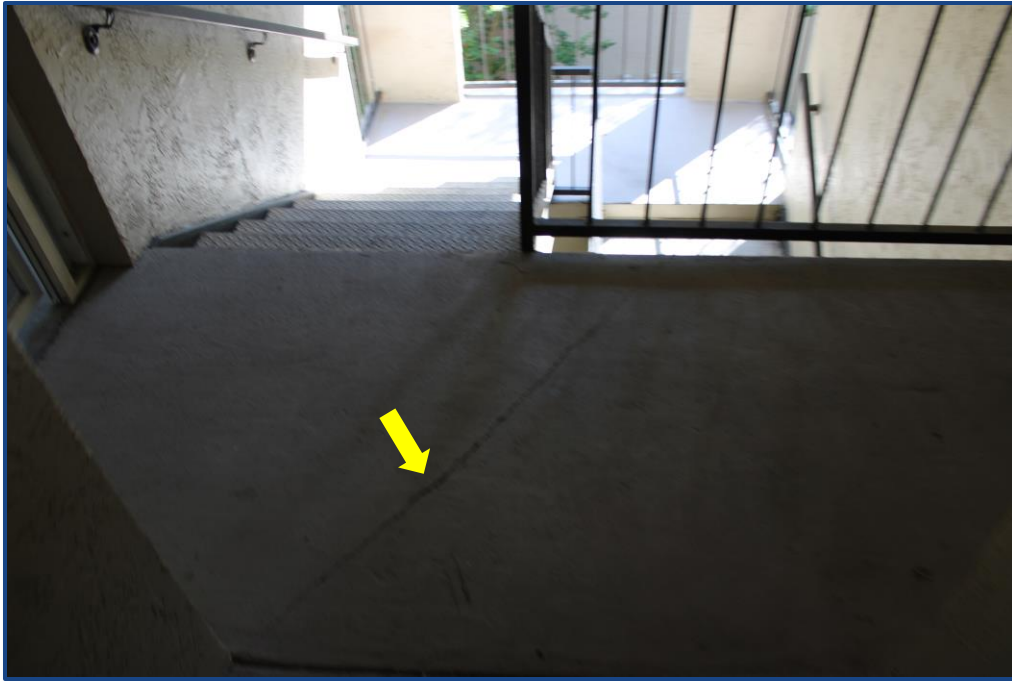
Photograph No. 13: Crack in the concrete slab located on the 3rd floor.

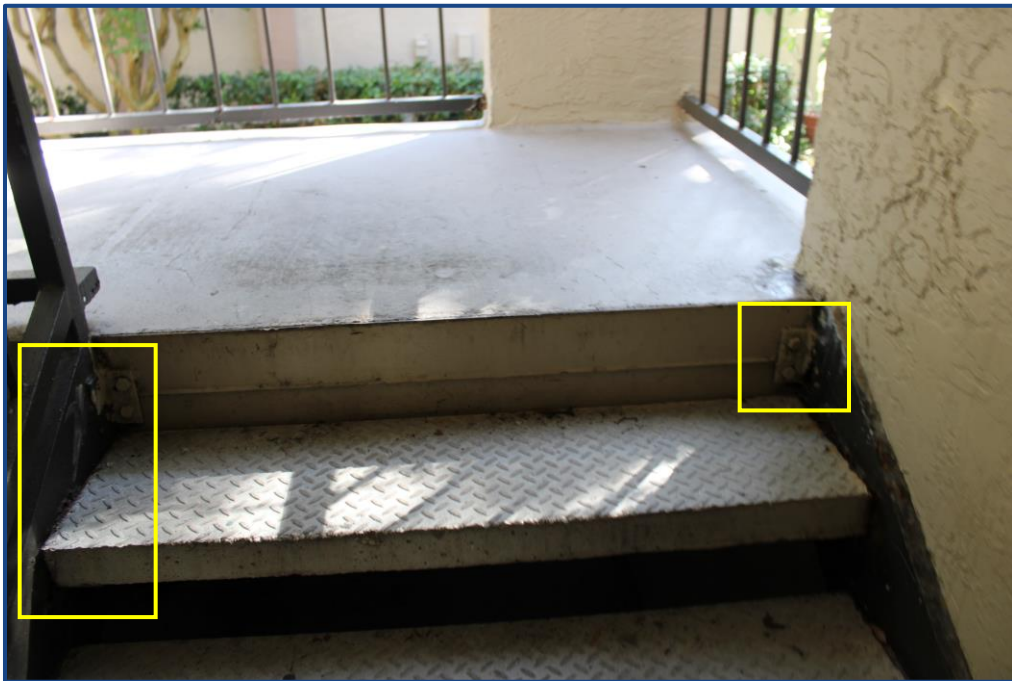
Photograph No. 14: Corrosion to the steel framing located in the east stairway.

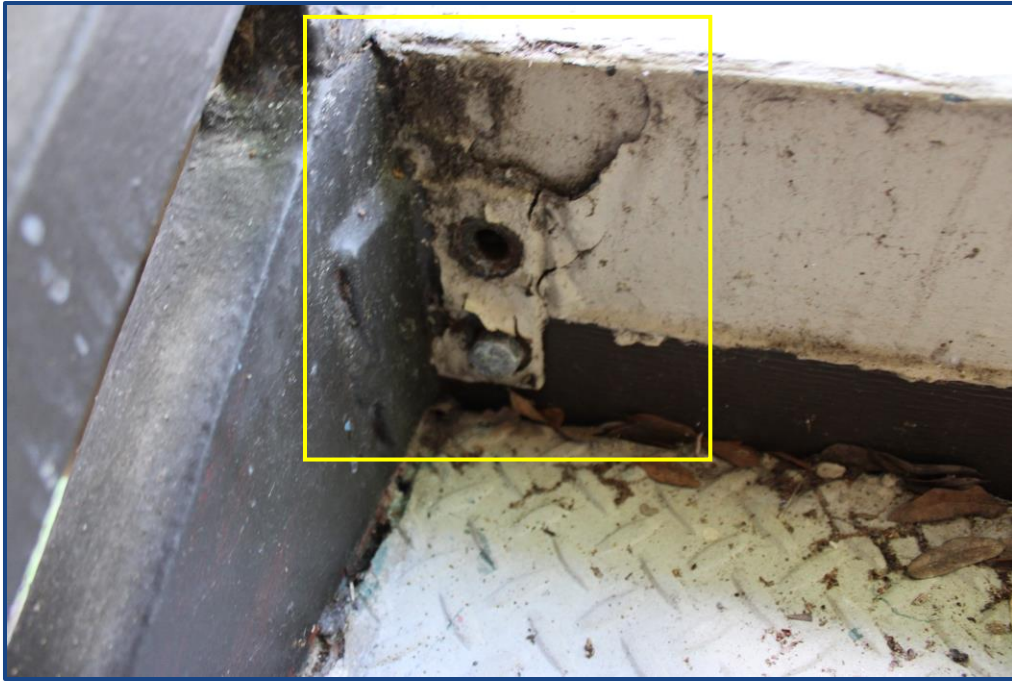
Photograph No. 15: Missing fastener and corrosion to the steel framing and metal flashing located in the west stairway.

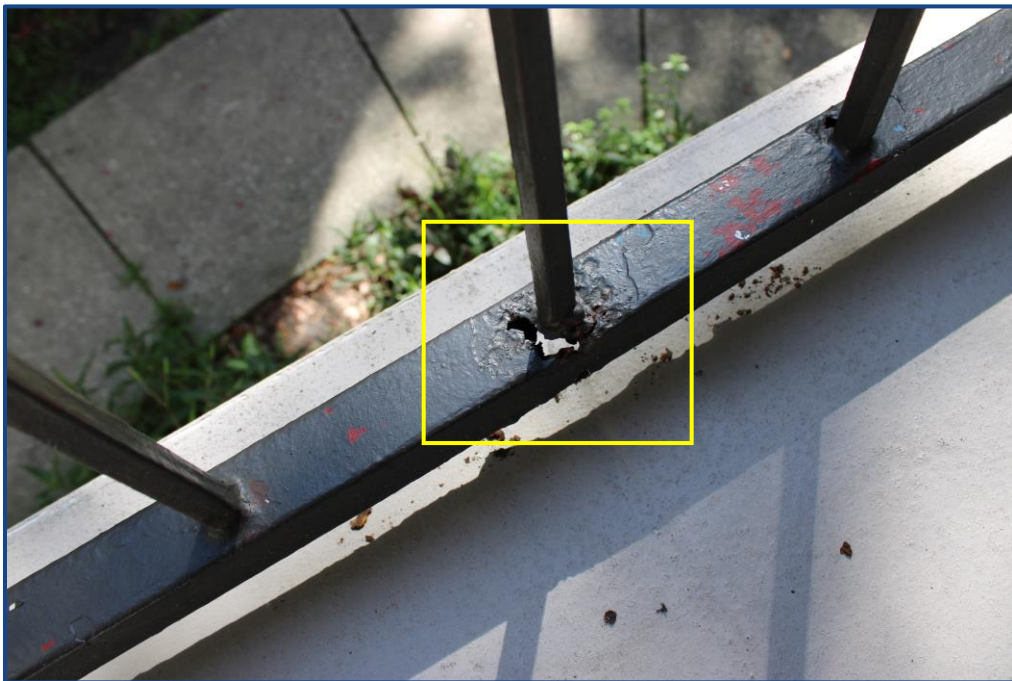
Photograph No. 16: Corrosion to the metal guardrail located in the east stairway.

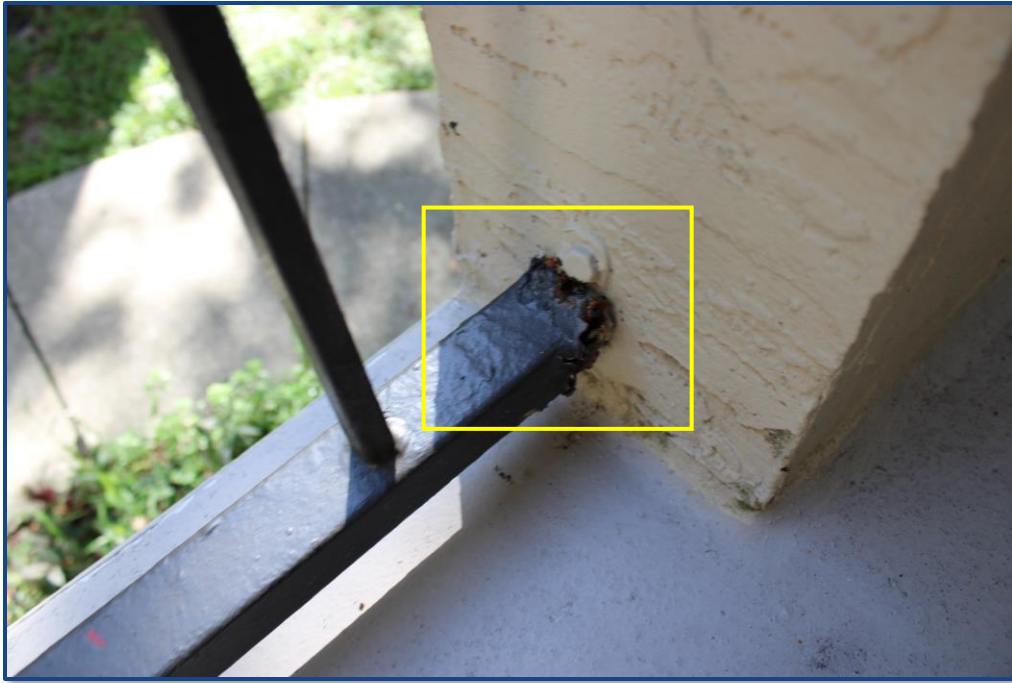
Photograph No. 17: Corrosion to the metal guardrail located in the east stairway.

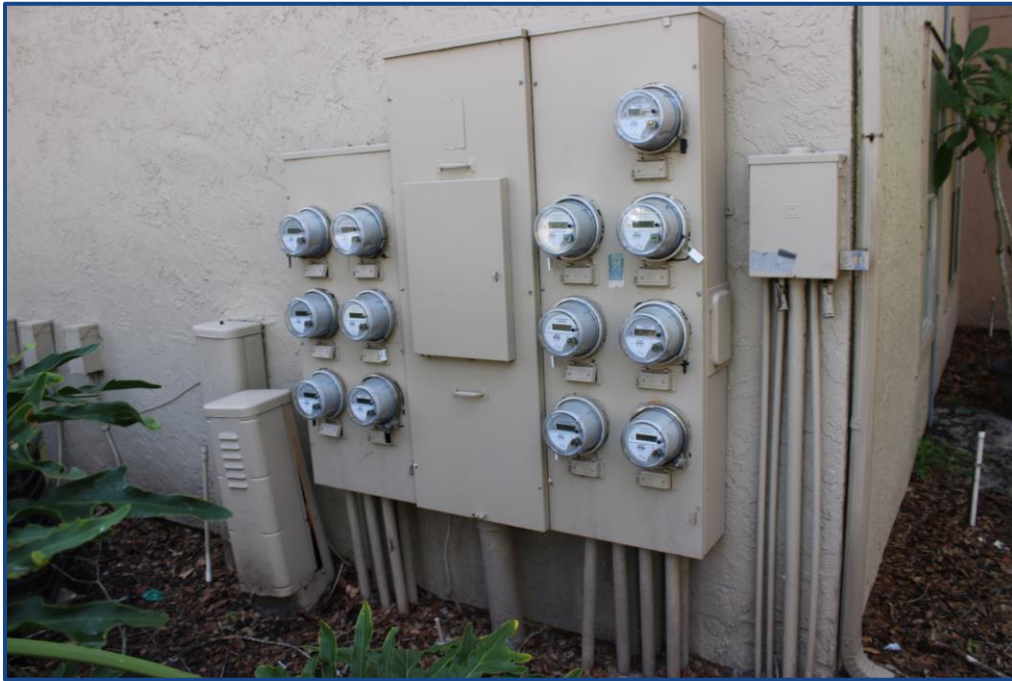
Photograph No. 18: Electrical meters.
