August 25, 2023

Janette Barcena
The Landing Condominium Association, Inc.
953 Salt Pond Place
Altamonte Springs, Florida 32714

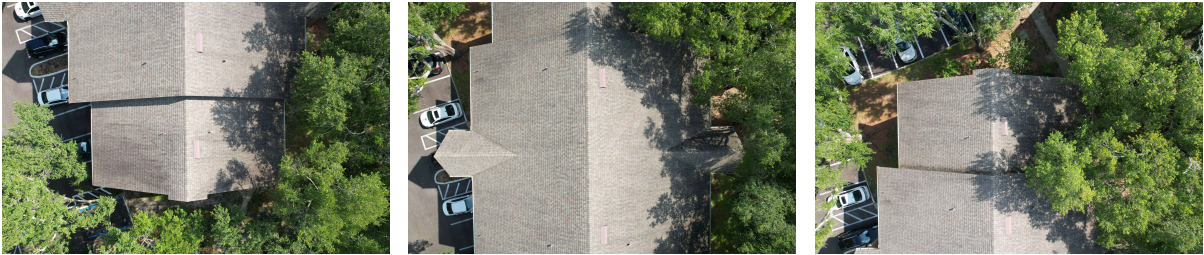
Roofing - Total Current Cost	\$25,150
Assigned Reserves	\$25,150
Fully Funded Reserves	\$6,287

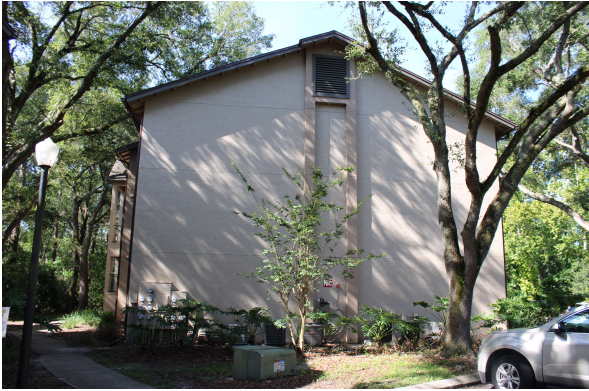
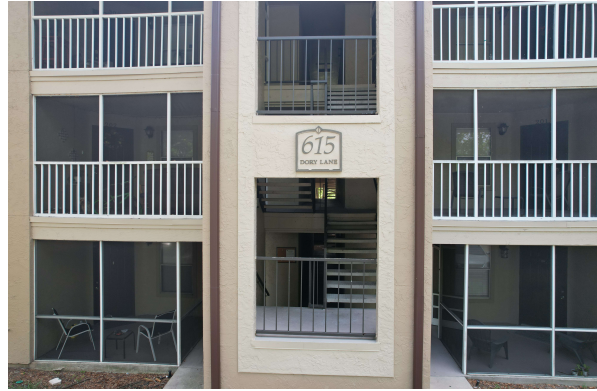
Stucco Repairs - 2030

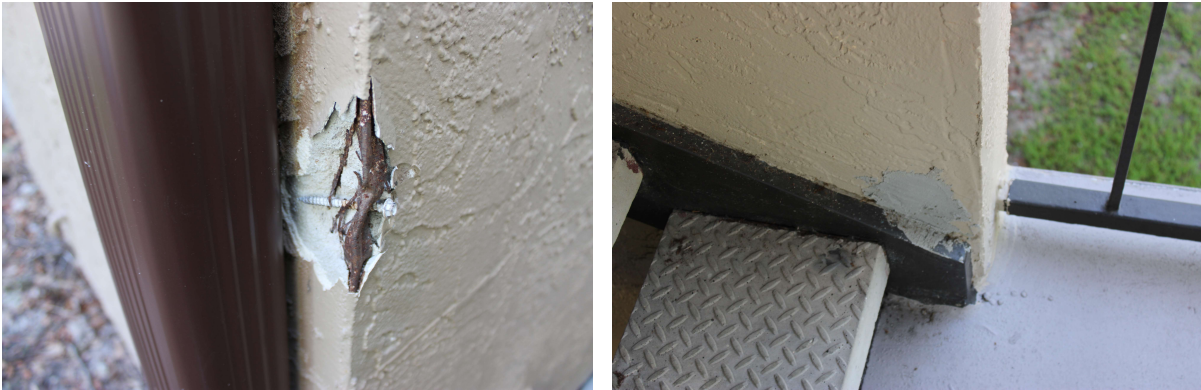
Painting - Total Current Cost	\$17,000
Assigned Reserves	\$17,000
Fully Funded Reserves	\$8,514

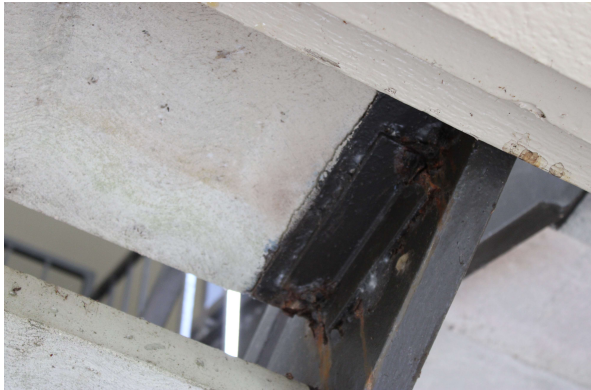
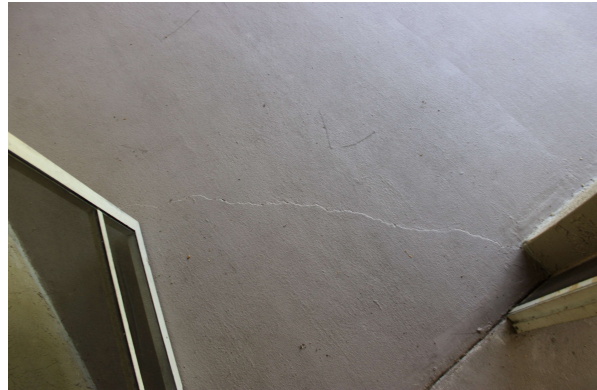
Concrete and Stairway Repairs for year 2024 shall include repairs to cracked concrete and corrosion to the steel framing referenced within this report.

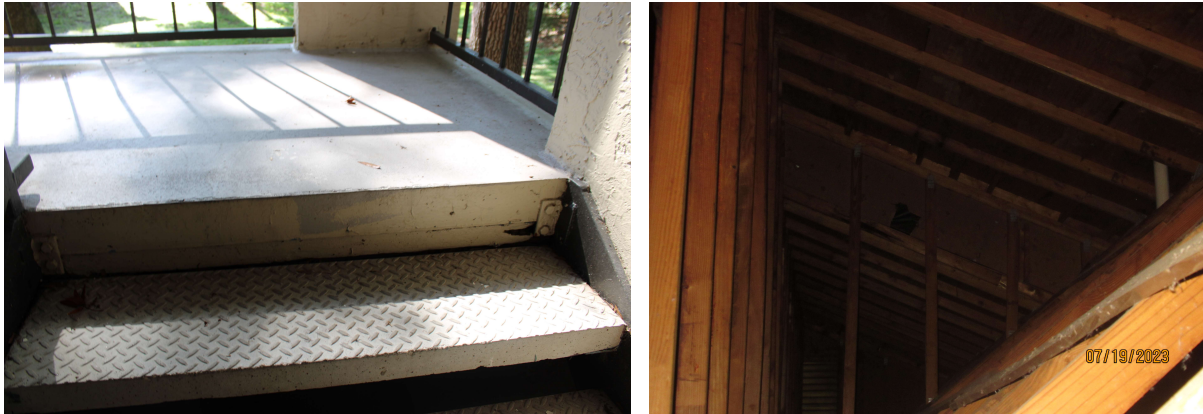
Wood Framing Repairs for year 2024 shall include repairs to the damaged wood beam and plywood wall sheathing referenced within this report.

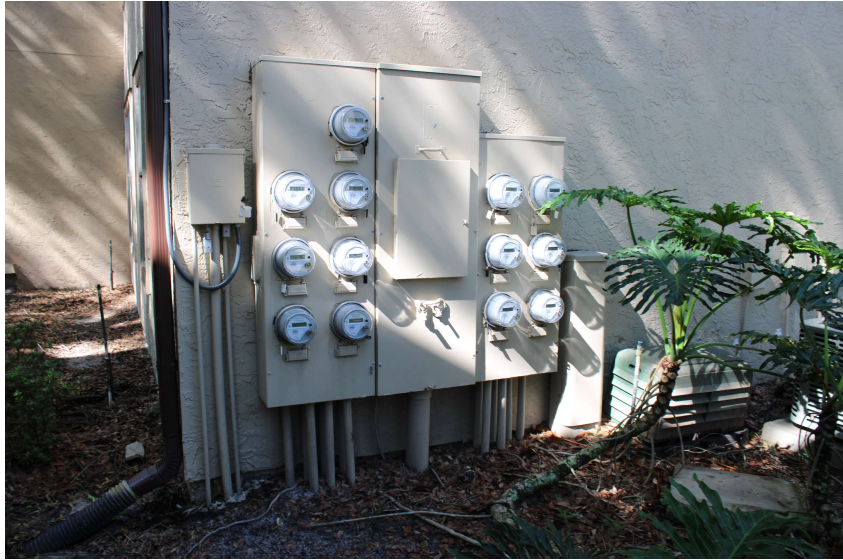
Electrical Systems - Total Current Cost	\$2,500
Assigned Reserves	\$5,000
Fully Funded Reserves	\$2,500

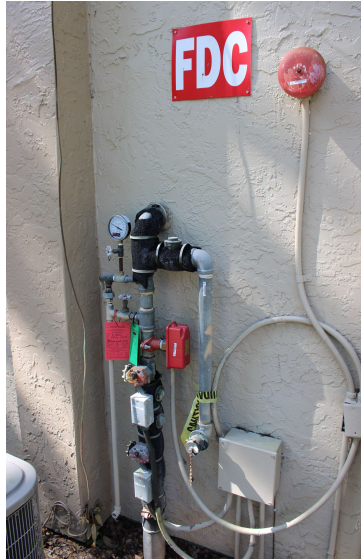
Fire Protective Systems - Total Current Cost	\$2,500
Assigned Reserves	\$5,000
Fully Funded Reserves	\$2,500

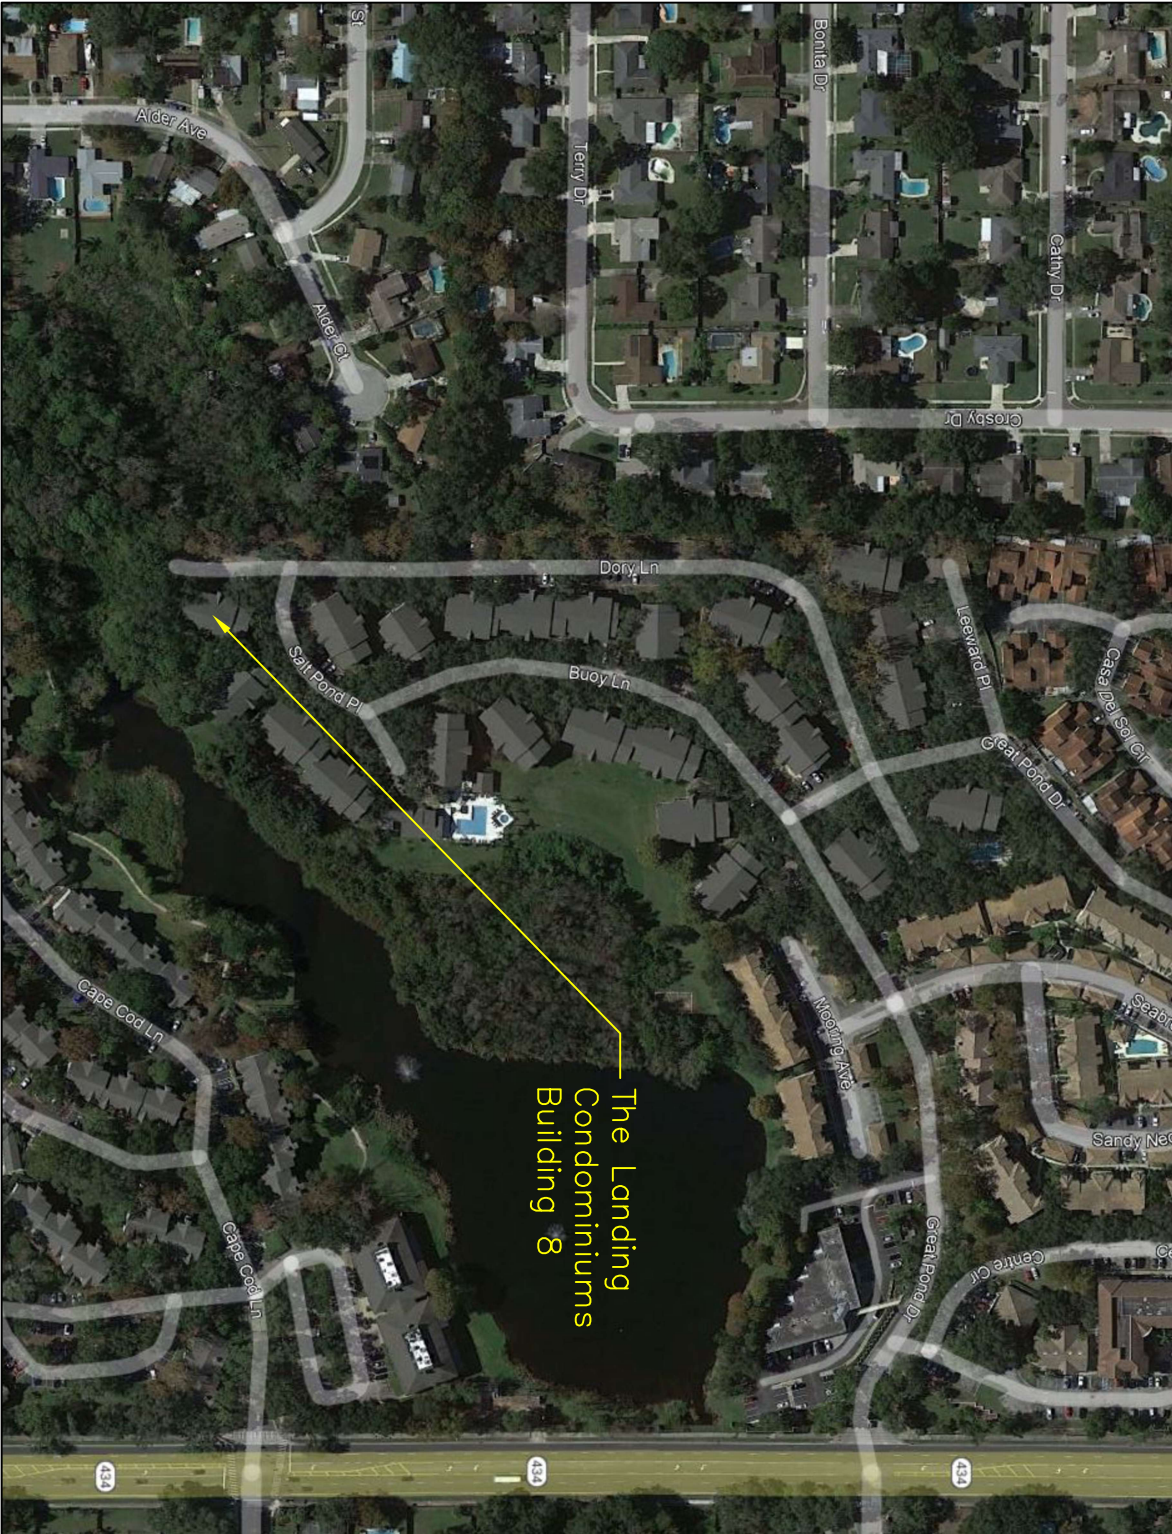
APPENDIX B
SITE LOCATION MAP

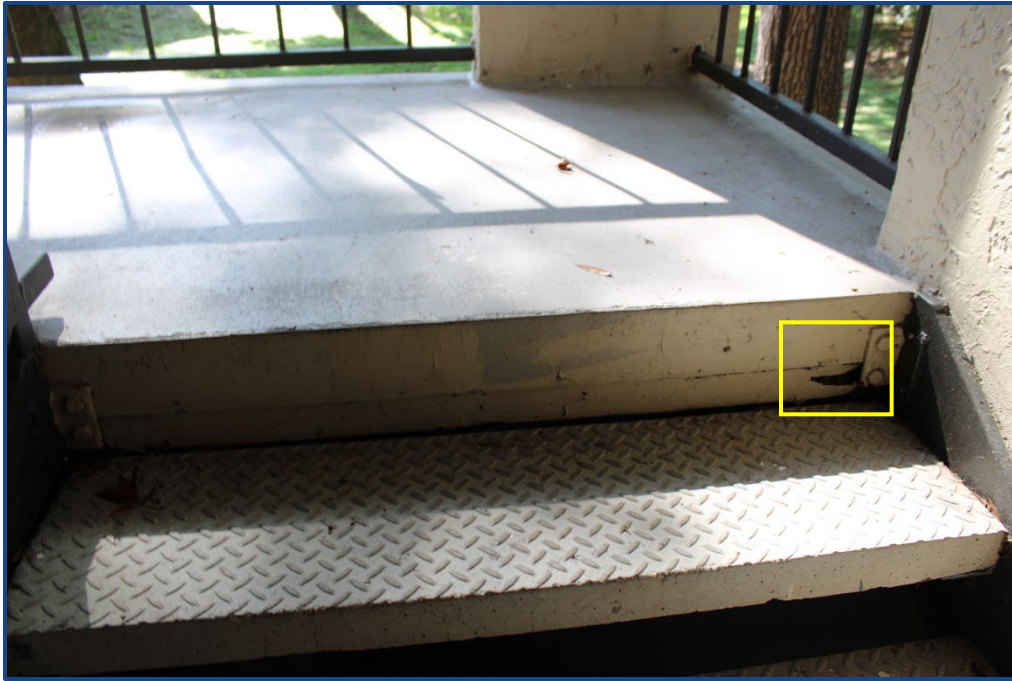
Photograph No. 11: Damage to the wood beam at the stairway landing located in the east stairway.

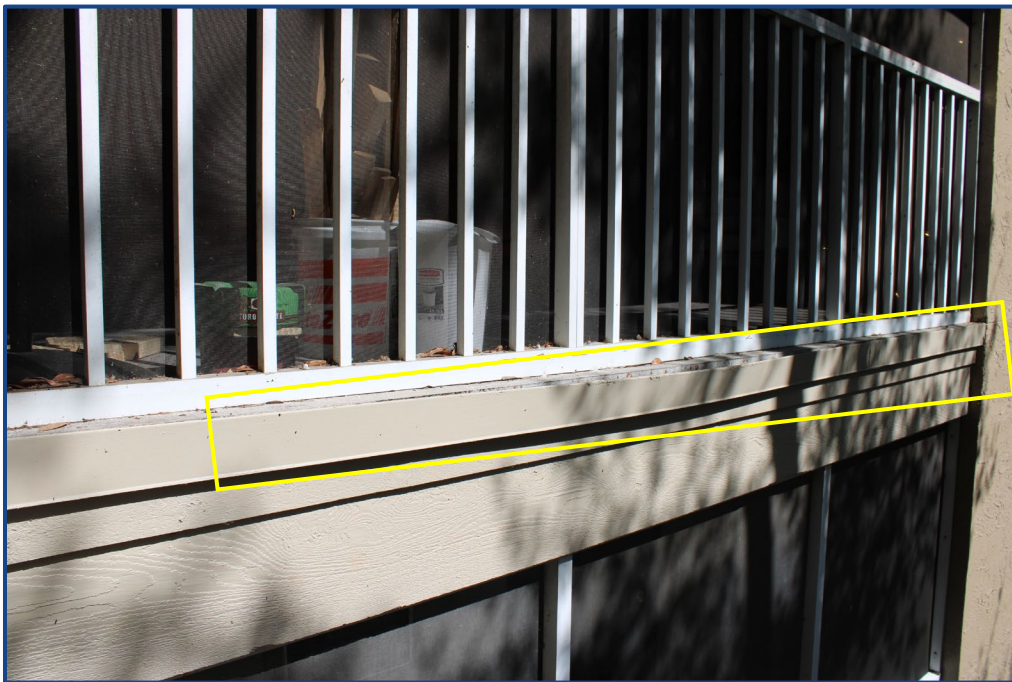
Photograph No. 12: Corrosion and separation of the metal flashing at the edge of the balcony slab on Unit 203.

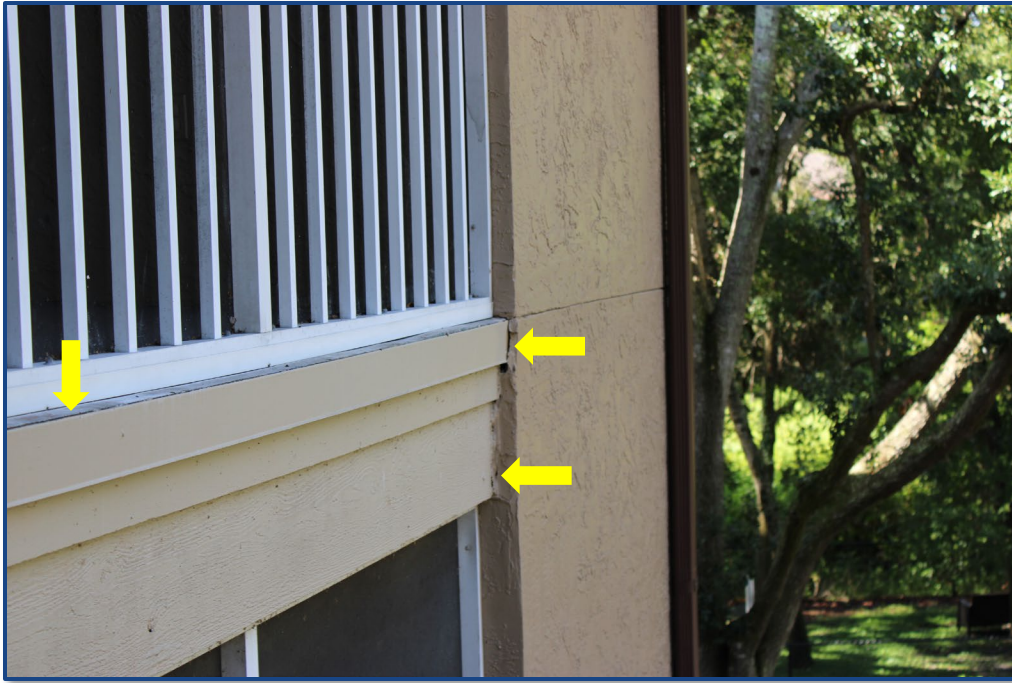
Photograph No. 13: Cracks in the stucco wall finish and separation of the metal flashing at the edge of the balcony slab on Unit 303.

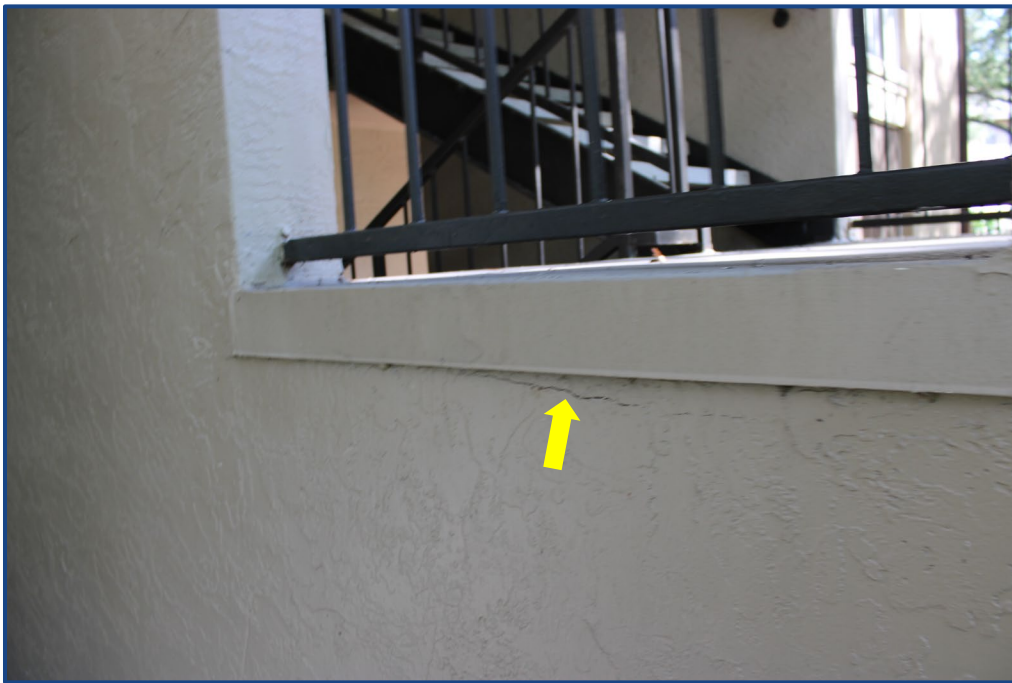
Photograph No. 14: Crack in the exterior wall stucco finish located on the east stairway.

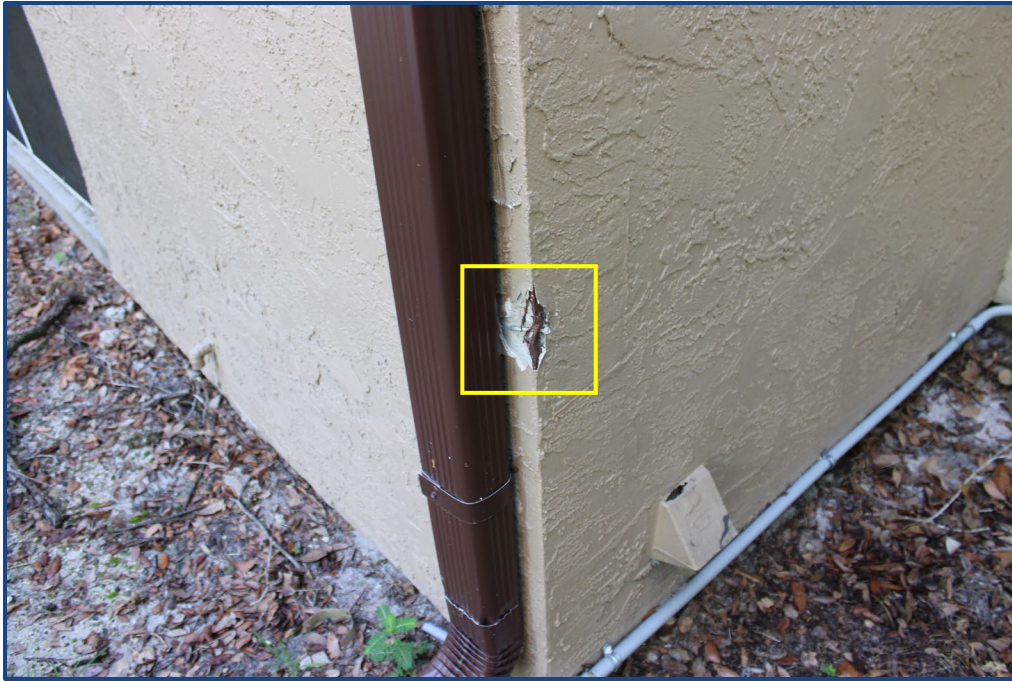
Photograph No. 15: Damage to the exterior wall stucco finish located at the west side of the building.

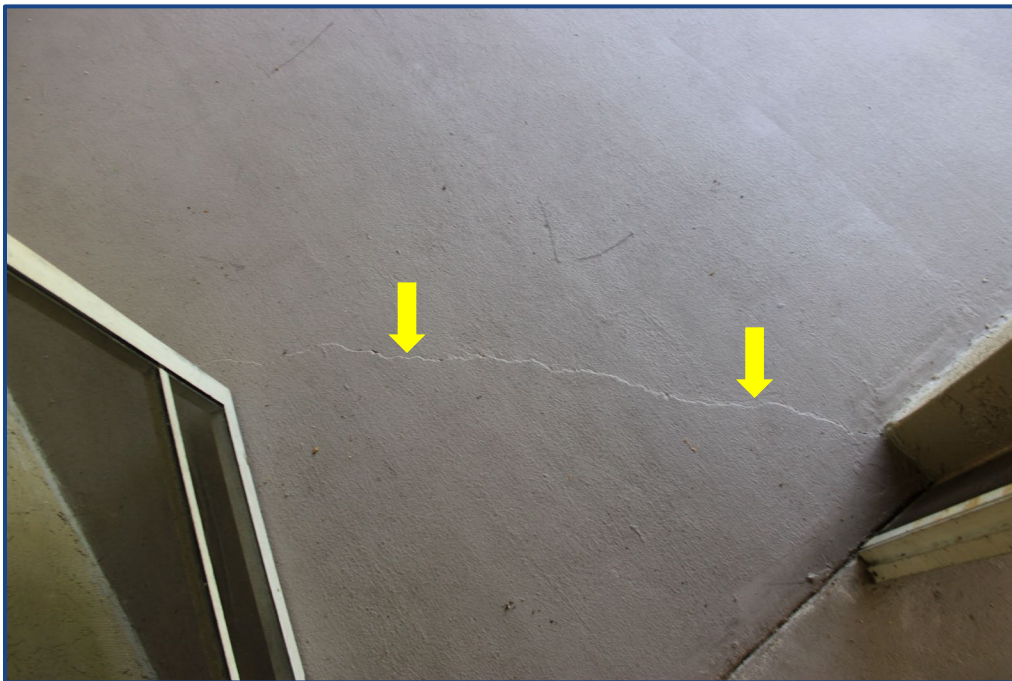
Photograph No. 16: Crack in the concrete balcony slab on Unit 303.

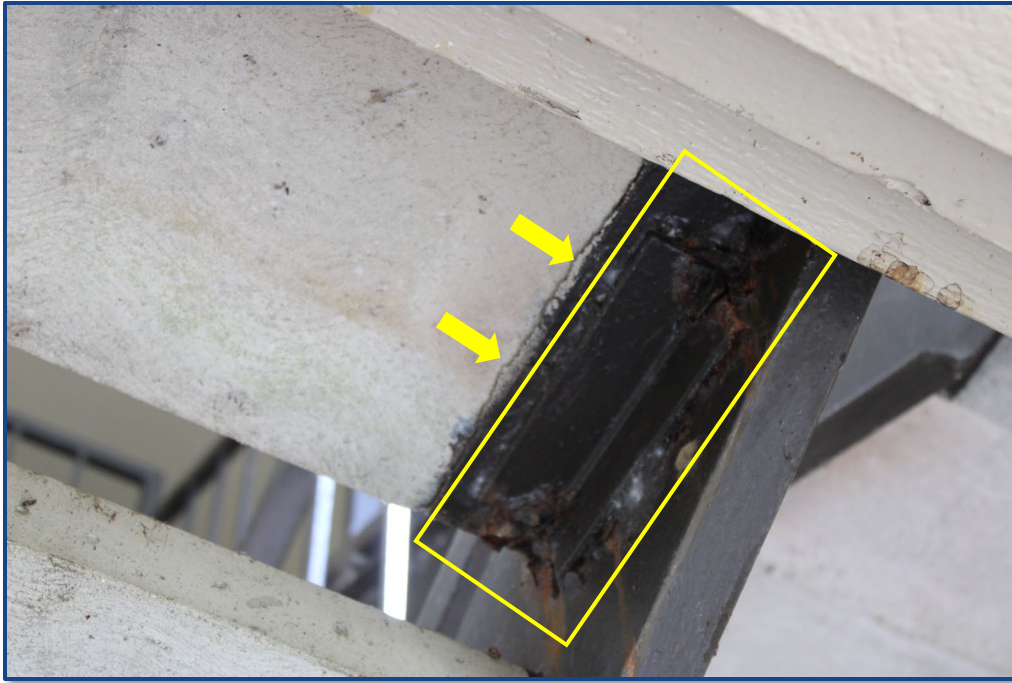
Photograph No. 17: Crack in a concrete step and corrosion to the steel framing located in the west stairway.

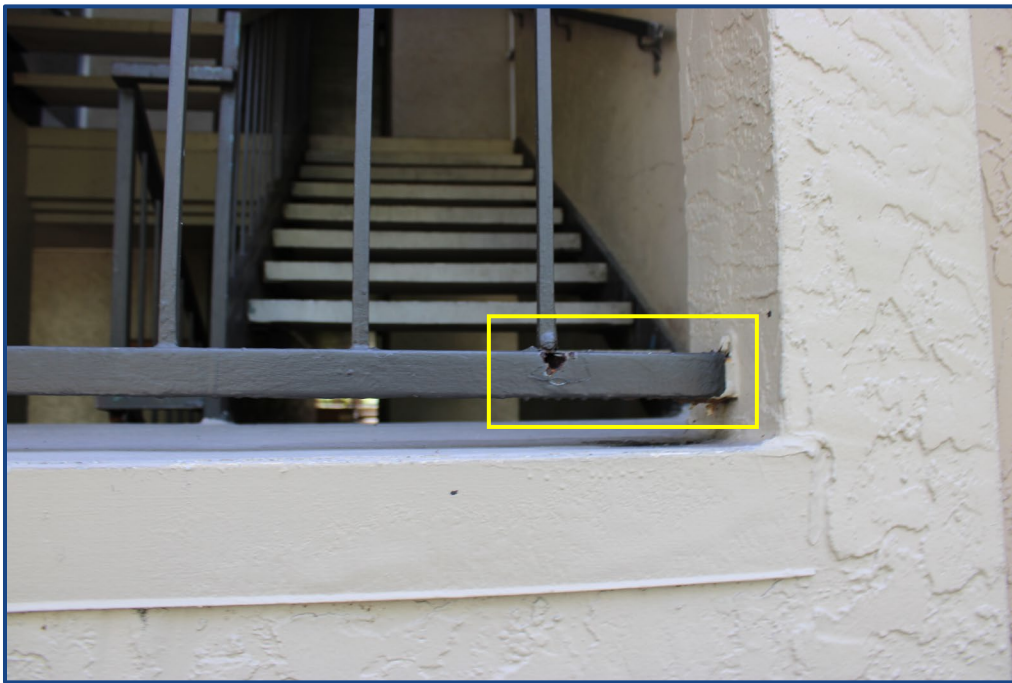
Photograph No. 18: Corrosion to the metal guardrail located in the west stairway.

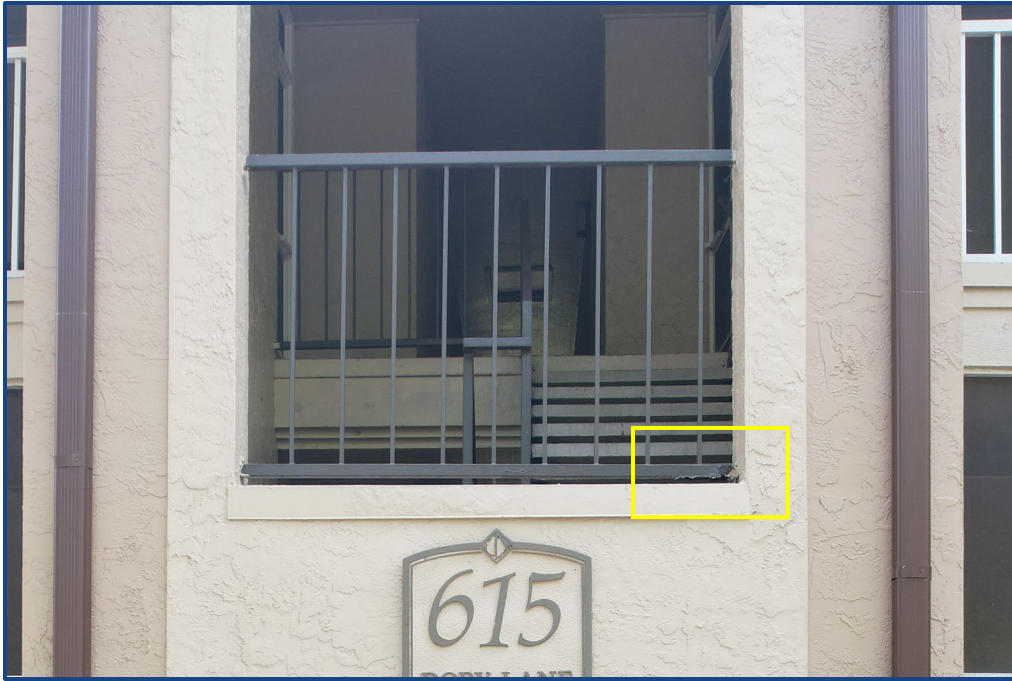
Photograph No. 19: Corrosion to the metal guardrail located in the west stairway.

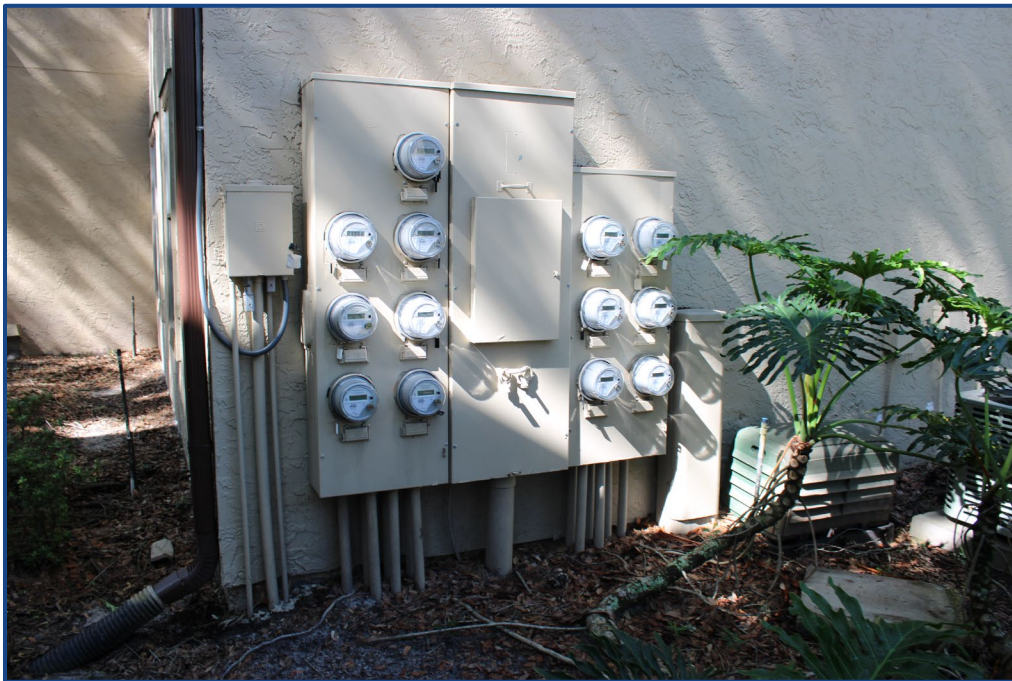
Photograph No. 20: Electrical meters.
