August 25, 2023

Janette Barcena
The Landing Condominium Association, Inc.
953 Salt Pond Place
Altamonte Springs, Florida 32714

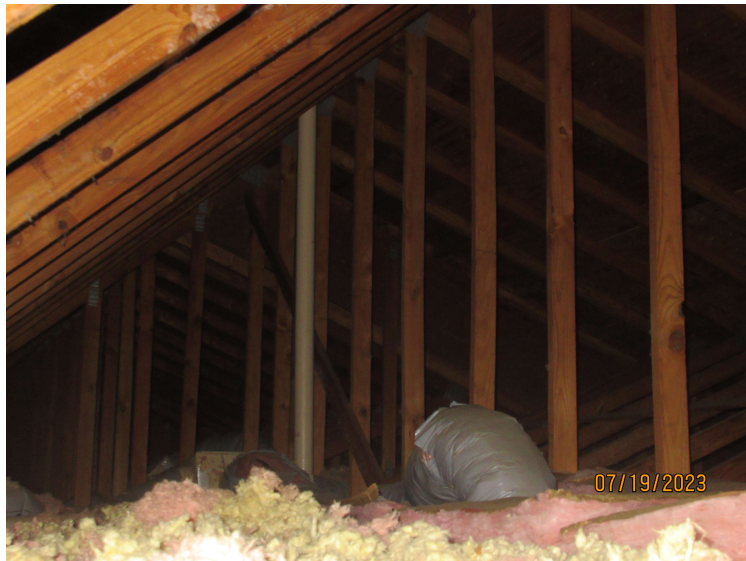
Plumbing - Total Current Cost	\$2,500
Assigned Reserves	\$5,000
Fully Funded Reserves	\$2,500

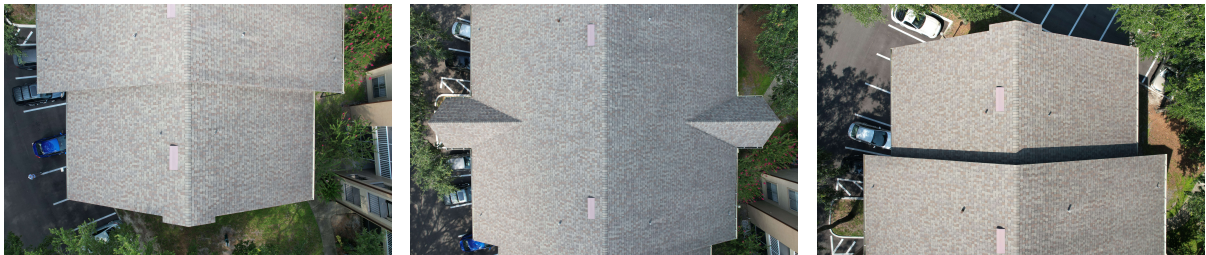
Roofing - Total Current Cost	\$25,150
Assigned Reserves	\$25,150
Fully Funded Reserves	\$6,287

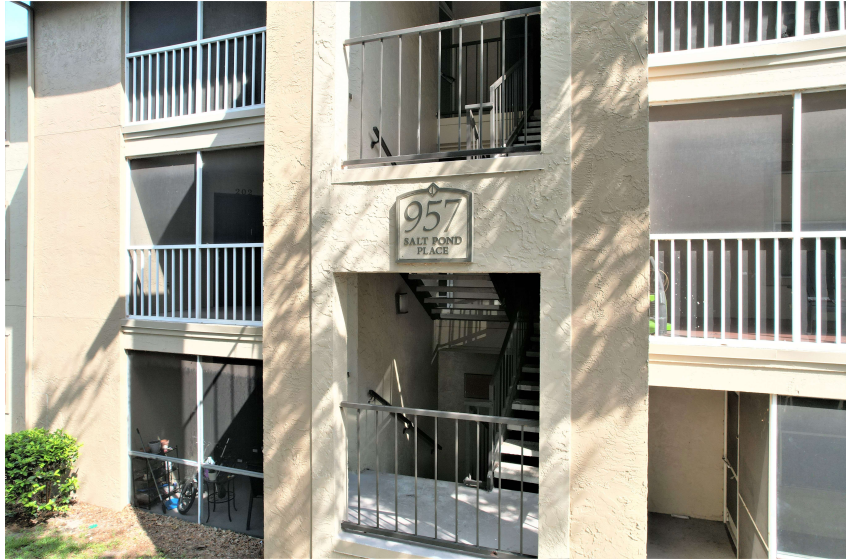
Stucco Repairs - 2030

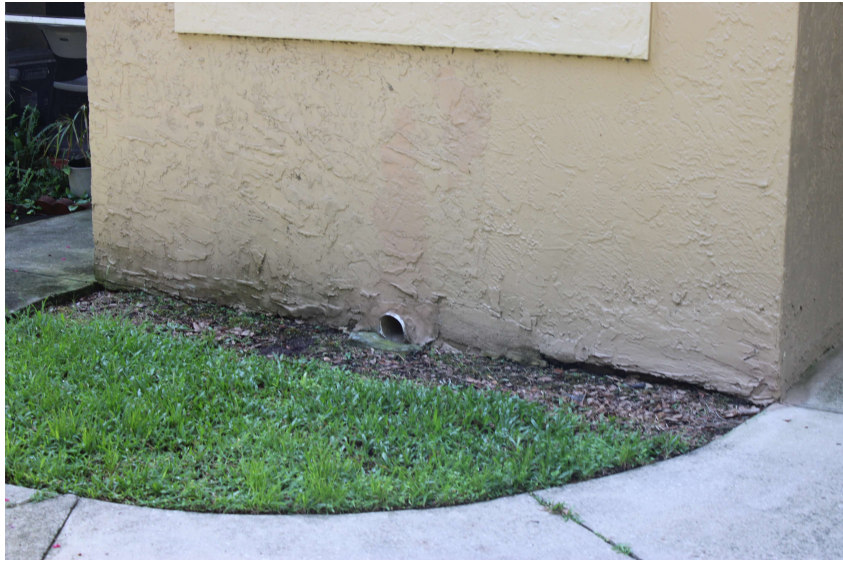
Painting - Total Current Cost	\$17,000
Assigned Reserves	\$17,000
Fully Funded Reserves	\$8,514

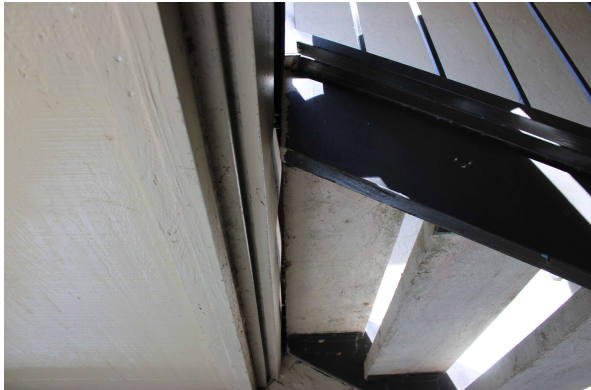
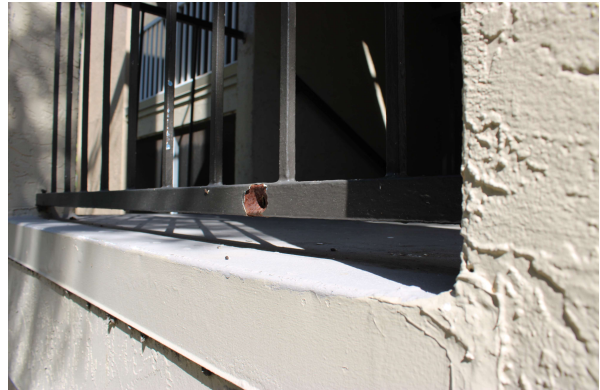
Concrete and Stairway Repairs for year 2024 shall include repairs to cracked concrete and corrosion to the steel framing referenced within this report.

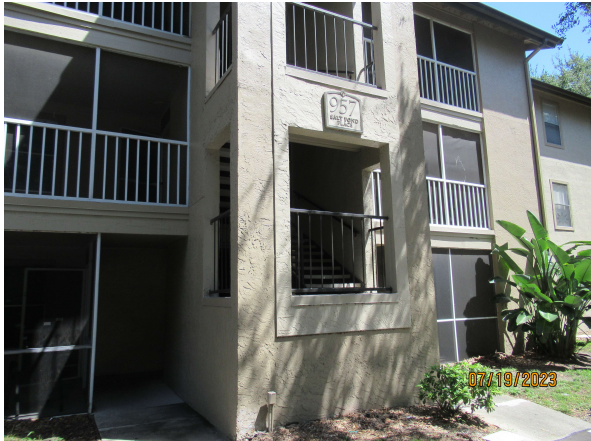
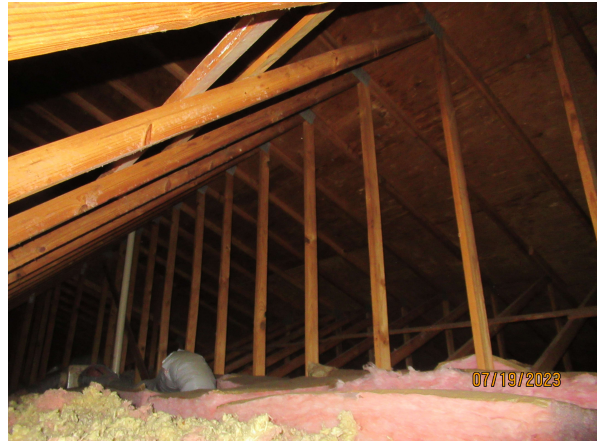
Wood Framing Repairs for year 2024 shall include repairs to the damaged wood beam referenced within this report.

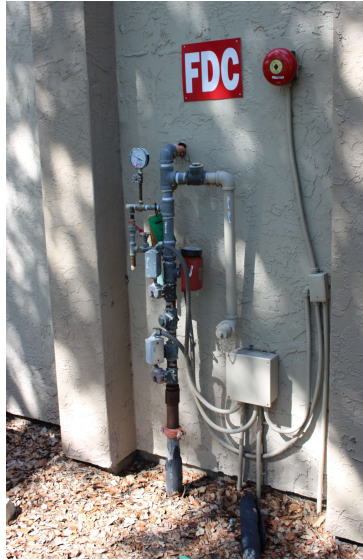
Fire Protective Systems - Total Current Cost	\$2,500
Assigned Reserves	\$5,000
Fully Funded Reserves	\$2,500

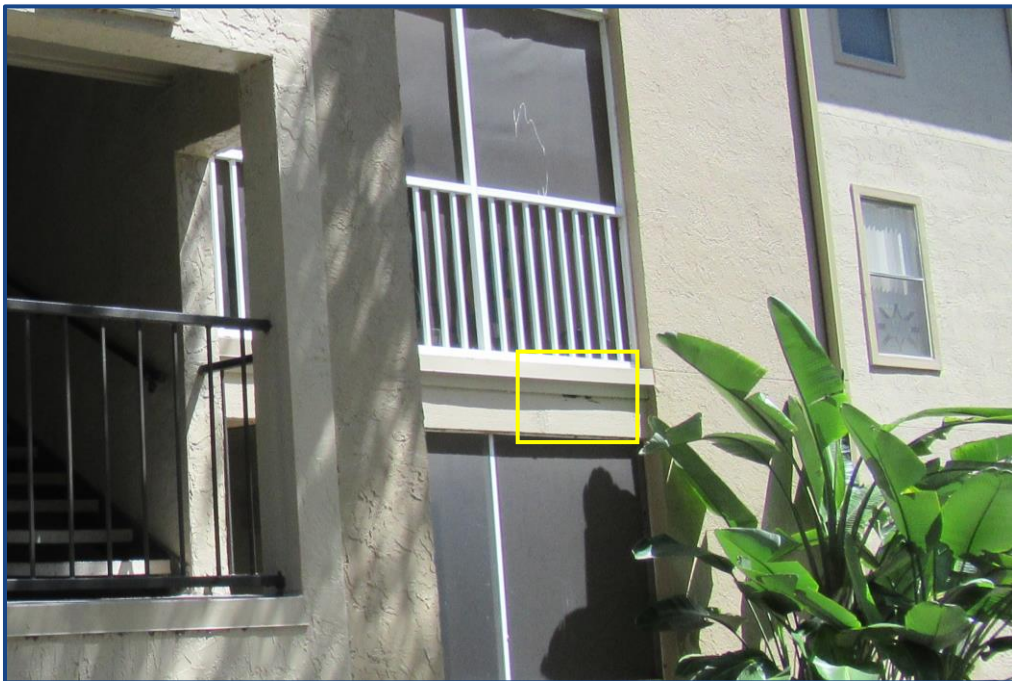
Photograph No. 10: Damage to the wood beam located at the balcony edge of Unit 201.

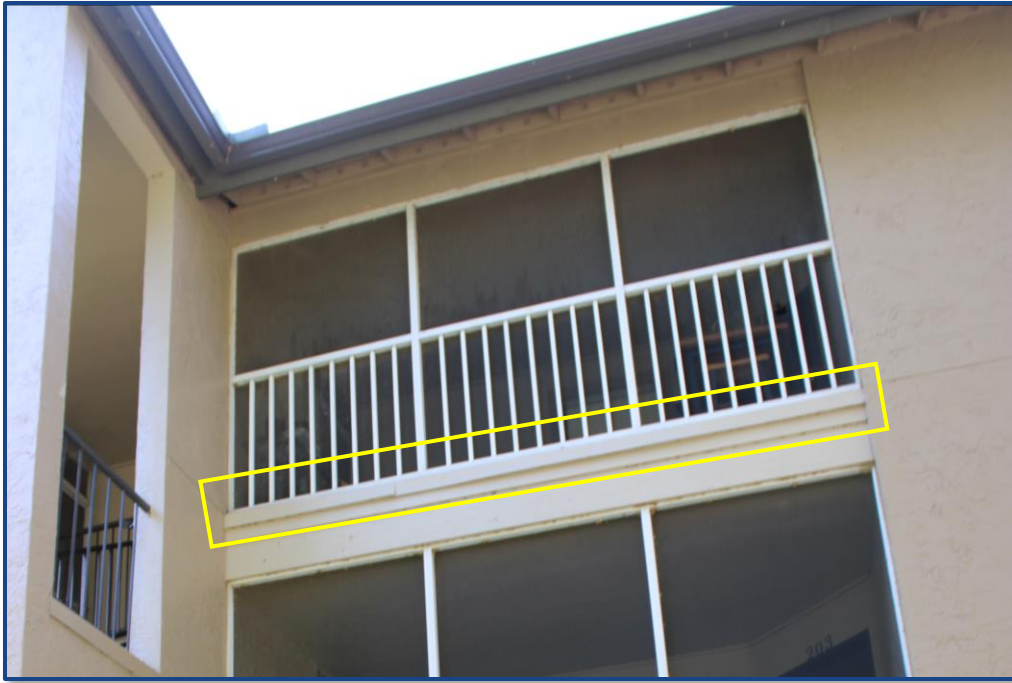
Photograph No. 11: Damage and separation to the metal flashing at the edge of the balcony slab on Unit 303.

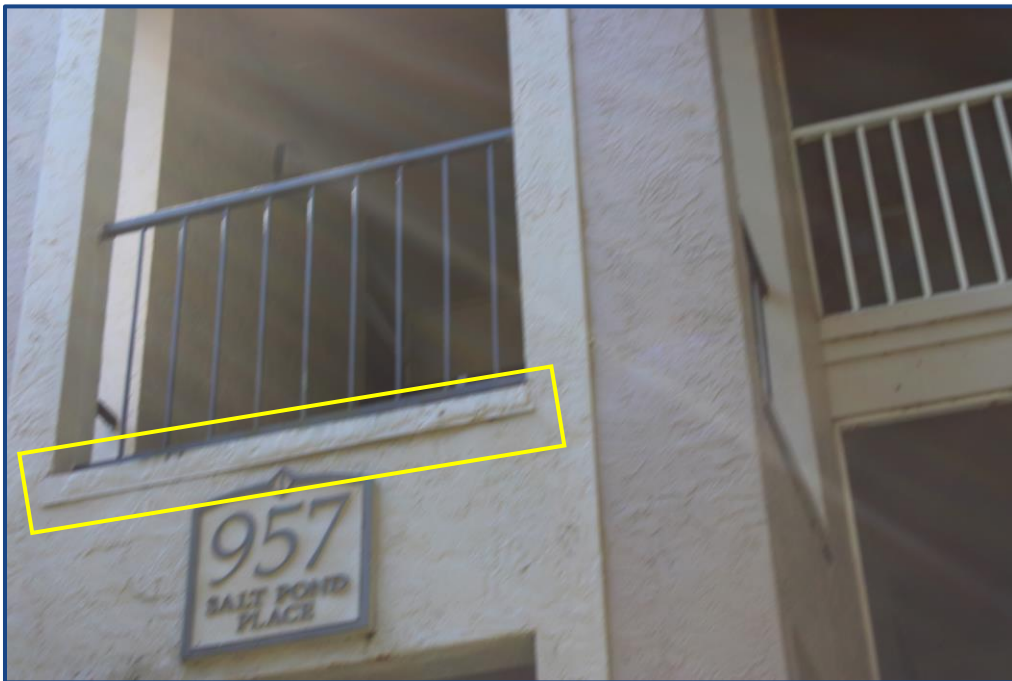
Photograph No. 12: Corrosion and damage to the metal flashing at the edge of the stairway landing slab at the north stairway.

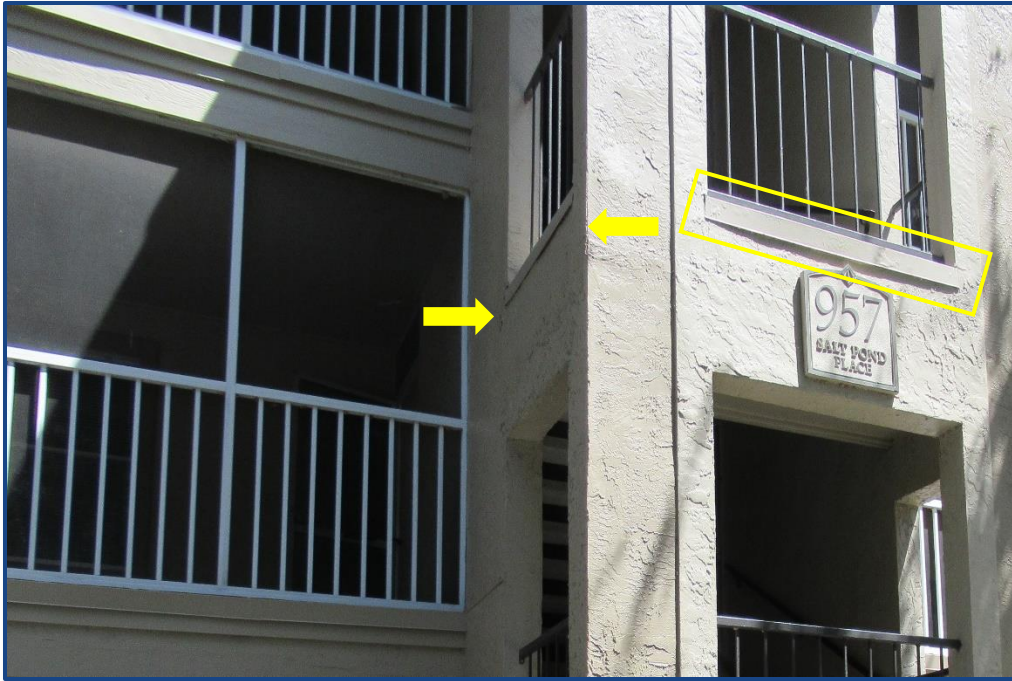
Photograph No. 13: Cracks in the stucco wall finish and corrosion and damage to the metal flashing at the edge of the stairway landing slab at the south stairway.

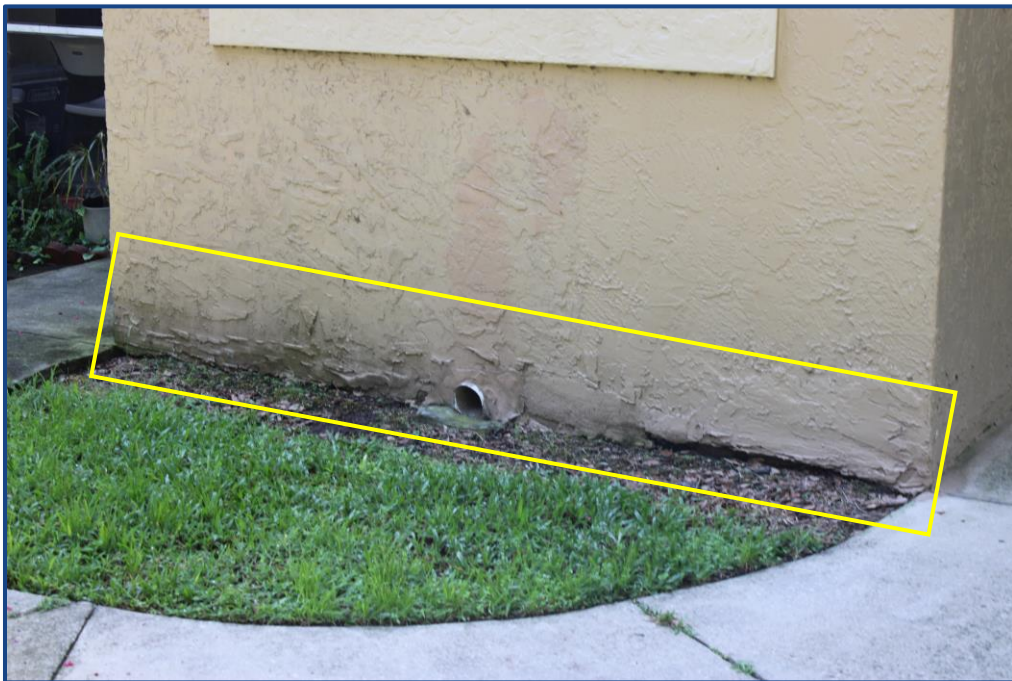
Photograph No. 14: Damage to the previously patched exterior wall stucco located at the drainage scupper in the north stairway.

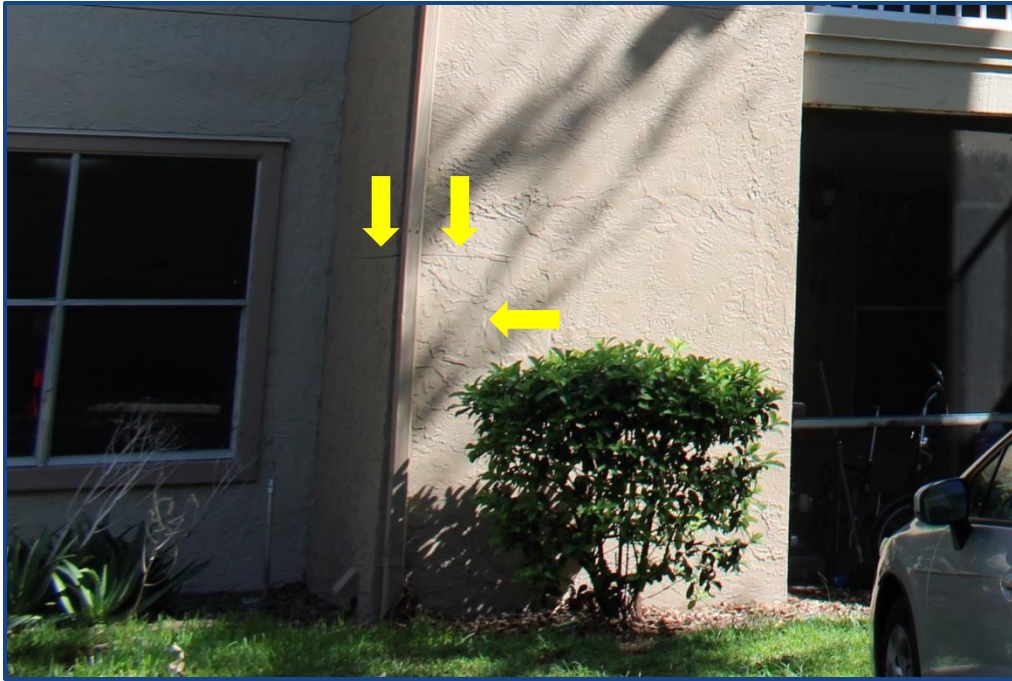
Photograph No. 15: Cracks in the exterior wall stucco finish located on the south side of the building.

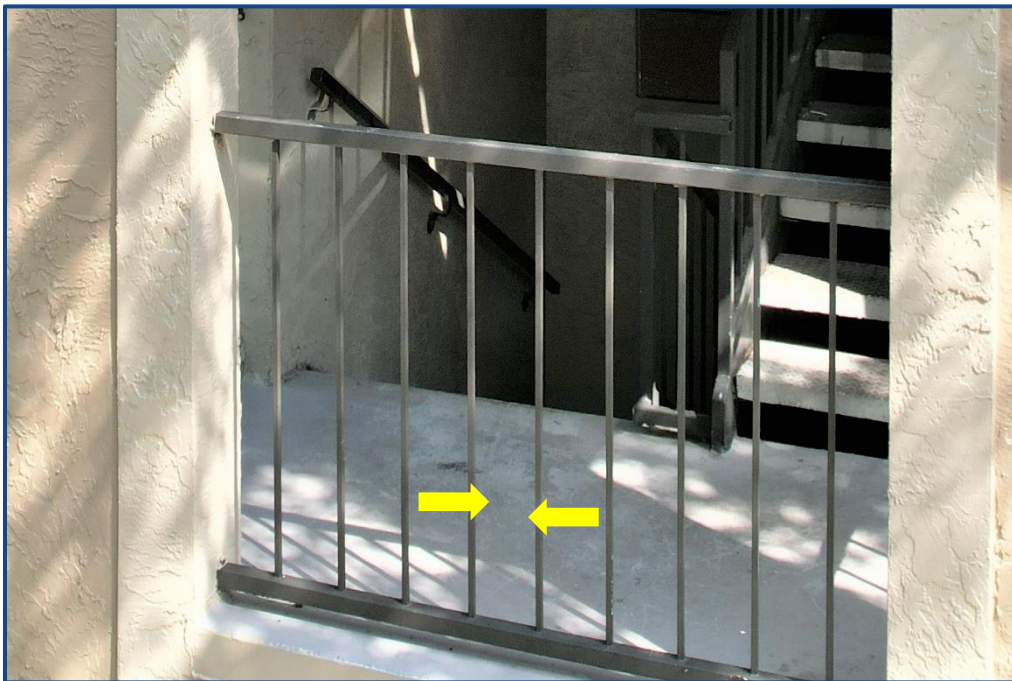
Photograph No. 16: Cracks in the stairway landing in the south stairway.

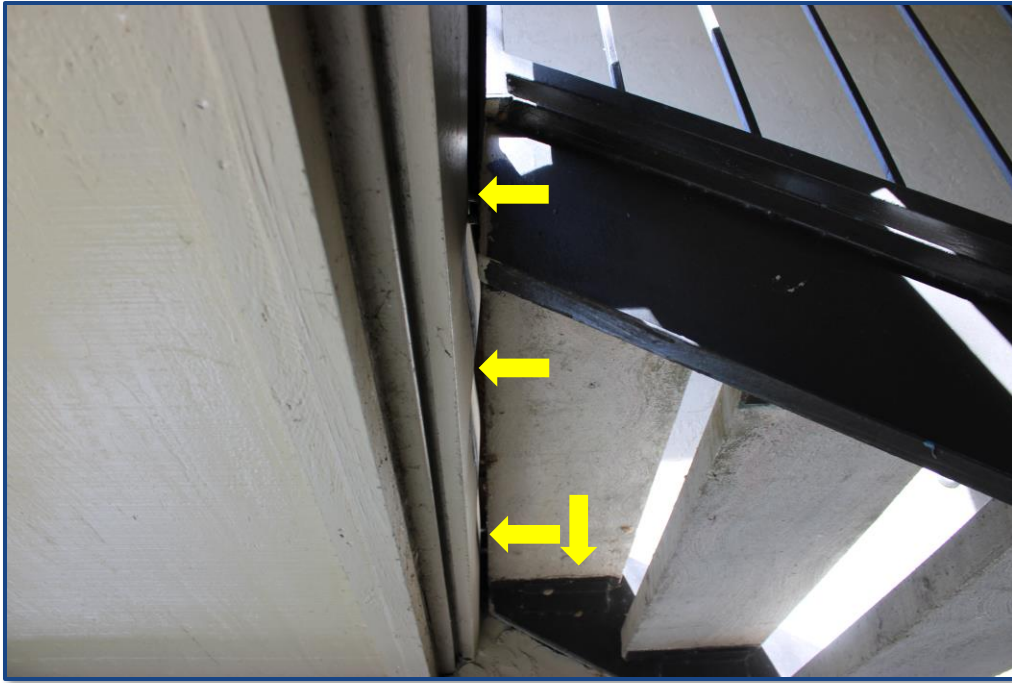
Photograph No. 17: Crack in a concrete step and separation of the steel framing from the stairway landing slab located in the south stairway.

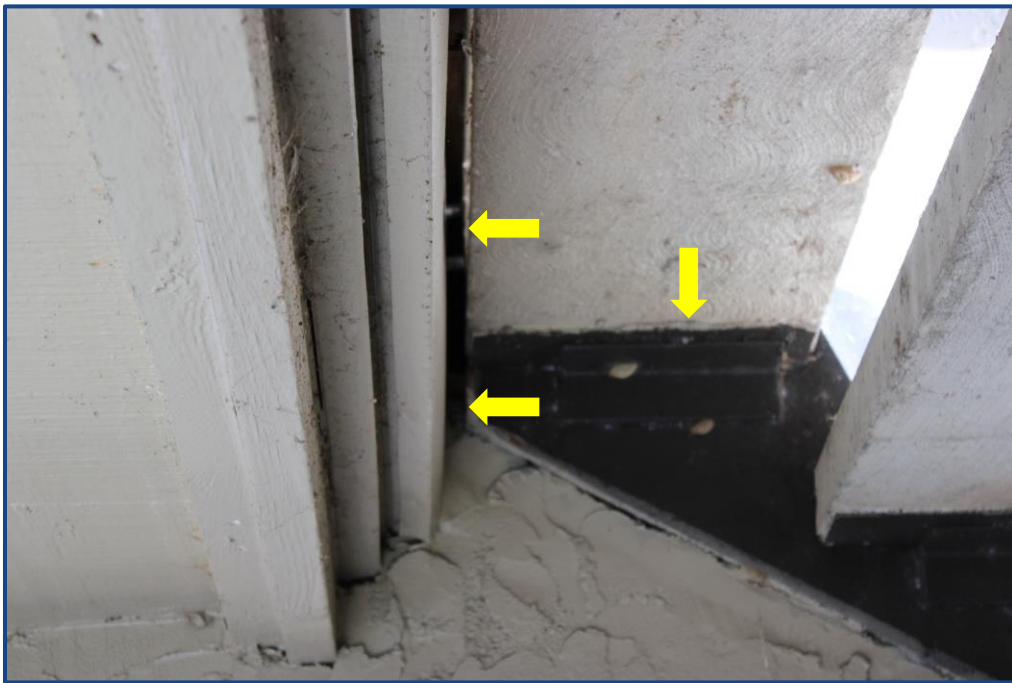
Photograph No. 18: Close-up view of the damages in Photograph No. 17.

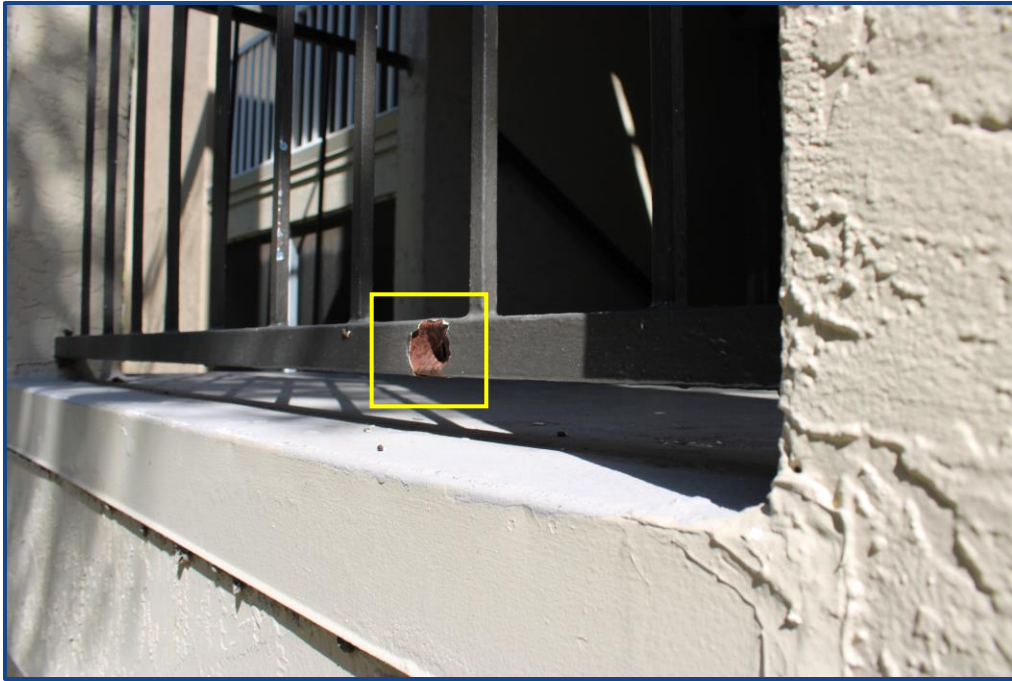
Photograph No. 19: Damage and corrosion to the metal guardrail located in the south stairway.

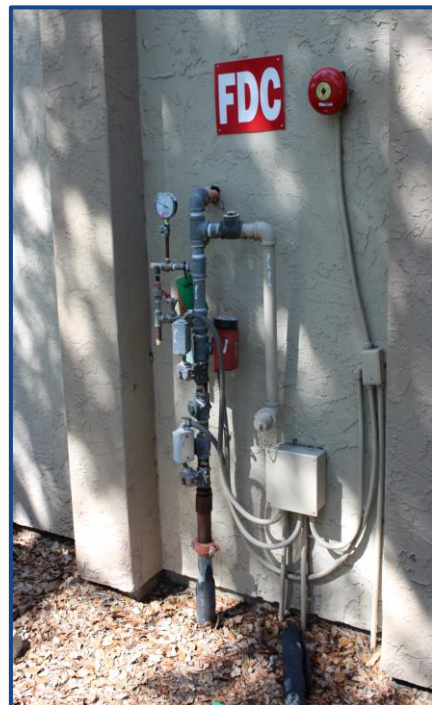
Photograph No. 20: Fire riser system and fire alarm.
