August 25, 2023

Re: The Landing Condominiums – Building 17  
Structural Integrity Reserve Study (SIRS)  
974 Leeward Place  
Altamonte Springs, FL 32714  
UES Project No: 0811.2300006.0000

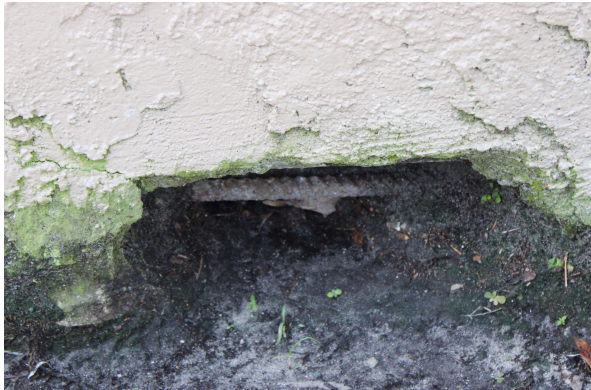
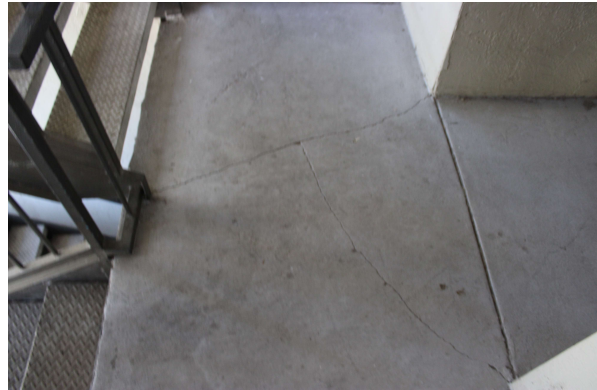
**Concrete and Stairway Repairs - 2024**

Concrete and Stairway Repairs for year 2024 shall include repairs to cracked concrete and exposed reinforcement steel referenced within this report.

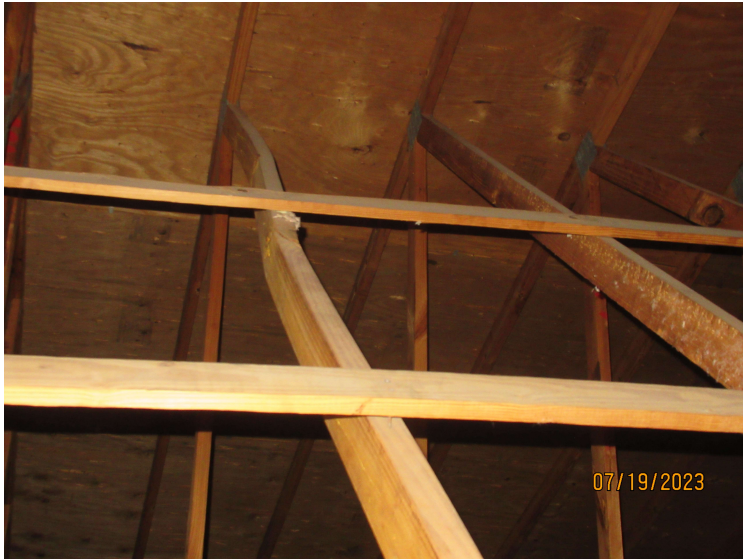
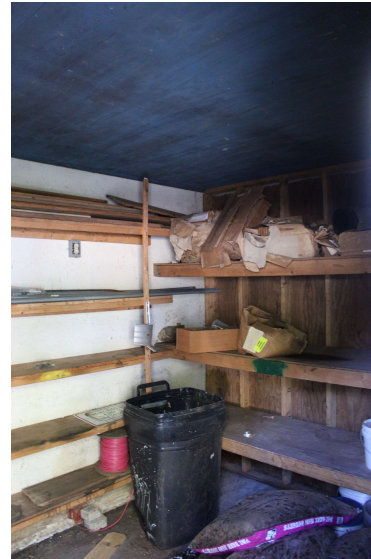
**Wood Framing Repairs - 2024**

Wood Framing Repair for year 2024 shall include repairs to the broken roof truss referenced within this report.
