Re: The Landing Condominiums – Building 11  
Structural Integrity Reserve Study (SIRS)  
623 Dory Lane  
Altamonte Springs, FL 32714  
UES Project No: 0811.2300006.0000

UES Milestone Inspections, LLC (UES) has completed the mandatory Structural Integrity Reserve Study (“SIRS”) as required for condominiums and cooperative buildings for the above referenced property. UES’s assessment was performed in general accordance with Florida Statute (FS)718.112(2)(g) (or 719.106(3)(k) for Cooperatives) (effective May 26, 2022) and local requirements of the Authority Having Jurisdiction (AHJ).

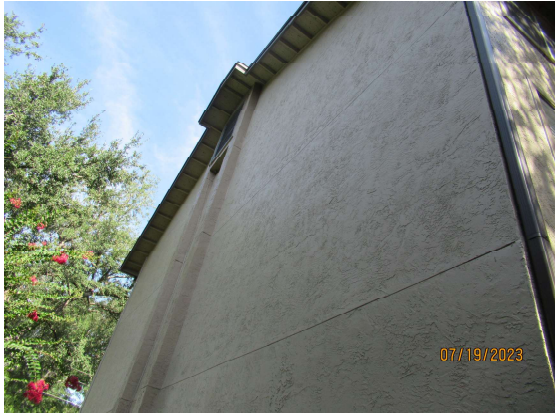
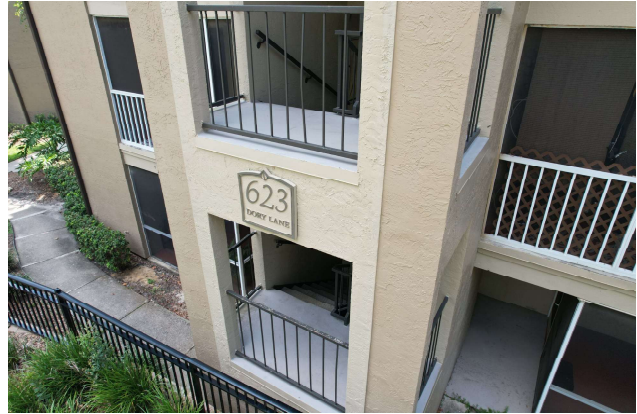
**Exterior Painting - 2027**

Asset ID	1006	1 Lump Sum	@ \$30,000.00
Category	Painting	Asset Actual Cost	\$30,000.00
Placed in Service	January 2020	Percent Replacement	100%
Useful Life	7	Future Cost	\$32,781.81
Replacement Year	2027	Assigned Reserves	\$30,000.00
Remaining Life	3	<i>No Future Assessments</i>
